**PAPUA NEW GUINEA
ACCIDENT INVESTIGATION COMMISSION
FINAL REPORT**

P2-MFK

Gippsland Aeronautics GA8–TC 320

Hard landing - Downdraft undershoot

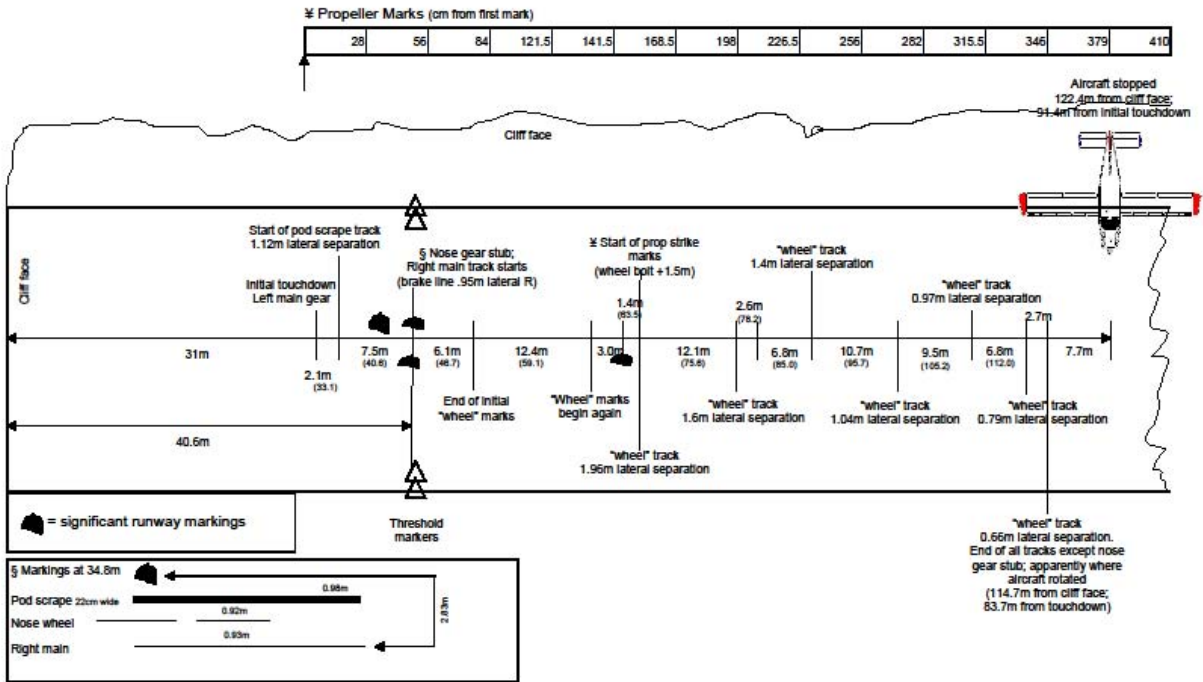
SENDENII Airstrip
MFK Heavy Landing "Wheel" Markings

From marks observed at Sindeni airstrip, the aircraft initial touchdown point was 9.6 meters before the threshold and slightly right of the extended runway centreline. The left-hand main wheel struck the ground first, followed by the left rear corner of the cargo pod, the right main gear, and the nose wheel shortly thereafter. Shortly after the left main wheel struck the ground, the wheel and stub axle assembly were separated from the main gear leg. This assembly bounced up and struck the left side of the aircraft vertical stabilizer with great force, severely damaging it.

As the oleo stub dug in more deeply, approximately 65 m after touchdown, runway marks indicate that the aircraft decelerated strongly enough that the right main wheel lifted off the ground and the aircraft pivoted almost 90° in a clockwise direction. Both pilots indicated that they felt the aircraft was "going to go over". An aircraft overturn would have considerably increased the risk of passenger injury and the likelihood of more serious aircraft damage.
