FINAL REPORT

**PAPUA NEW GUINEA
ACCIDENT INVESTIGATION COMMISSION
AIRCRAFT ACCIDENT REPORT**

P2-MCJ

Double propeller overspeed

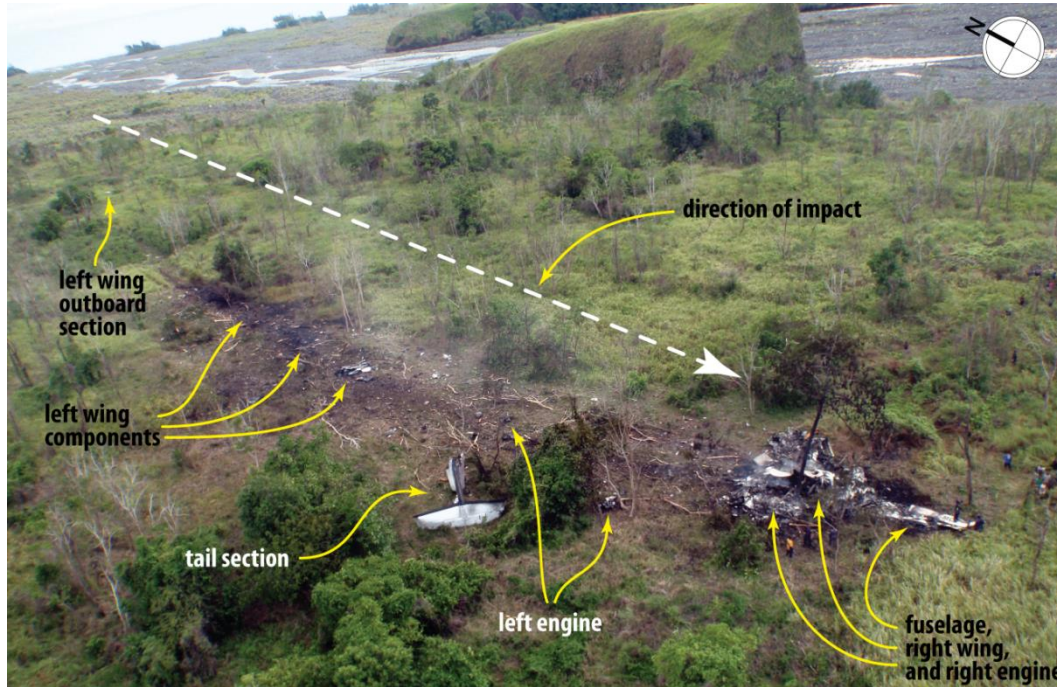
Figure 16: Accident site and wreckage trail

The wreckage trail was approximately 300 metres long, oriented on a magnetic bearing of 175 degrees. Evidence from tree and ground impact marks, and wreckage field length and splay, indicated the aircraft struck the terrain in a controlled state with a shallow angle of entry (Figure 16).

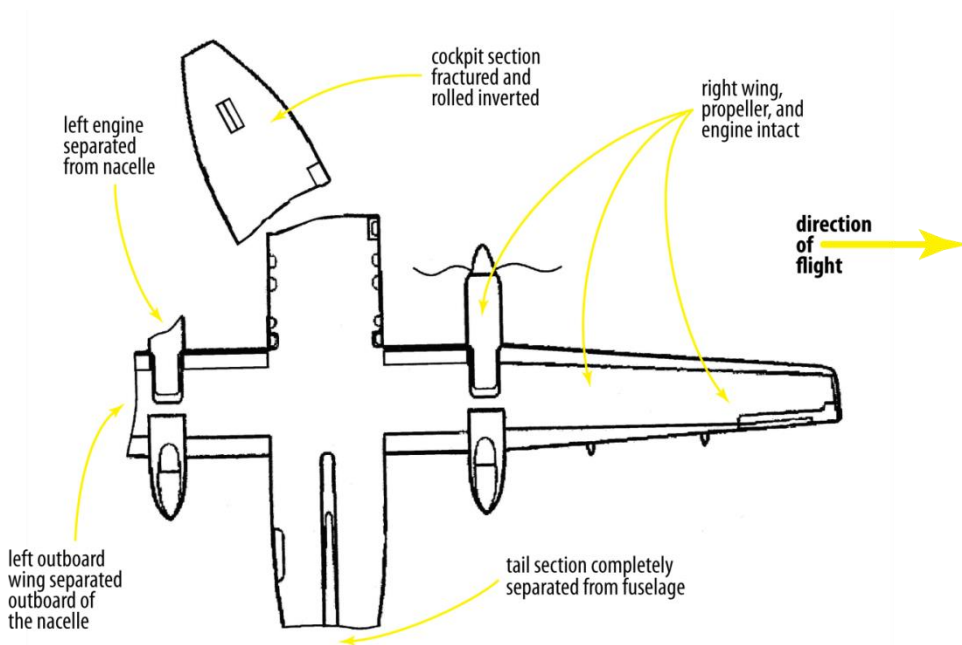
Figure 21: Main wreckage layout

The fuselage was completely incinerated down to ground level by the post impact fire.

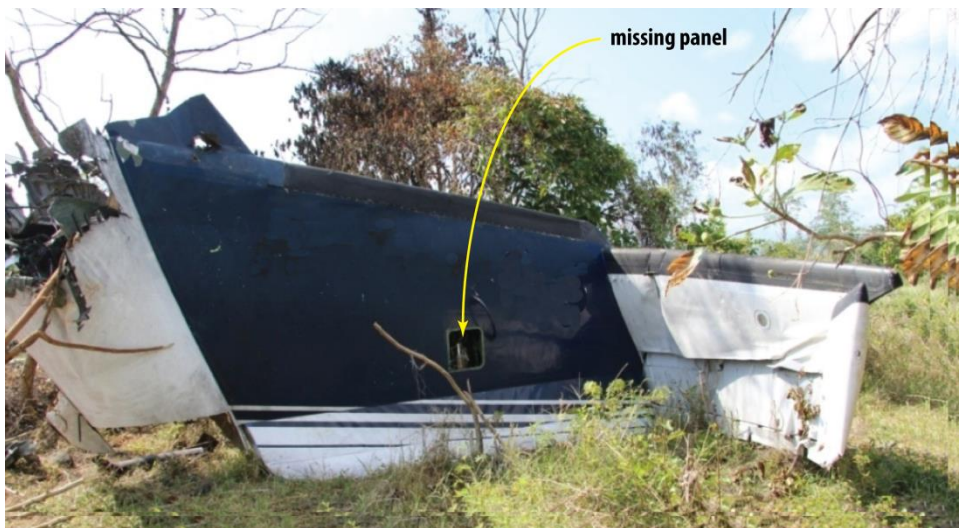
Figure 22: Tail section

Flight control systems were inspected within the tail and no defects were identified. All tail section flight control components were accounted for. The FDR and CVR racks were located in this area of the wreckage

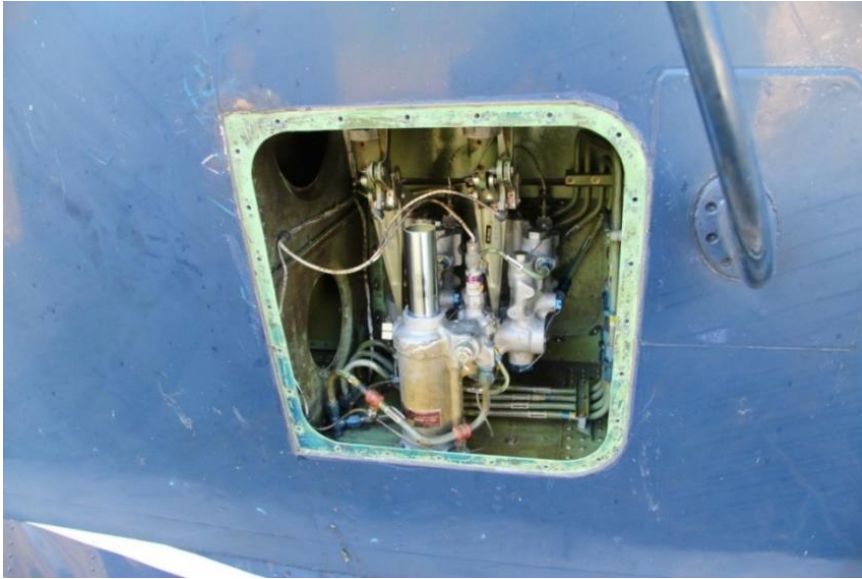
Figure 23: Missing panel on vertical stabiliser

During the on-site investigation, in a period when the investigation team was off-site, persons not associated with and unknown to the investigation team removed a panel from the vertical stabiliser mid-section without permission (Figure 23).

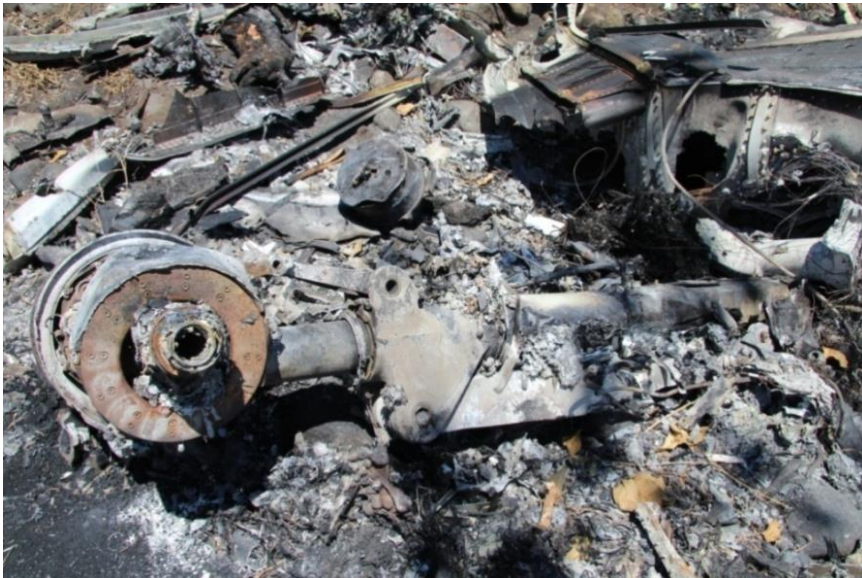
Figure 24: Left main landing gear in retracted position

The left and right main landing gear were inspected on site and noted to be in the retracted position (Figure 24).

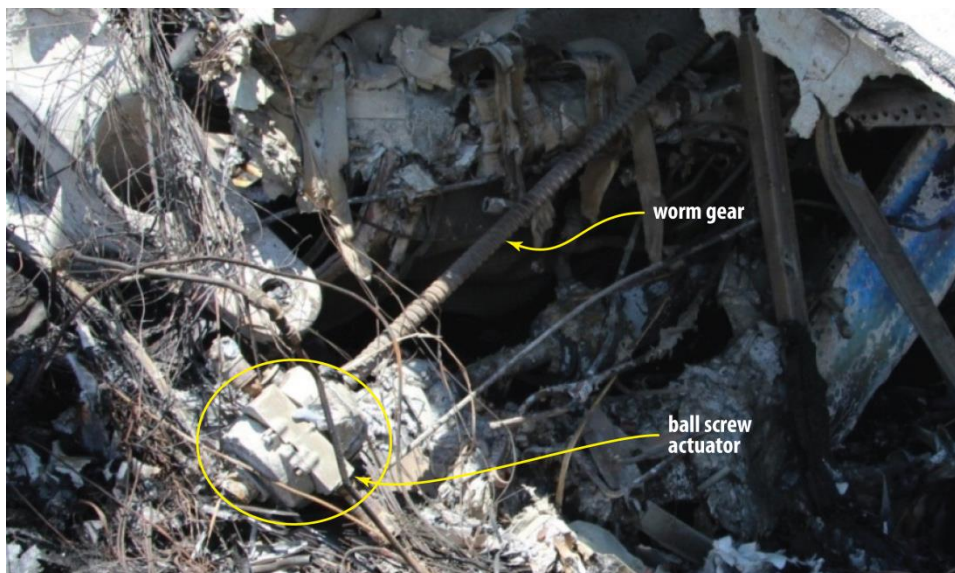
Figure 25: Flap actuator in fully retracted position

The ball screw type flap actuators were located on the accident site. Flap position can be determined from the flap ball screw actuator position on its worm gear. The ball screw actuator positions were noted to be in the fully retracted position (Figure 25).

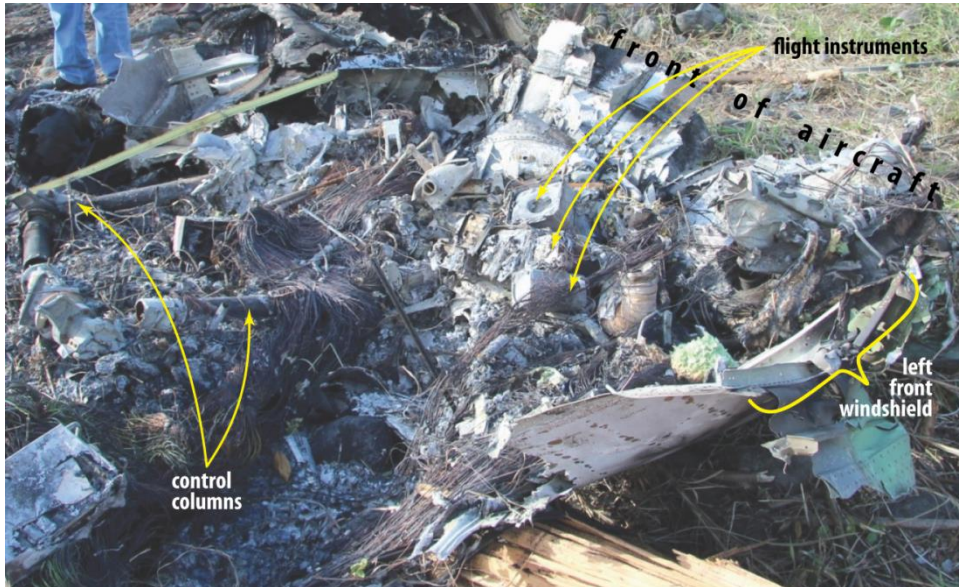
Figure 26: Cockpit section

The complete destruction of the cockpit section prevented a detailed inspection of cockpit instruments and switch settings. Figure 26 shows the cockpit completely incinerated in an upside down position.

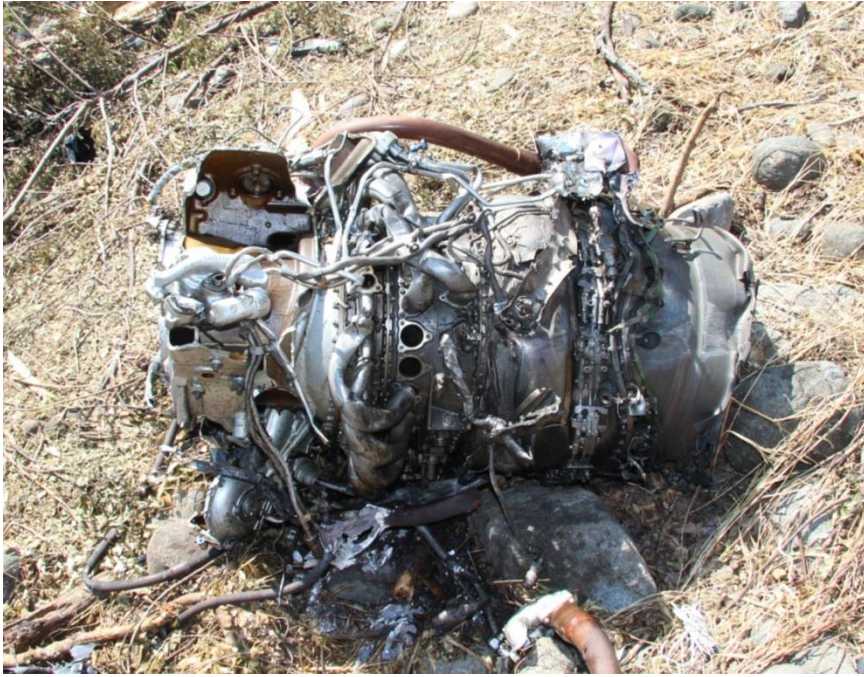
Figure 29: Left engine turbo-machinery section

The turbo-machinery section had significant post impact damage (Figure 29). It was inspected on site through the air intake to the compressor and through the exhaust outlet to the power turbine. The first stage centrifugal compressor had small nicks and gouges present in the blades' leading edges.

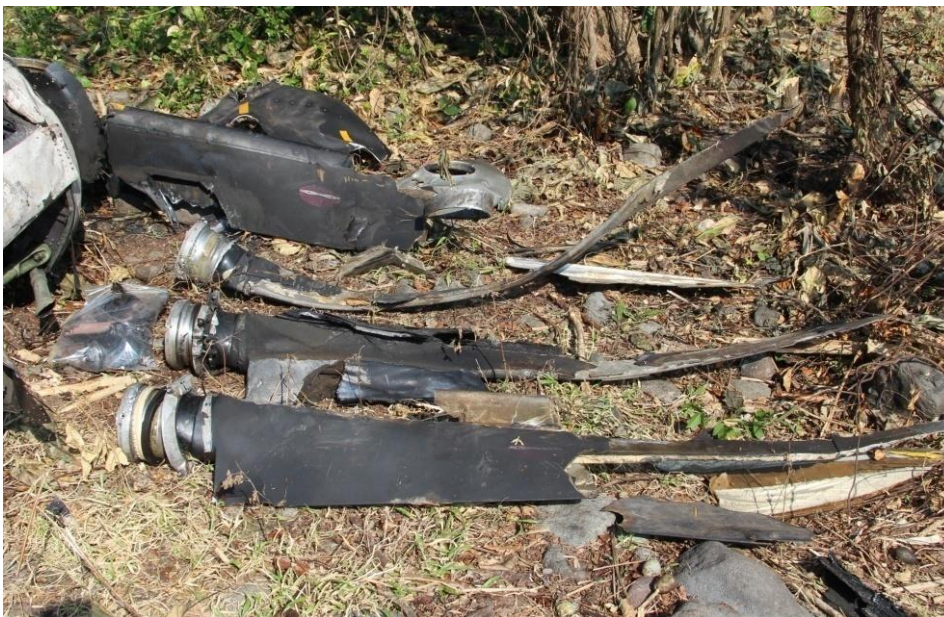
Figure 31: Left propeller blades relocated next to propeller hub

The lack of rotational damage to the propeller blades was consistent with little to no power being delivered to the propeller by the engine at the time of impact.

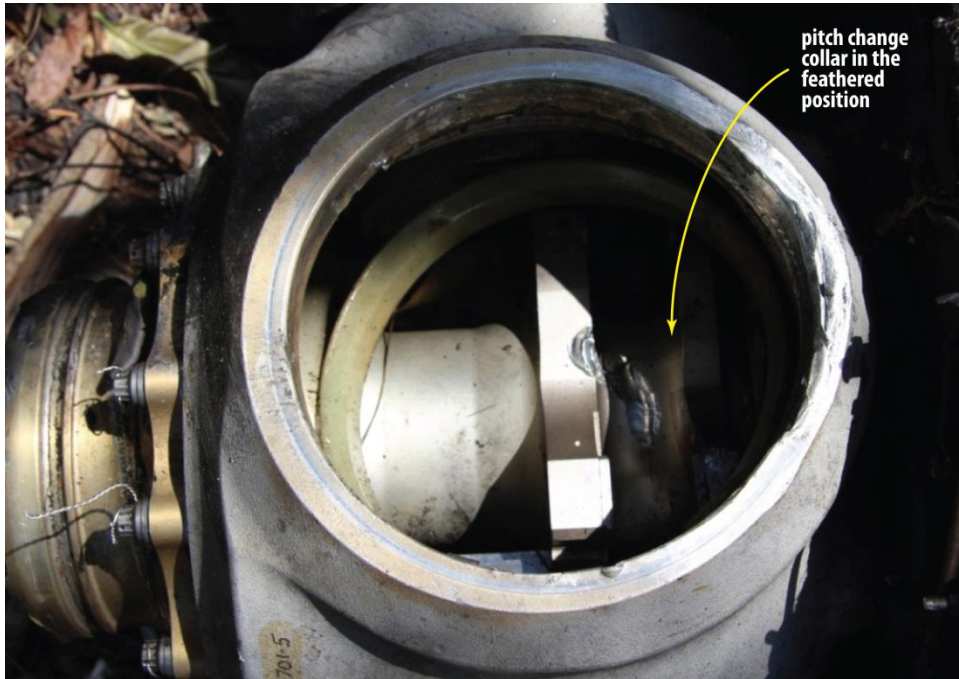
Figure 32: Left propeller actuator

The left propeller actuator pitch change collar was in the fully aft position, which indicated that the propeller was feathered at the time of impact (Figure 32).

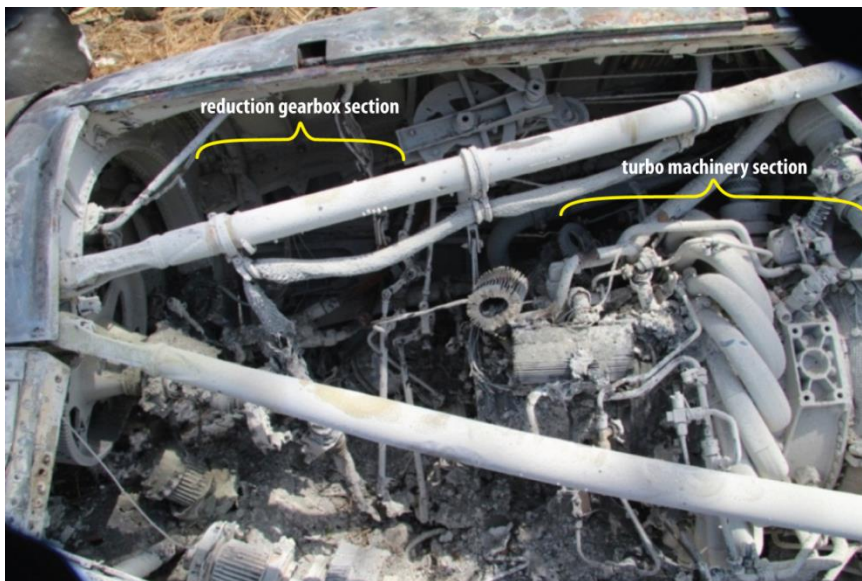
Figure 34: Right engine with left cowl removed

The reduction gearbox to the compressor outer case had been completely incinerated. All of the engine's external components had significant thermal damage which precluded any type of detailed examination (Figure 34).

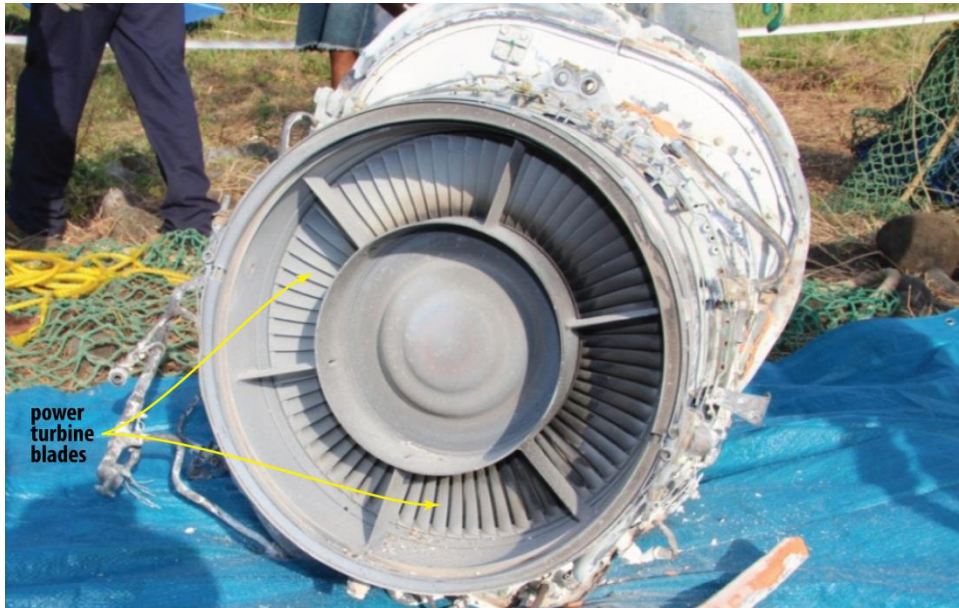
Figure 35: Right engine turbo-machinery section viewed from the rear

The turbo-machinery section remained relatively intact (Figure 35). Inspection through the turbine exhaust outlet revealed that the final stage turbine was relatively undamaged, in contrast to the damage observed in the left engine (Figure 30). No pre-impact damage was identified during the on-site inspection of the right engine.

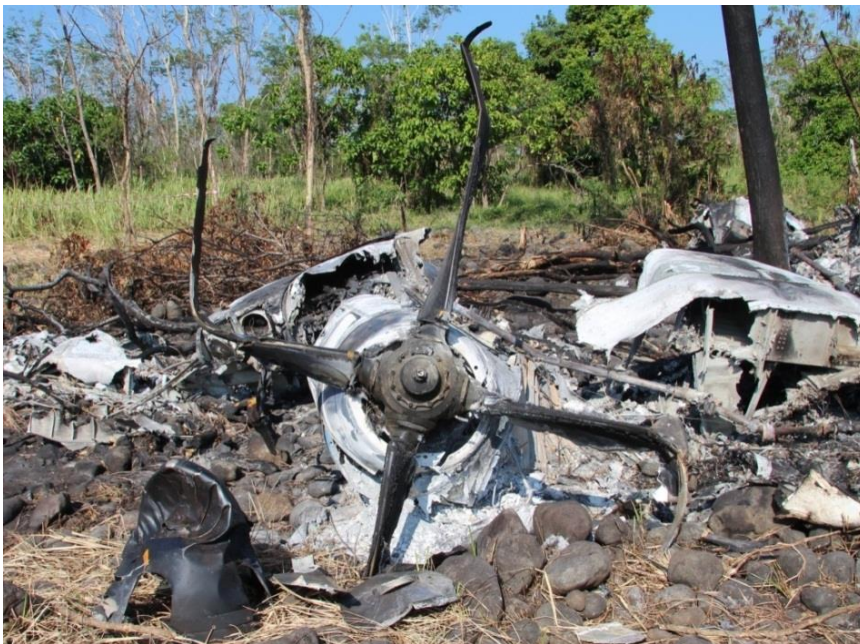
Figure 36: Right propeller assembly with spinner removed

The propeller was found to be intact with all four blades retained within the hub. Damage observed on the propeller blades indicated that they were rotating in the feathered position at slow speed when the aircraft impacted terrain (Figure 36).

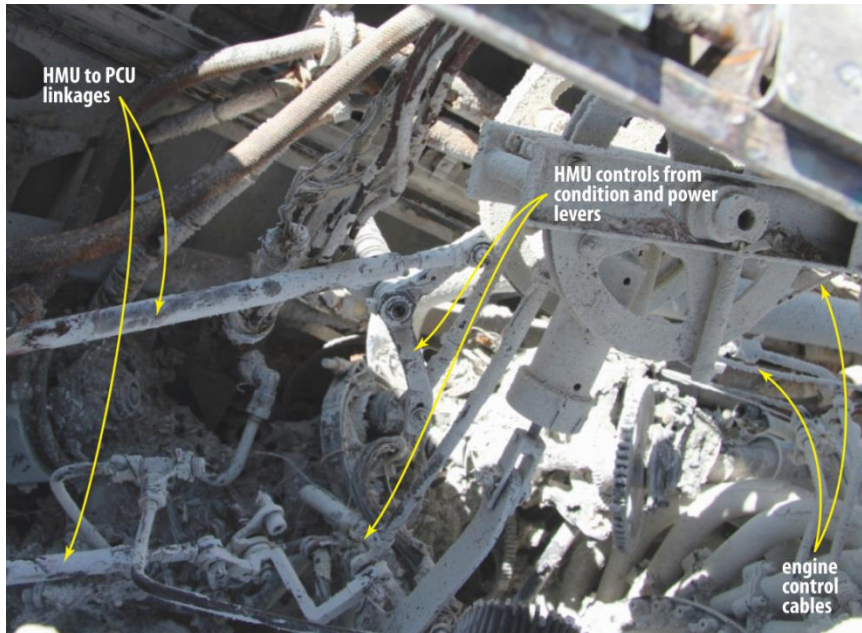
Figure 37: Right engine controls inside nacelle

unit (HMU) control arms even though the HMU had completely disintegrated. The propeller control unit (PCU) linkages from the HMU were also present even though the PCU had disintegrated. Continuity of the controls within the engine nacelle was confirmed, with no defects identified.

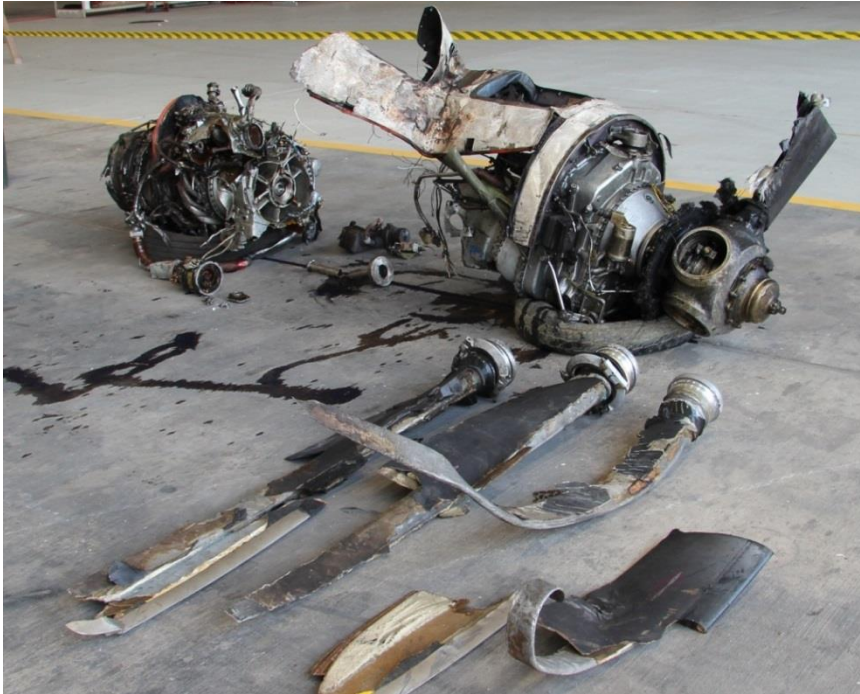
Figure 39: Left engine and propeller after recovery

Figure 39 shows the left engine and components in the condition they were delivered to the hangar in Port Moresby. The propeller blade that remained attached to the hub was cut in its mid-section to facilitate airlifting it from the accident site. The external general inspection did not reveal any anomaly that was not attributable to the propeller overspeed and/or impact damage.

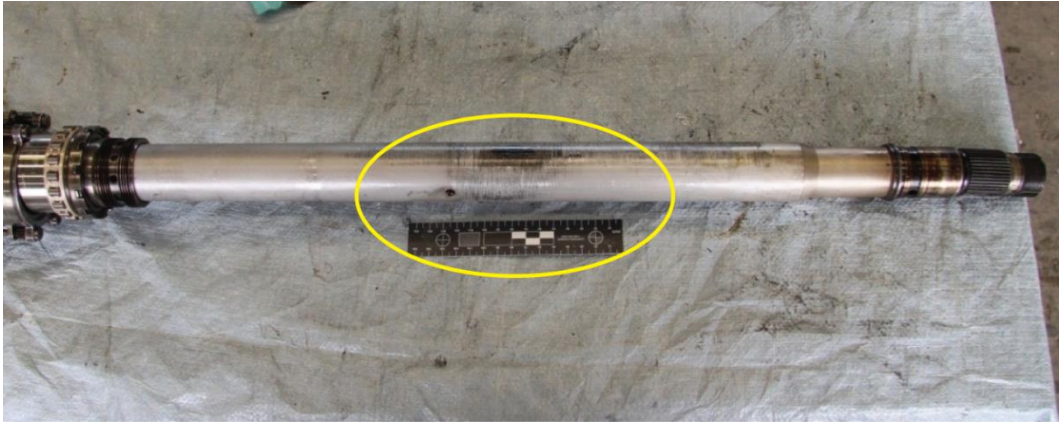
Figure 40: Power turbine shaft with circumferential rub marks

The left engine displayed signs of pre-impact engine failure. The power turbine shaft that connected the two power turbines with the reduction gearbox displayed signs of circumferential rubbing contact marks (Figure 40). The rubbing contact marks were consistent with deflection of the power turbine shaft into the concentric low pressure turbine shaft due to the propeller overspeed reaching or exceeding the power turbine shaft bending critical speed of approximately 130 % N_p .

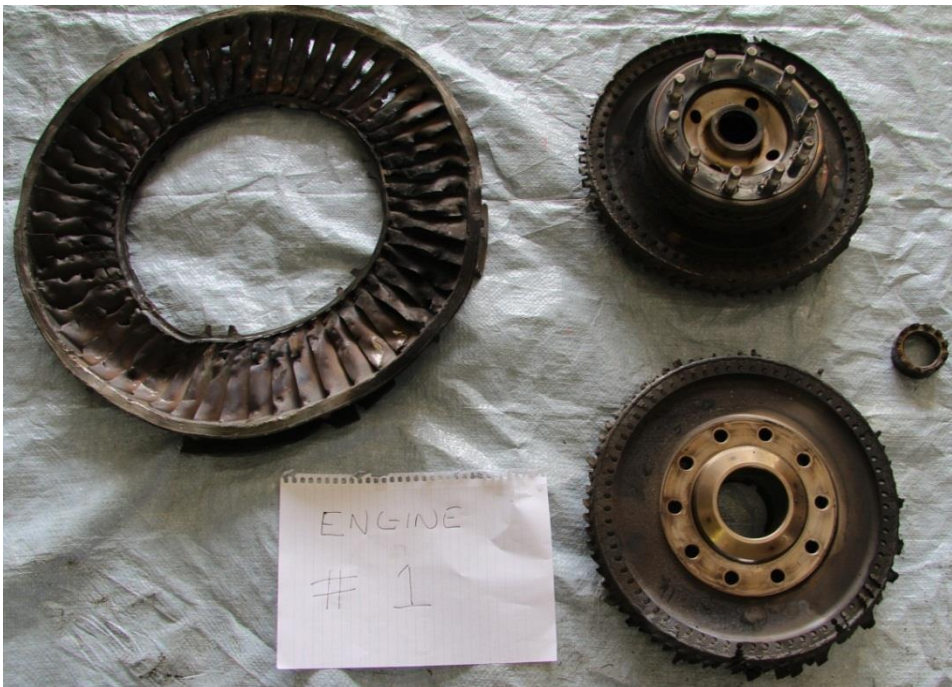
Figure 41: Left engine first and second stage power turbine and nozzle guide vanes

The power turbine blade shedding observed is characteristic of the propeller overspeed reaching the power turbine blade design separation speed of approximately 145 % N_p . The fracture surfaces themselves displayed signs of thermal damage. The damage indicated that the engine had still been running after the power turbine blades had released due to the propeller overspeed. Figure 41 shows first and second stage power turbine blade separation at the roots and significant mechanical damage to the second stage power turbine nozzle guide vanes.

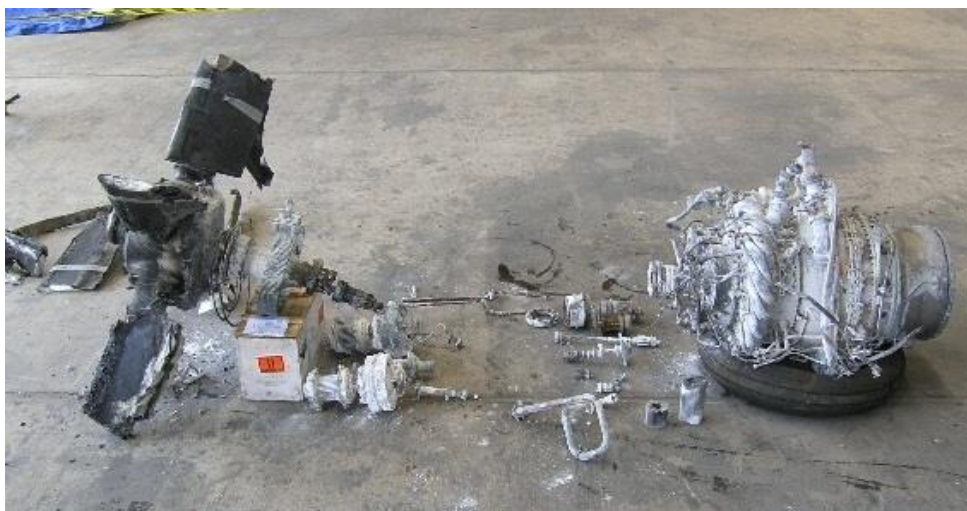
Figure 42: Right engine and propeller as recovered

The right engine was significantly damaged by post-impact fire. The reduction gearbox, overspeed governor and pump, hydro-mechanical unit, and propeller control unit outer casing were incinerated which precluded them from inspection. The PCU worm gear could still be inspected (Figure 42).

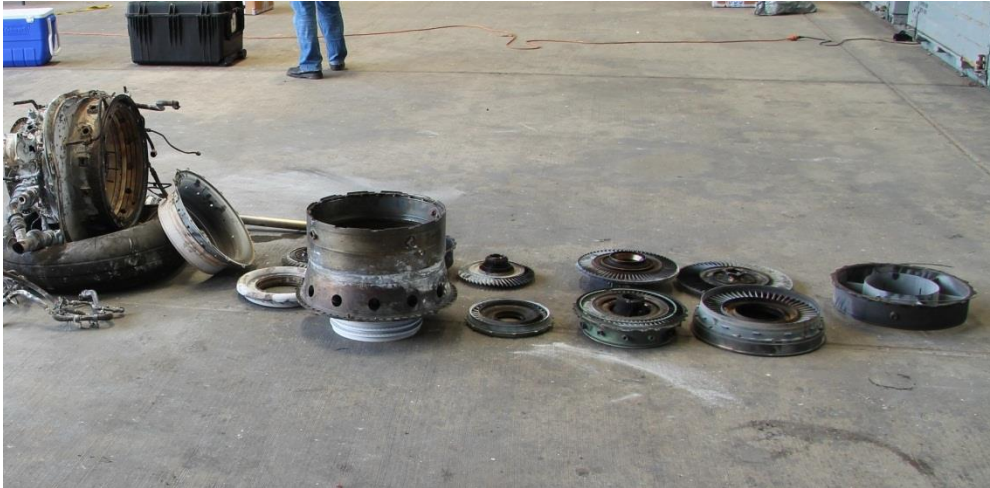
Figure 43: Disassembled right turbo-machinery section

The turbo-machinery section was relatively intact and was disassembled and inspected in detail (Figure 43). The turbo-machinery section exhibited no internal mechanical damage, nor any evidence that it had been back-driven by a significant propeller overspeed. This was in contrast to the left engine which had significant propeller overspeed-related damage. Further, the turbo-machinery section did not display any signs of pre-impact defects.

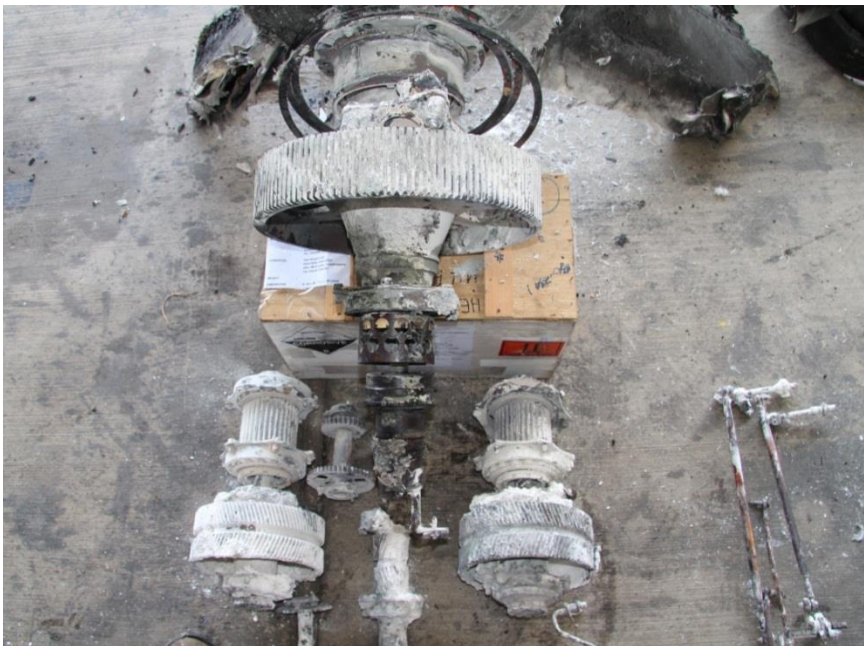
Figure 44: Right engine reduction gearbox section as recovered

The reduction gearbox housing was completely consumed by fire. The reduction gearing was contained in the nacelle area and was recovered separately. The remaining components of the reduction gearbox were inspected, including all the internal gears, propeller control unit worm gear, and the propeller transfer tube which was still connected to the core of the PCU (Figure 44). No pre-impact anomalies were identified in any of these components.

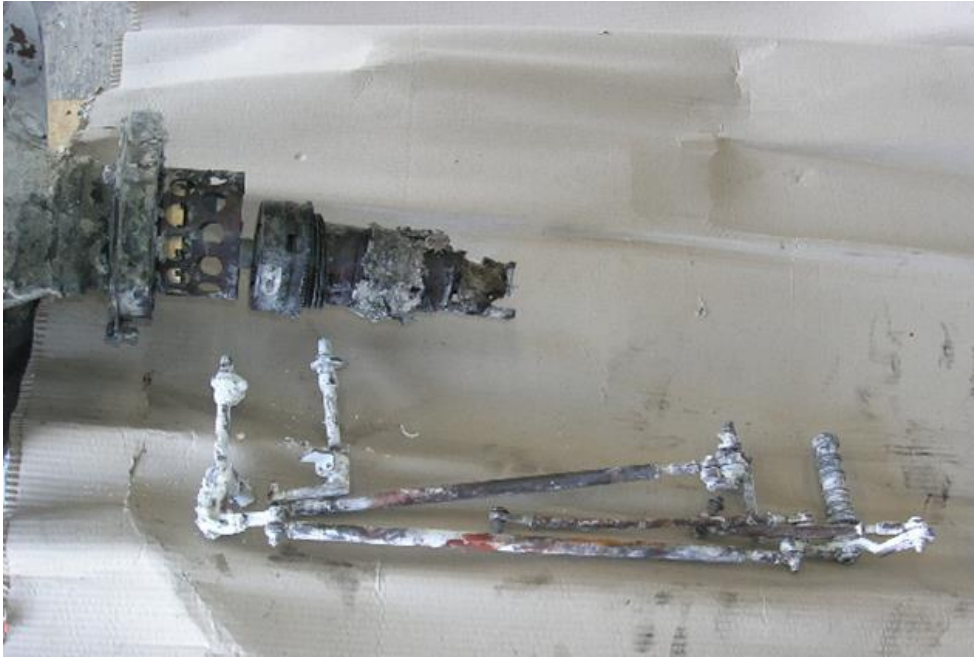
Figure 45: Remaining section of PCU and PCU to HMU linkages

The only remaining section of the PCU available for inspection (Figure 45) was the servo control unit which was still attached to the propeller transfer tube. No pre-impact anomalies were identified within the servo control unit.

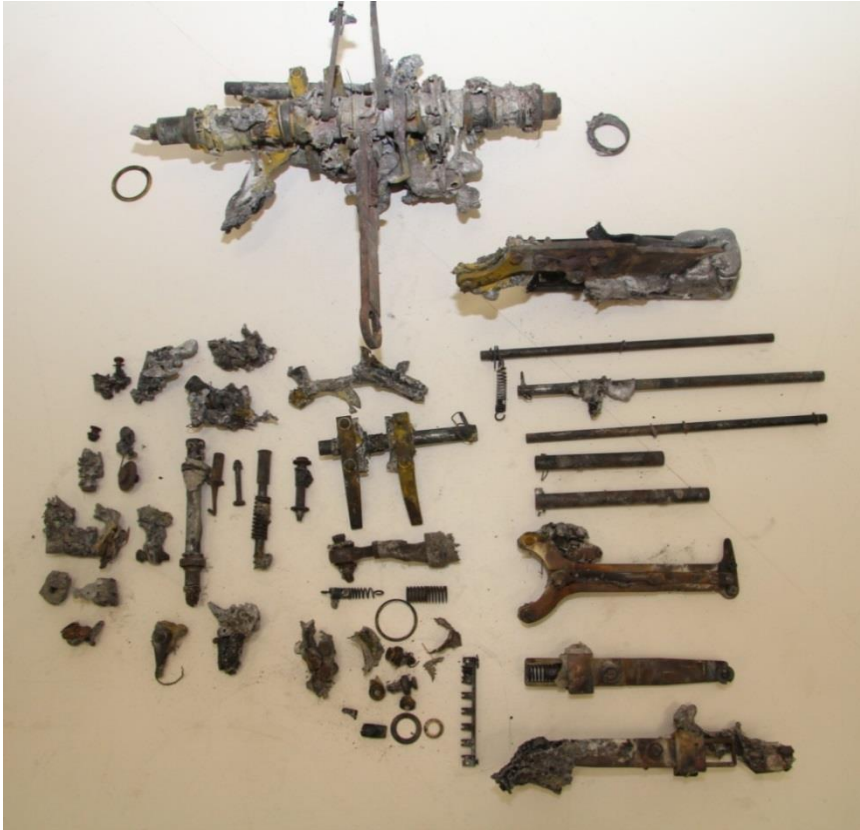
Figure 46: Power lever quadrant components

A detailed examination of the remaining components of the power lever quadrant (Figure 46) was conducted. The inspection revealed that the springs that hold down the power lever triggers were in place and intact.

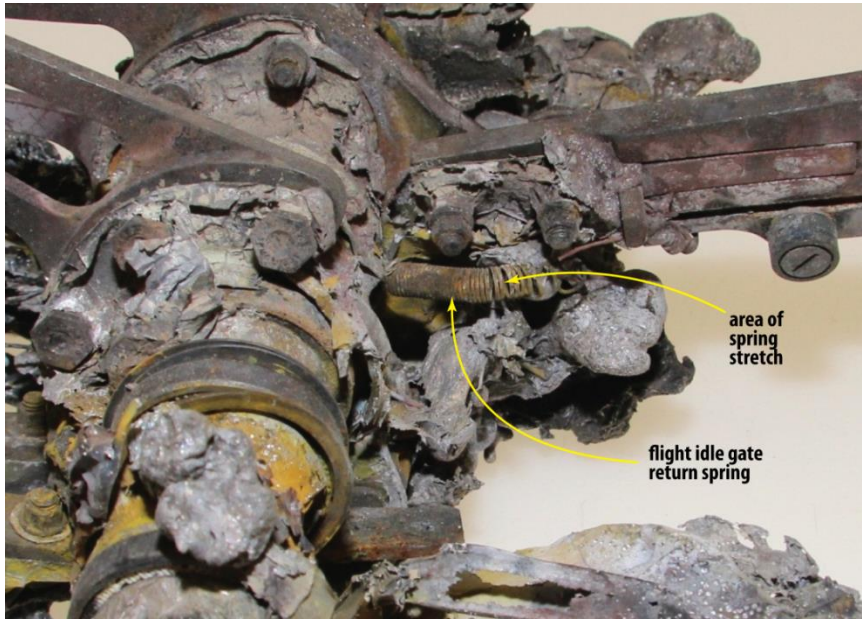
Figure 47: Close-up of power lever quadrant with flight idle return spring

A detailed inspection of all the power lever quadrant components was conducted with no pre-accident defects identified.

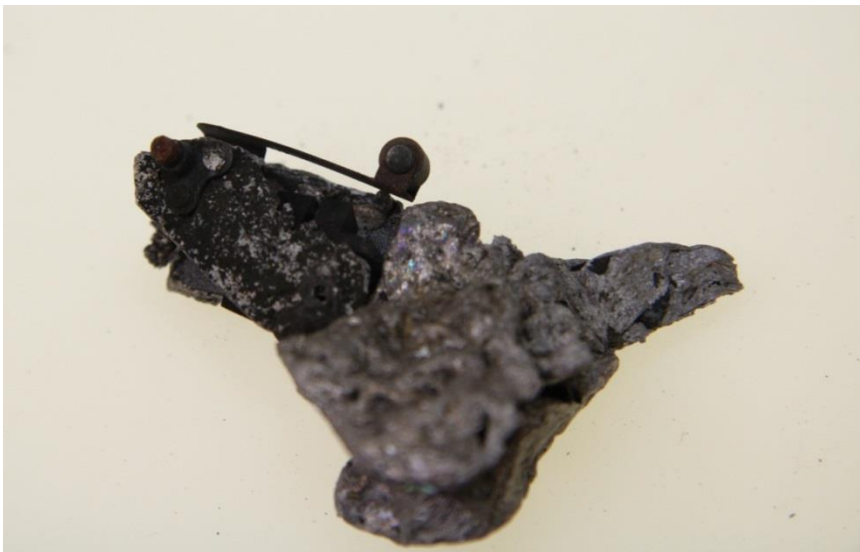
Figure 48: Close-up of the beta warning horn microswitch

The microswitch that activates the beta warning horn was recovered. It had significant thermal damage which precluded any type of functional test (Figure 48).
