AIC 14- 1006

**PAPUA NEW GUINEA
ACCIDENT INVESTIGATION COMMISSION
SHORT SUMMARY REPORT**

21 September 2014

VFR into IMC – contact with trees involving Bell 206L, P2-HCO

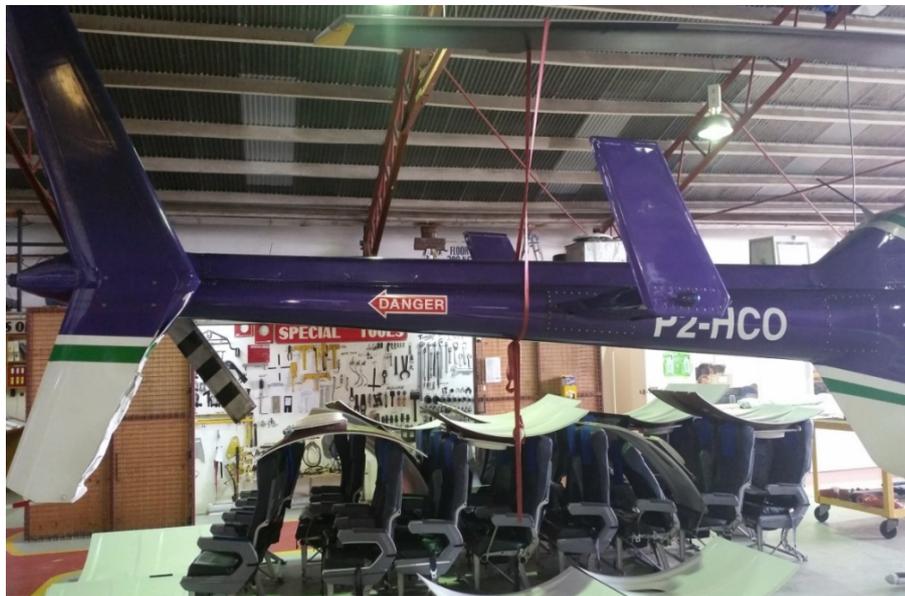
The pilot took evasive action by pulling back on the cyclic and raising the collective to avoid colliding with the trees. He was able to manoeuvre away, but during the turn the lower section of the vertical stabilizer and the tail rotor blades made contact with the trees.

Figure 2: Damaged lower section of the vertical stabilizer

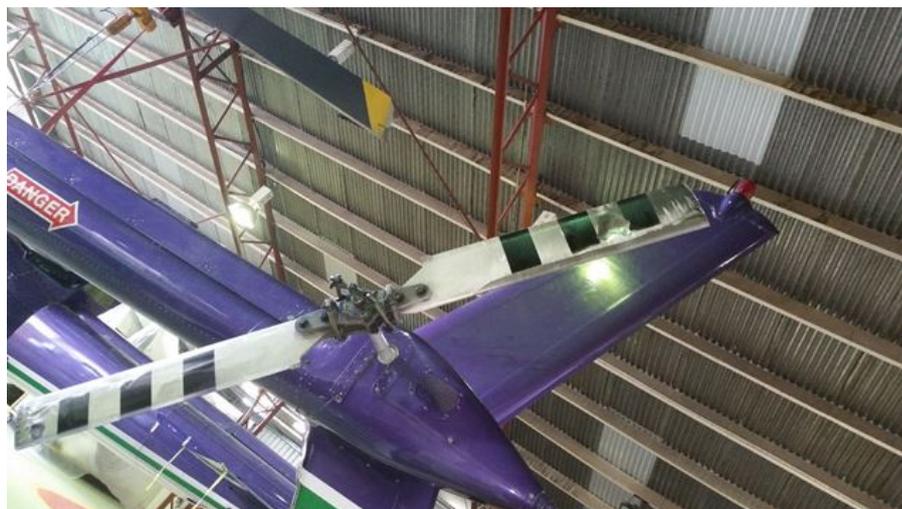
Figure 3: Evidence of tail rotor damage
