**AIC 15-1002**

**ACCIDENT INVESTIGATION COMMISSION**

**P2-NOX**

**Engine failure - fuel starvation**

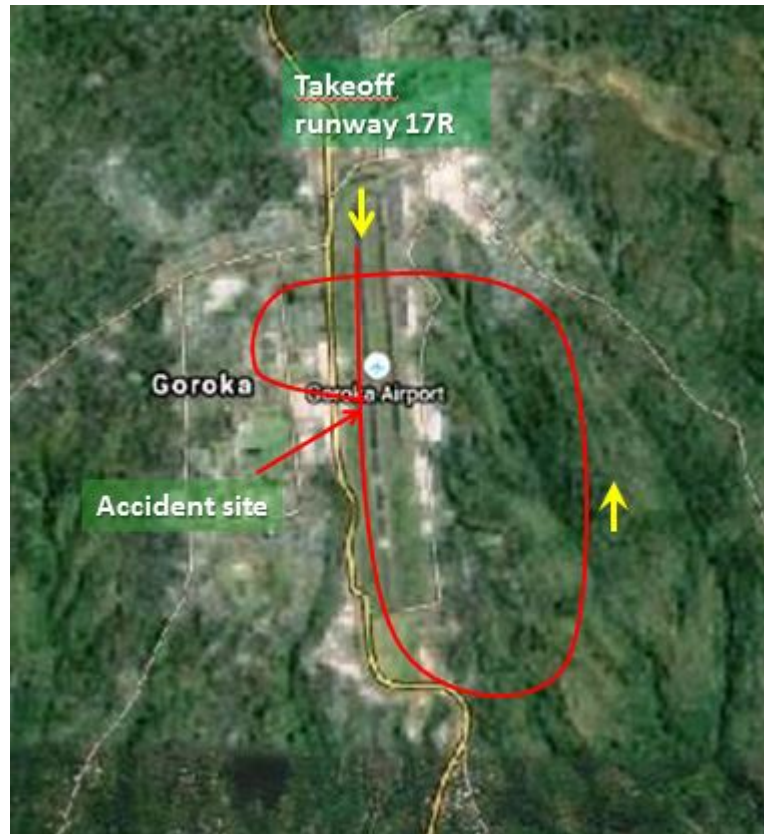
Figure 1: Aerial view of the flight path.

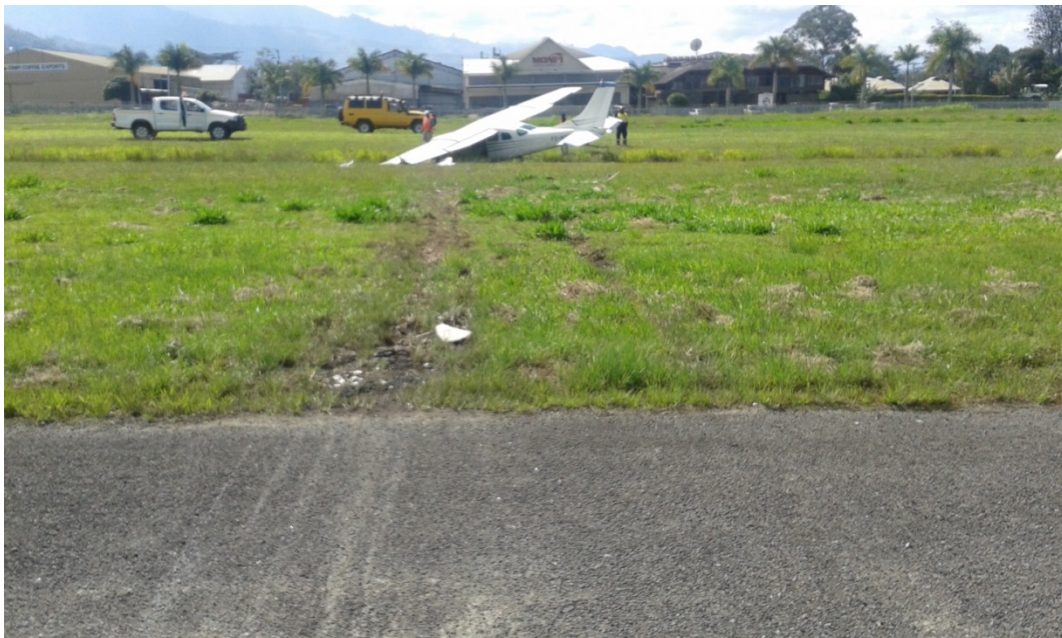
The takeoff for the third circuit was normal and the pilot did a left turn to position the aircraft on the dead side at circuit height. He turned crosswind abeam the tower for a left downwind runway 35. During the turn the engine's power decreased and then failed. The pilot reported that he attempted to restart the engine a couple of times, but the engine failed to start. He manoeuvred the aircraft and position it on left downwind for runway 35 left. Realising that he was losing height rapidly and would not reach the threshold of runway 35 left, the pilot turned the aircraft towards the airstrip to land across the runway. The aircraft touched down heavily across runway 35 left, destroying the cargo pod, and continued onto the grass between the two runways,. After travelling approximately 100 m the aircraft ending up in the drain east of runway 35. It was substantially damaged.

Figure 2. Initial impact point

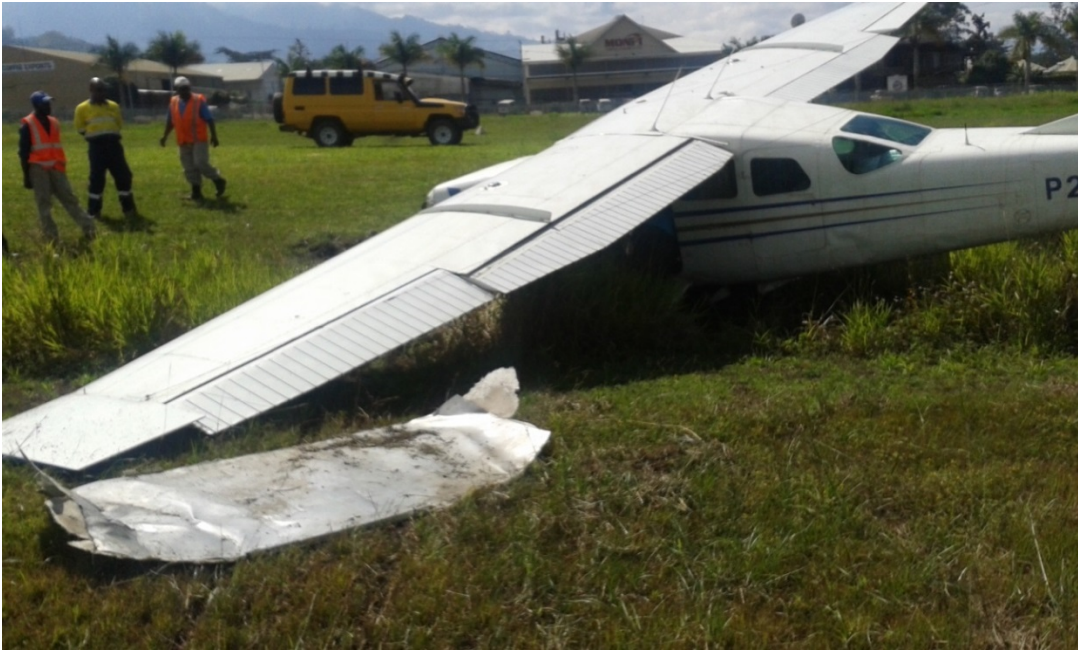
**Figure 3. Aircraft coming to rest in the drain**

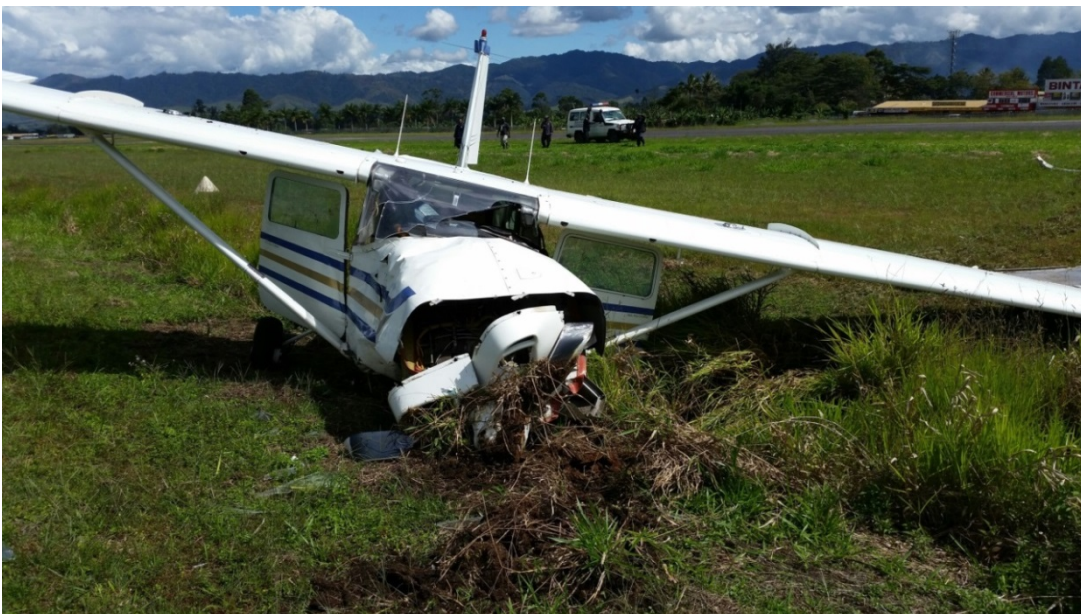
**Figure 3: Damage to the propeller and the engine.**

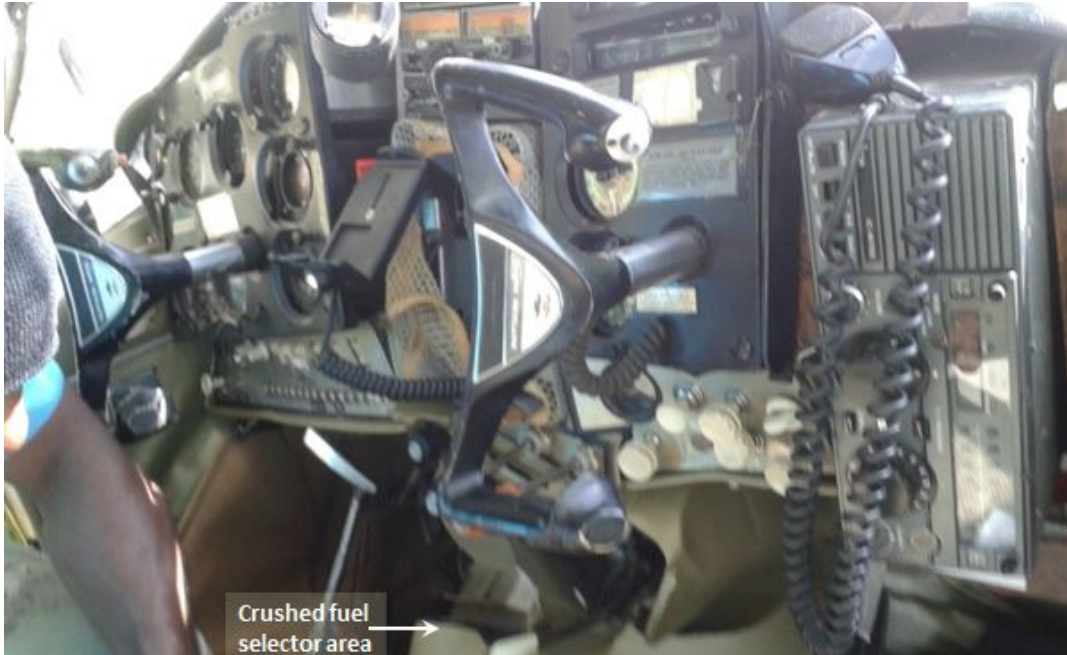
The AIC investigators checked the aircraft's fuel tanks and found that the right tank had no fuel in it. The left tank had some fuel in it, but the contents could not be verified because the wing was sitting at an angle. The fuel selector valve position could not be verified because the area of the cockpit where the selector valve was located was crushed and distorted during the impact with the drain area.

**Figure 4. Damage to the cockpit area**
