AIC 14 1008

**PAPUA NEW GUINEA
ACCIDENT INVESTIGATION COMMISSION
SHORT SUMMARY REPORT**

P2-HBS

Loss of tail rotor effectiveness during landing

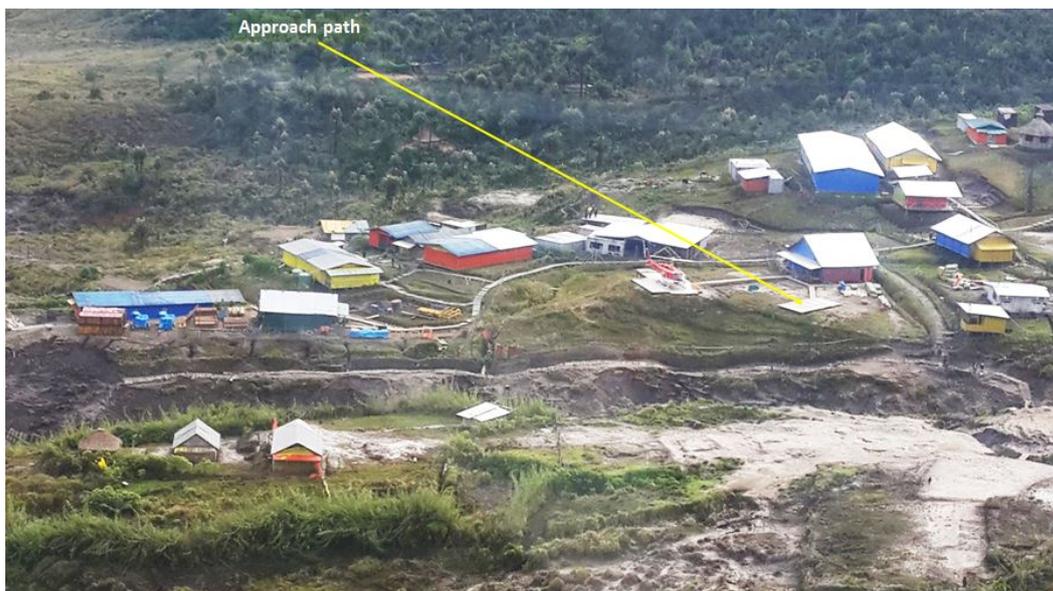
On approach to land with the weight 109 kg above the maximum permissible gross weight and high density altitude, power available was less than power required to maintain control at low airspeed close to the ground.

Figure 1: The approach path

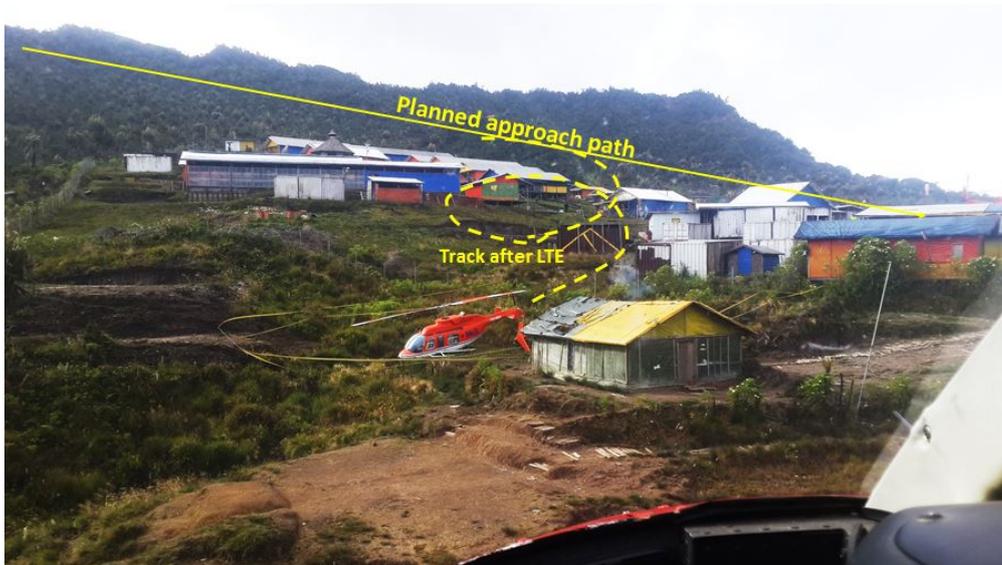
Witnesses on the ground stated that ‘the approach did not look like anything out of the ordinary; it was not steep, nor shallow’. Approximately 4 m from the pad, the helicopter started to make a slow 180° turn to the right while descending. The helicopter then rapidly rotated through another 360° and ended up approximately 150 m northwest of the helipad.

The helicopter entered a Loss of Tail Rotor Effectiveness (LTE) condition and the pilot lost control of the helicopter at a low height from which recovery was not possible. The helicopter impacted the ground at 04:06 UTC².

Figure 2: The flight path after Loss of Tail Rotor Effectiveness

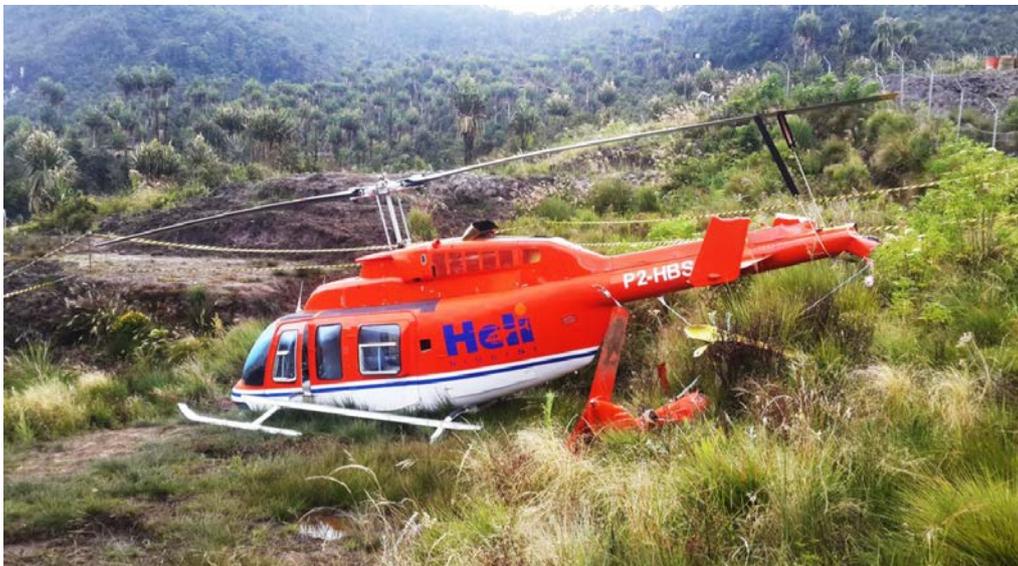
Figure 3: Bent skids and severed tail boom as a result of heavy landing

The AIC determined that the pilot attempted to land the helicopter at high altitude at a weight 122 kg above the allowable HOGE weight at that altitude. Because the power available was less than power required to maintain control at low airspeed close to the ground the helicopter lost tail rotor effectiveness.

Pilots are to utilize company W&B forms requiring them to fill in the boxes and determine aircraft suitability. It also requires pilots to use HOGE performance and not HIGE performance figures as the determining factor. The technique for landing is to arrive in Ground Effect (IGE) so that the extra margin enhances safety.
