FINAL REPORT

AIC 15-2029

Bell Helicopters B407

In-flight External Load Jettison

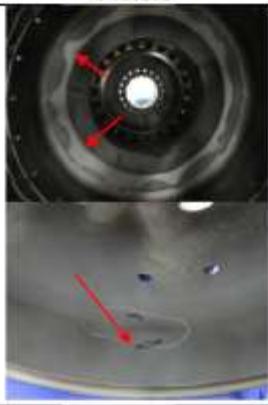
Nomenclature / Discrepancy / Disposition	Picture
Combustion Liner 23064570

CRACKS ON RELIEF SLOTS, DOUBLE LIP AREA & DEFLECTOR PLATE RELIEF SLOTS. [REPAIR]

The combustion Liner exhibiting cracking which we feel is repairable. The cost of these repairs can be extensive and easily reach the point of beyond economical repair. That part has been advance shipped to a Rolls Royce authorised repair station for assessment. A new part is held in stock should the repair cost be considered uneconomical.

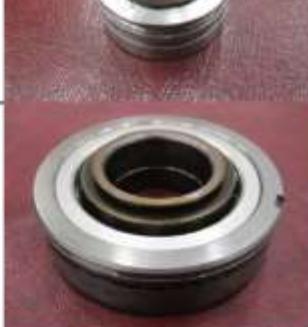
Nomenclature / Discrepancy / Disposition	Picture
No.1 BEARING 23066716 Scoring on rollers [REPLACE]

MATING RING 23004514 Scored sealing face. [REPLACE]

SEAL ASSY 23004513 Fail leak test [REPLACE]

BEARING, BALL 23009670 CEB 72-6067R1 COMPLIANCE. [REPLACE]
