## INTERIM FACTUAL REPORT

AIC 19 -1002

Air Tractor AT-502B

Impact with tree

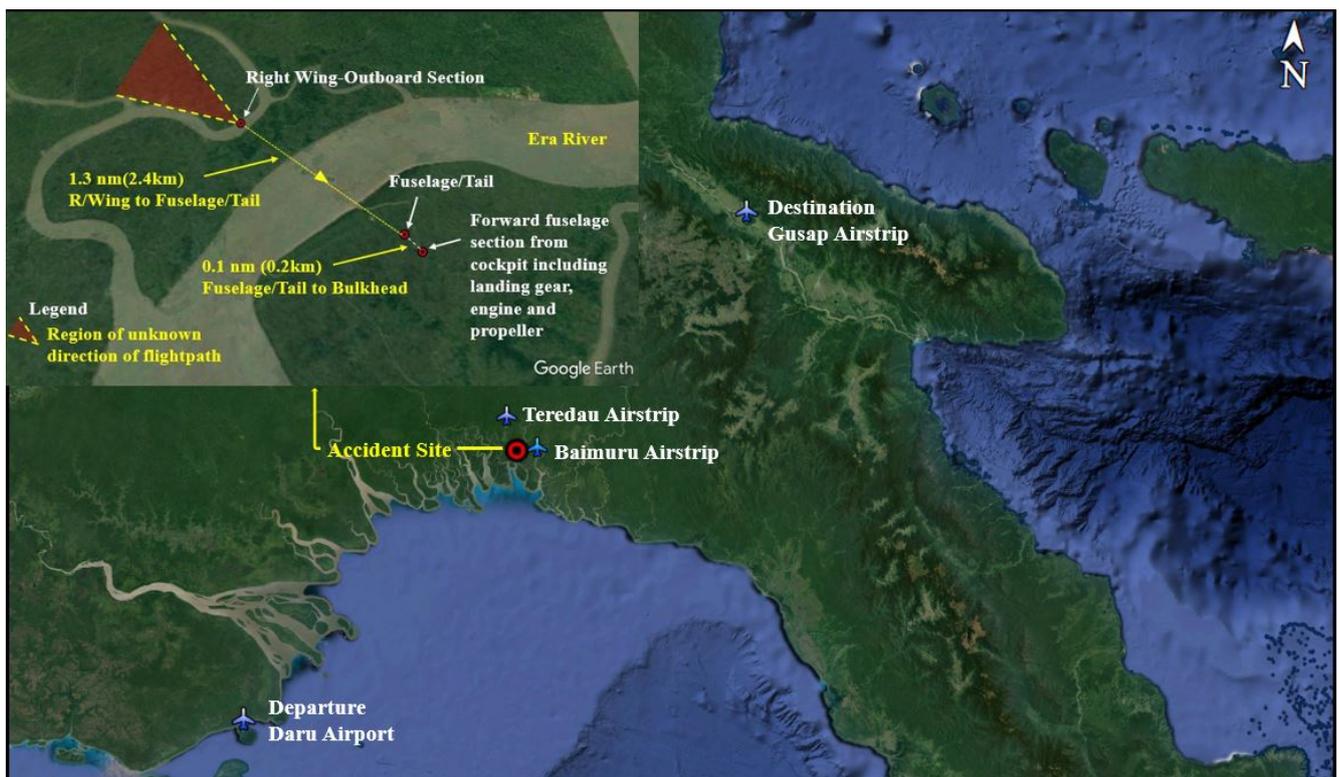
Figure 1: Depiction of accident location in relation to Baimuru Airstrip

The investigation team found that the outboard section of the aircraft’s right wing was torn off as the wing clipped palm trees. The aircraft continued for another 1.3 nm before it impacted a thick tree trunk about 13 metres above ground level. The forward fuselage and engine section separated from the airframe at the bulkhead between the cockpit and the hopper. The forward fuselage including the hopper, main landing gear, engine and propeller continued another 290 metres along the direction of the flight path before becoming deeply embedded in mud. (See figure 1).

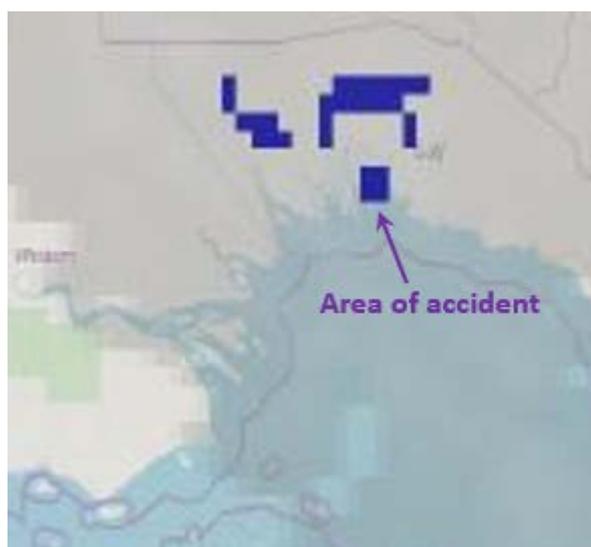
**Figure 2: Weather in the area of the accident.**

In Figure 2 the grey area is low cloud and light rain across the whole area. The blue areas denote rain.
