INTERIM FACTUAL REPORT

AIC 19-1003

P2-TAH

Helicopter Impact with water

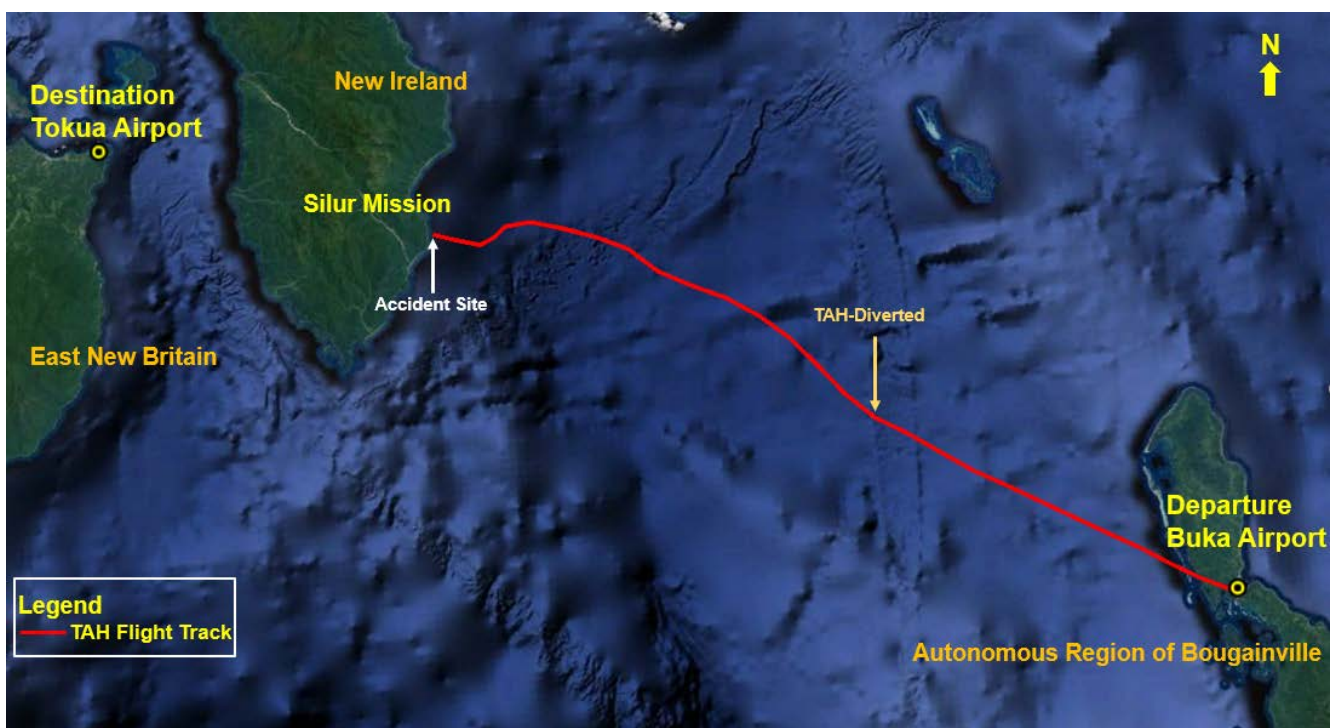
Figure 1: TAH recorded track from depart to accident.

At 00:45 the pilot made a routine report to Air Traffic Services that his operations were normal, below 5,000 ft and he was estimating Tokua at 01:25. The helicopter failed to arrive at Tokua and wreckage of the helicopter was subsequently located approximately 0.9 nm seaward of the coast about 4 nm south east of Silur Mission, New Ireland Province.

During the investigation interview, the passenger informed the AIC investigators that they flew through bad weather and had to divert to the nearest land, on the south east of New Ireland Province. The cloud was very low and visibility was significantly reduced in rain. The flight track data on *Spidertracks* showed that the aircraft diverted from its planned track about 50 nm north west of Buka Airport.

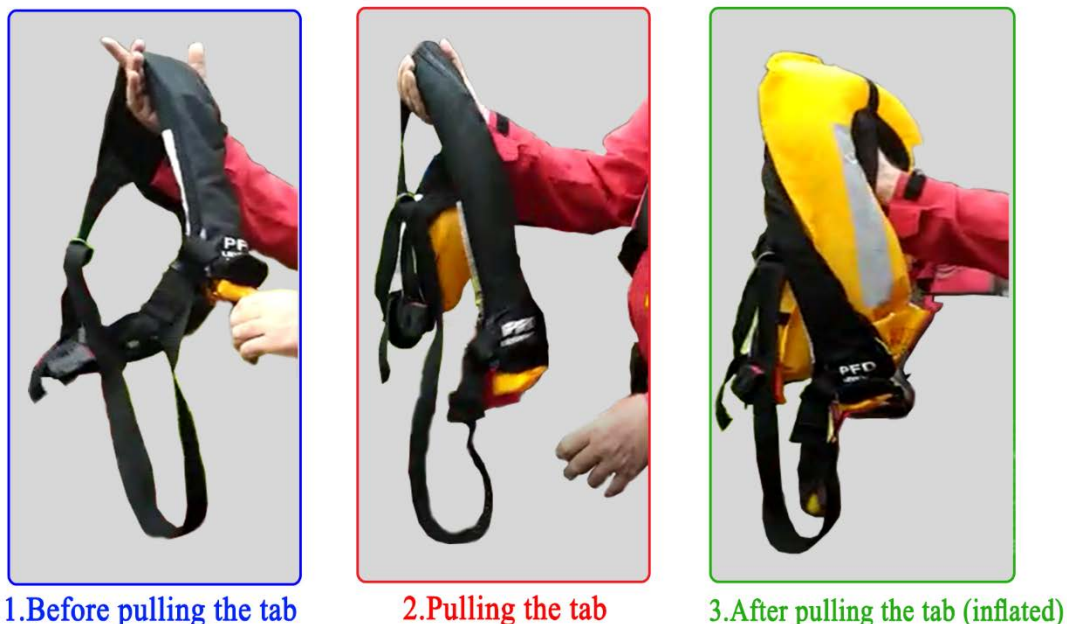
Figure 2: Testing the pilot's life jacket

The pilot was wearing a life jacket, but it was not inflated. The life jacket was subsequently tested during the day following the accident and it inflated normally. The reason the life jacket was not inflated is yet to be established. The investigation is awaiting the pathologist report to determine the manner and cause of the pilot's death.
