PRELIMINARY REPORT

AIC 20-1002

Cessna 208 Caravan

Loss of control during landing at Miyanmin Airstrip

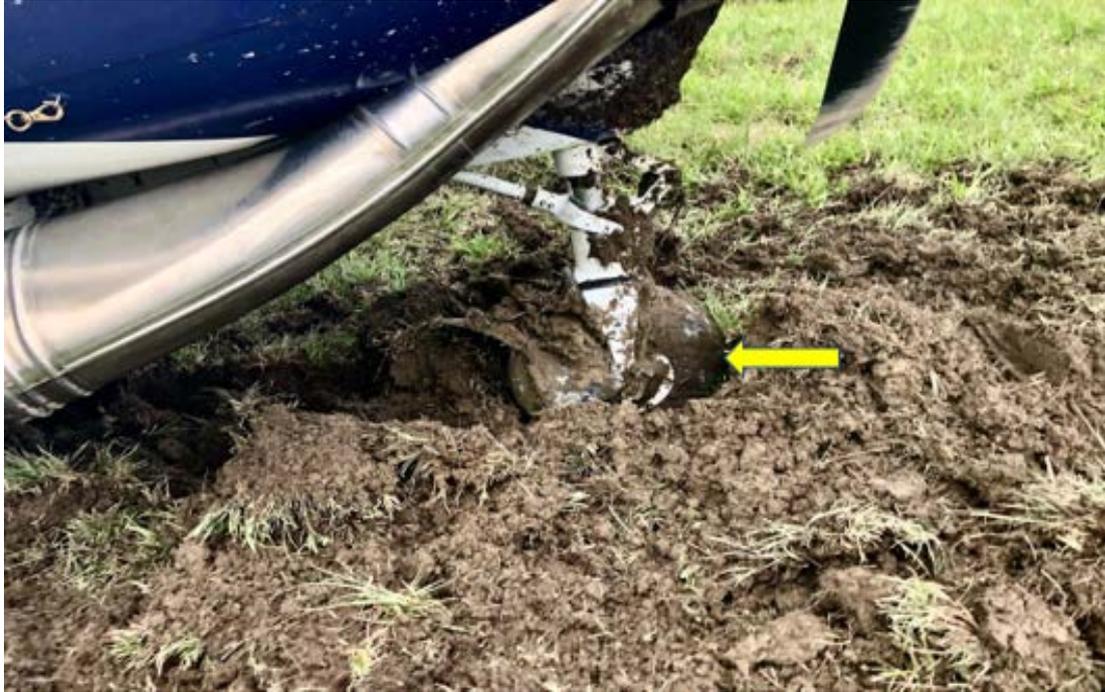
Figure 2: Nose wheel bogged in soft mud

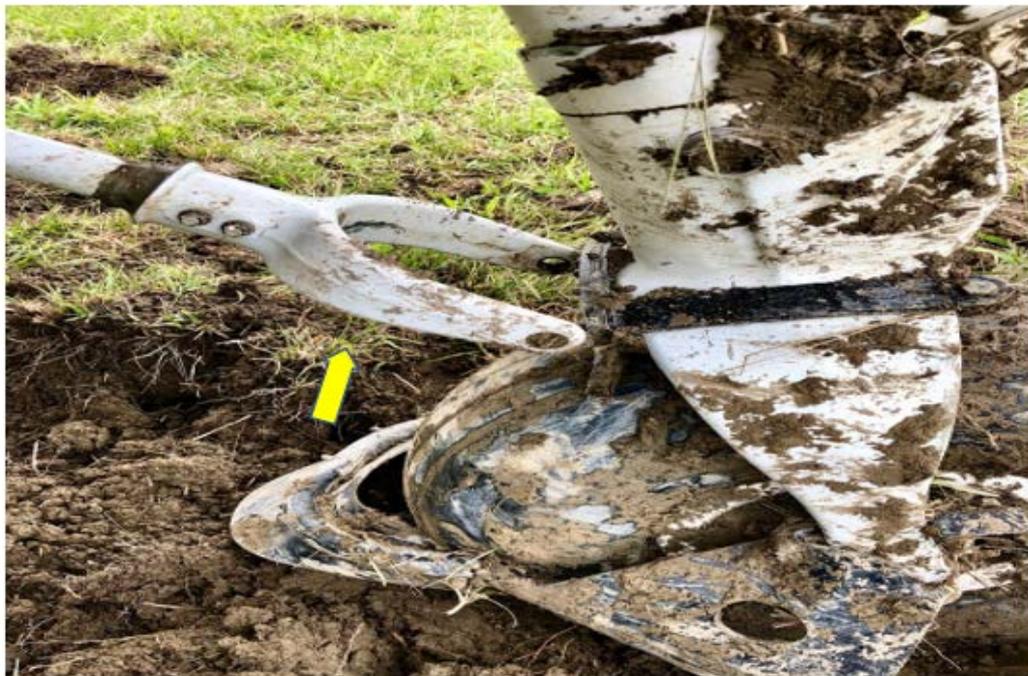
The aircraft sustained substantial damage. The nose landing gear spring attachment bolts had sheared off resulting in the drag link spring getting detached from the Nose wheel landing gear (NLG). The three propeller blades were bent and the outboard aileron section of the right wing was bent upwards.

Figure 3: Detached NLG Spring from nose wheel landing gear

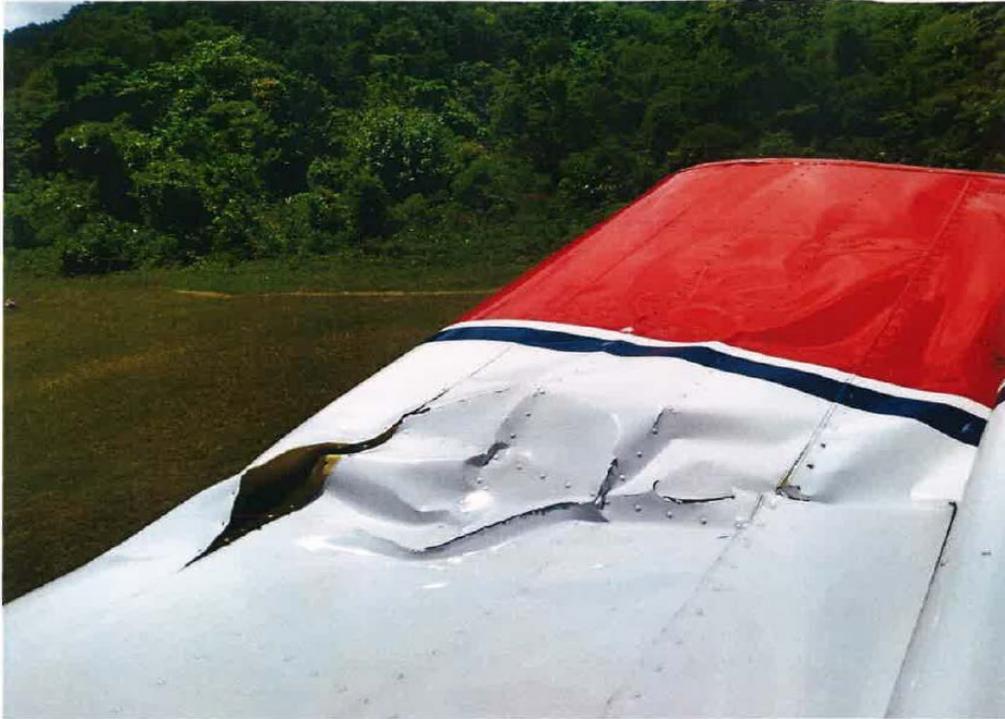
Figure 4: Right-hand wing tip damage

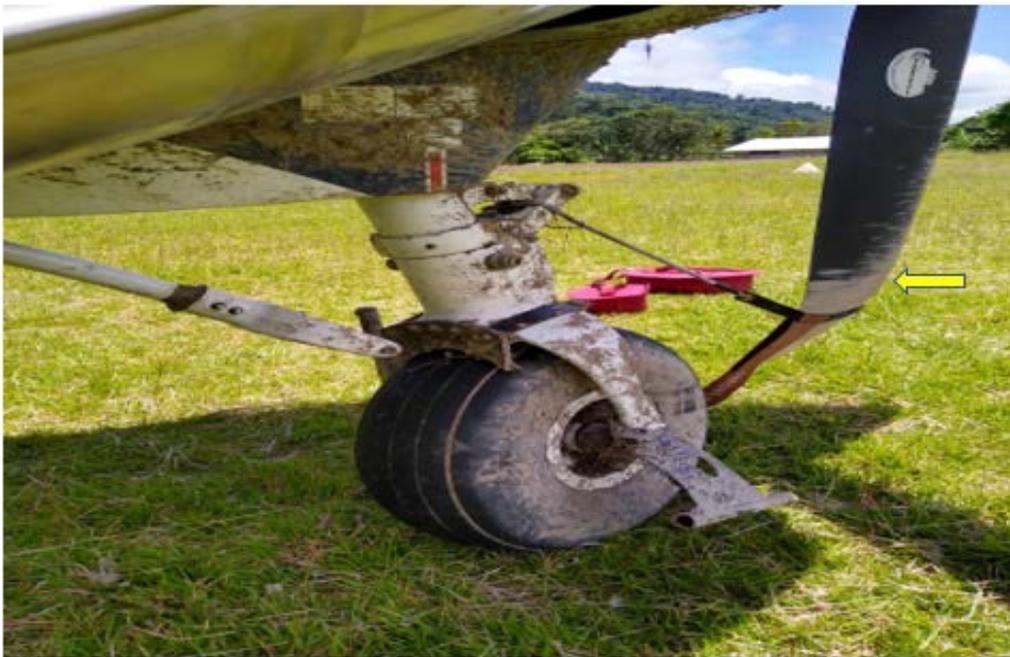
Figure 5: Evidence of damage in a propeller blade

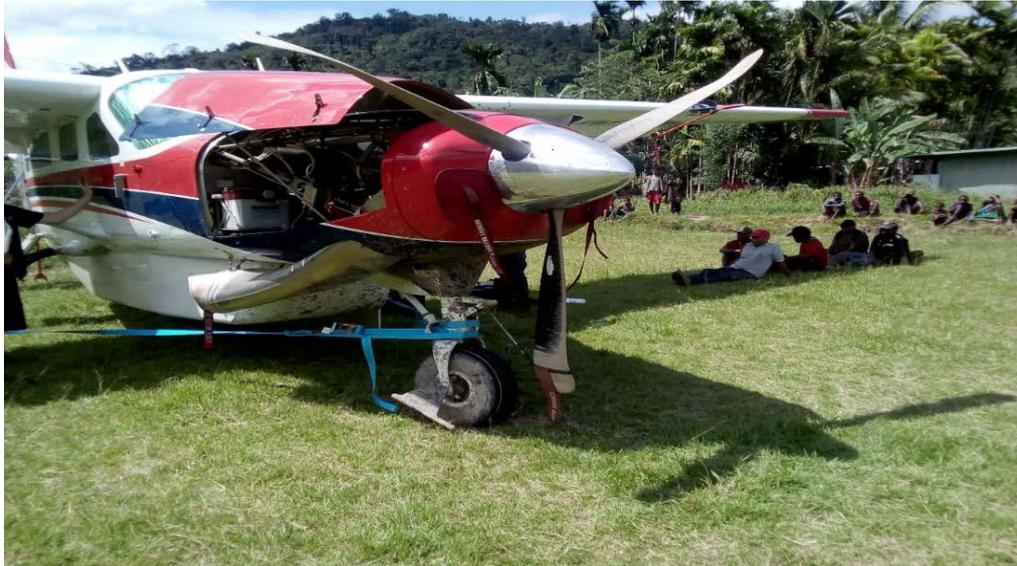
Figure 6: P2-MAI after being moved by the crew and the locals from the accident location to bottom of the airstrip.
