FINAL REPORT

AIC 19 - 1002

Air Tractor 502B

Controlled Flight into terrain

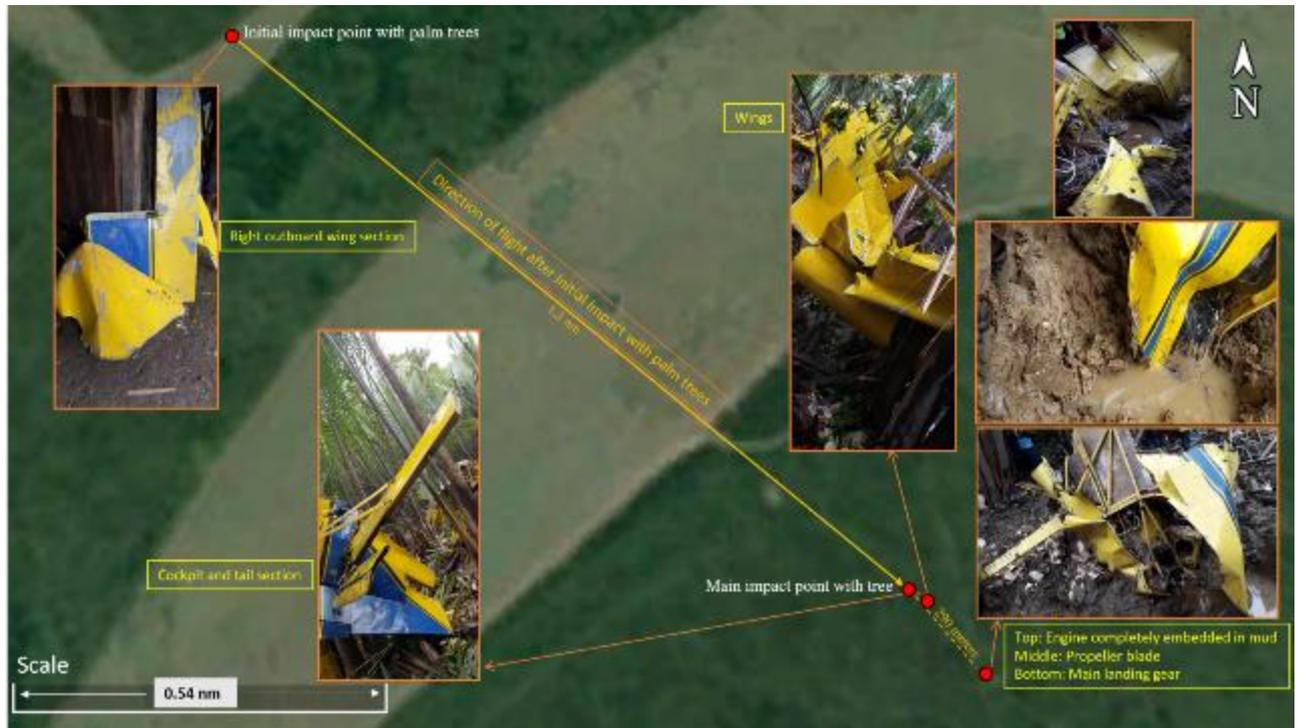
Figure 10: Depiction of wreckage trail along final flightpath

The investigation determined that after the initial impact, the flatter angle at which the aircraft flew for 1.3 nm (see Figure 10) until the final impact, required a significant amount of engine power to maintain level flight. Moreover, the distance (290 meters) between the engine, the main landing gear, the hopper and where the cockpit including the tail of the aircraft were found, was a result of the momentum produced by the high engine power present during the dynamics of the final impact.

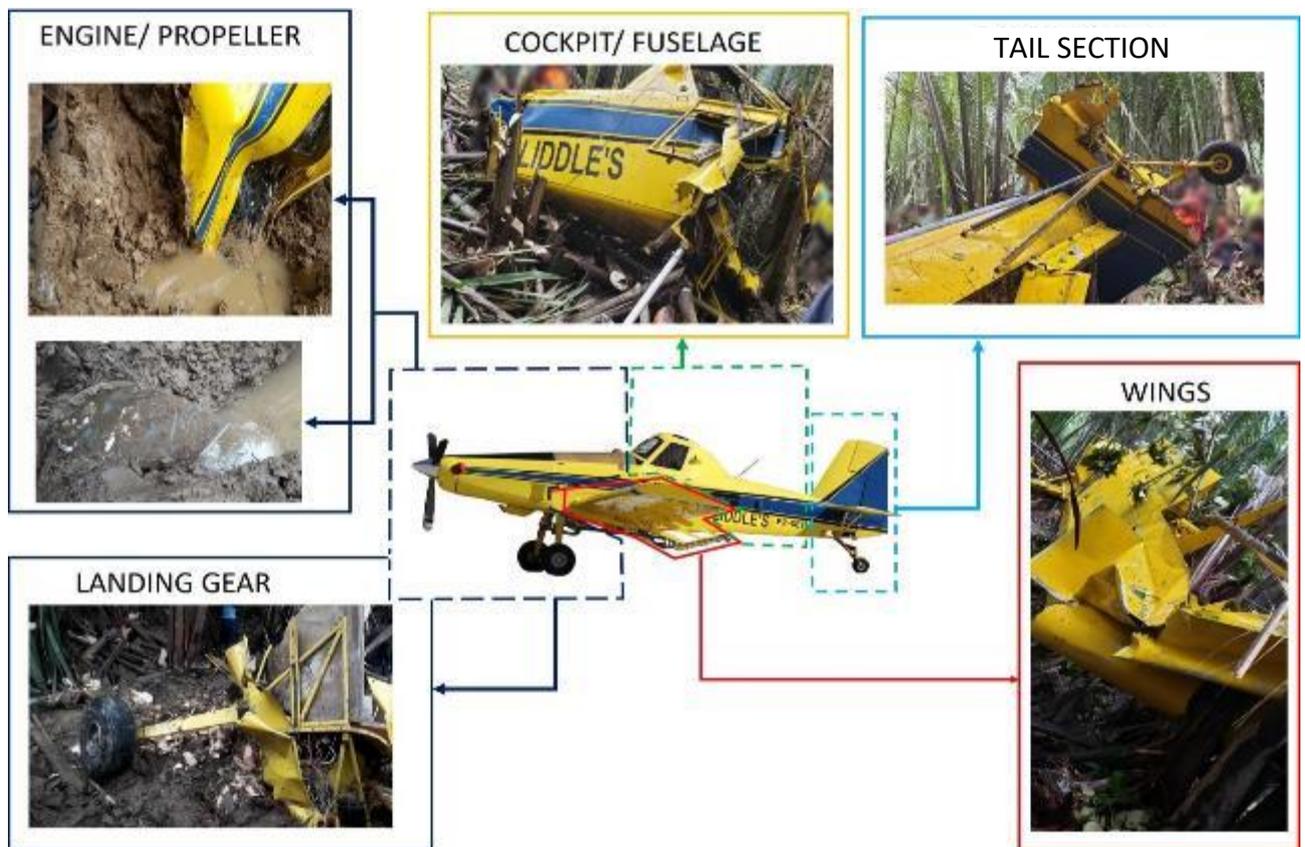
Figure 11: Wreckage distribution

The general spread of wreckage indicated that the aircraft had been tracking to the south-east prior to final impact. Aircraft components were found within a 1.3 nm radius from the main impact point (see Section 1.1 and Figure 5).

The aircraft's approximate attitude and angle of impact was calculated using the position of aircraft components and angle crush damage to the forward, cockpit, tail and wing sections respectively (see Figure 11).

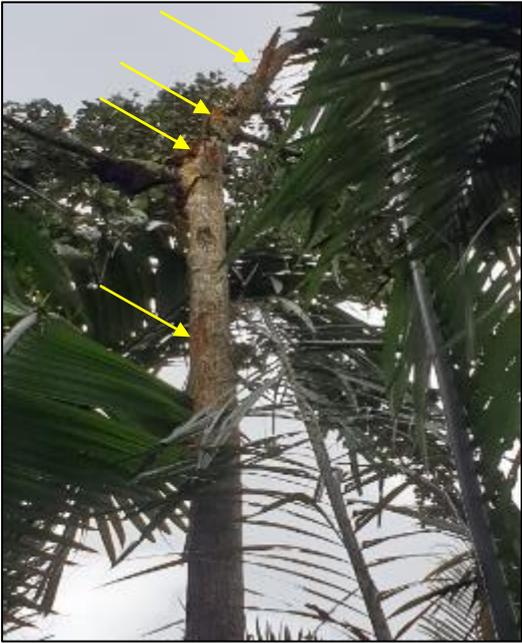
The investigation team found that the aircraft initially clipped a protruding palm tree, separating the outboard section of the right wing. The aircraft continued for another 1.3 nm before it impacted a tall thick tree 43 feet AGL. The forward fuselage and engine section separated from the airframe at the bulkhead between the cockpit and the hopper. The forward fuselage including the hopper, main landing gear, engine and propeller continued another 290 metres along the direction of the flight path before becoming deeply embedded in mud.

Figure 12: Tree showing evidence of impact.

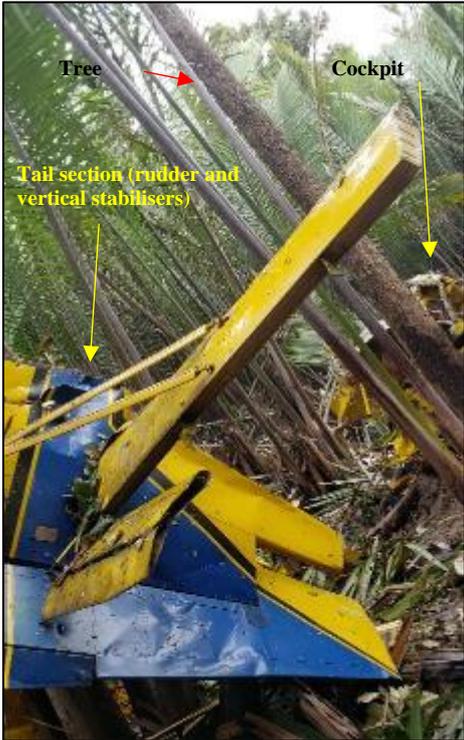
Figure 13: Tail section and cockpit with reference to the tree

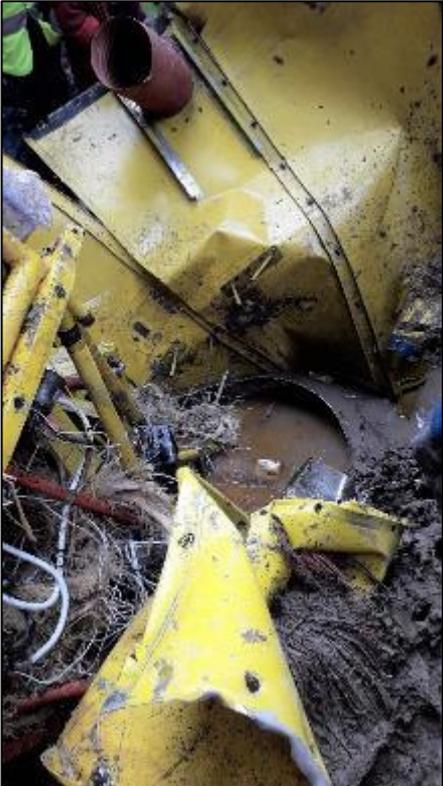
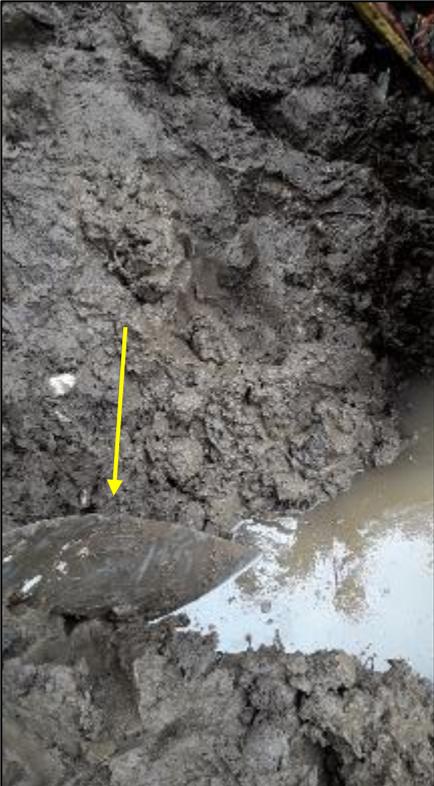
Figure 14: Engine completely embedded in mud (Left) and propeller blade tip (Right).

The investigation team conducted an on-site examination of the aircraft, its engine and propeller. The investigators found that there was rearward bending of the propeller blade at the shank of the only visible blade. This rearward bending indicated that subsequent to final impact, the propeller stopped turning in flight before being deeply embedded in mud.

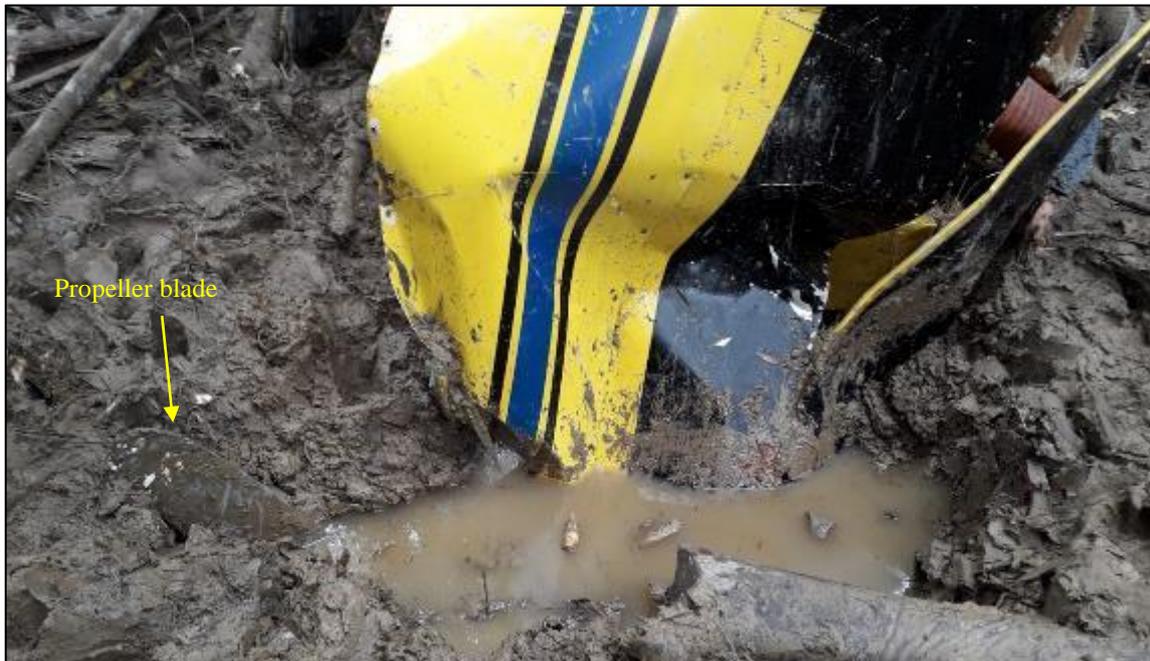
Figure 15: Engine and propeller section embedded in mud

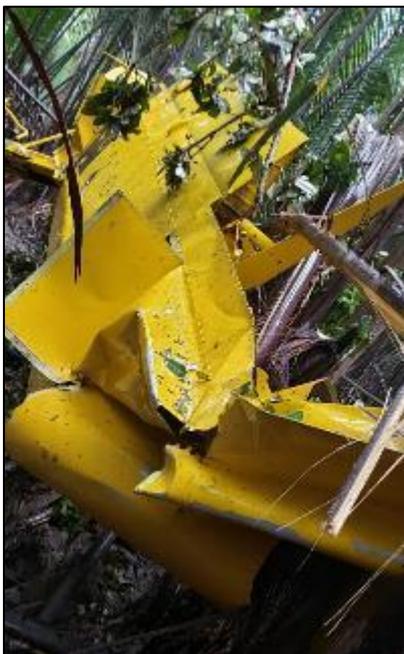
Figure 16: Left wing

When the aircraft wings were found at the accident site, both the right and left fuel tanks were empty. Local villagers reported smelling fuel around the vicinity where the wings were located. Investigators found that both fuel tanks were punctured during the accident sequence, as the wings separated from the main fuselage resulting in the loss of fuel.

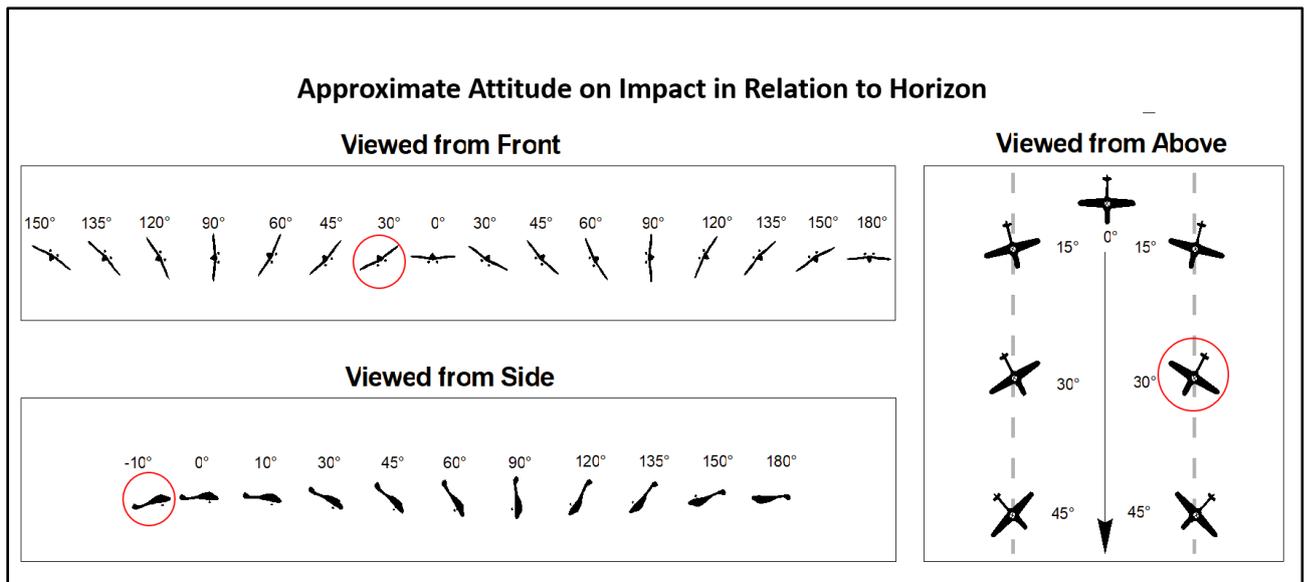
Figure 17: Depiction of approximate aircraft attitude on impact

A thorough examination of the position of aircraft components and damage observed showed that the aircraft impacted the tree at a right-wing low, nose up attitude at the point of impact.

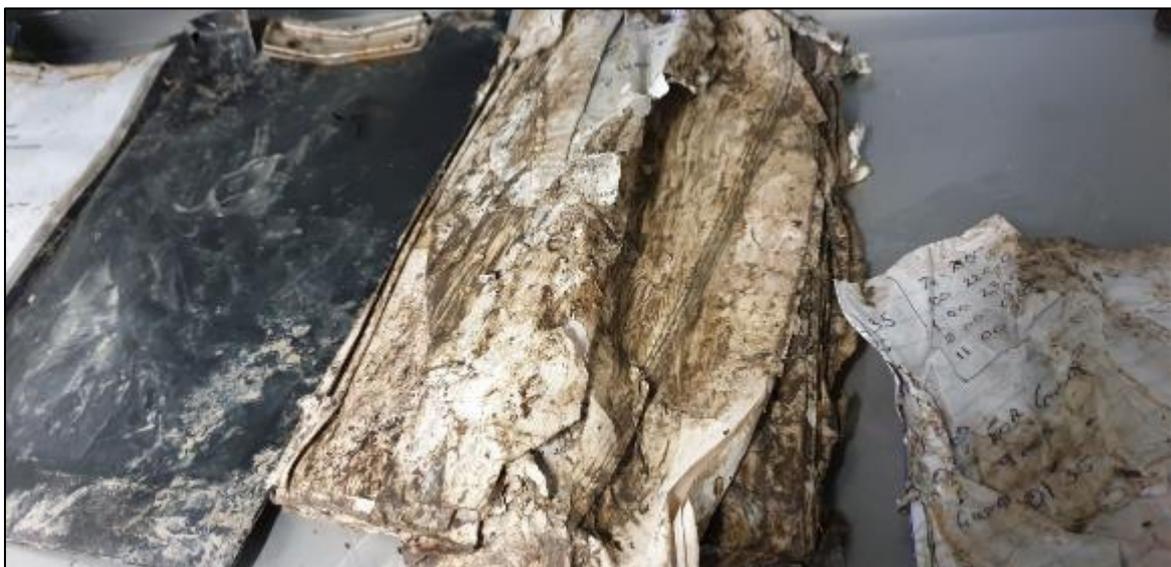
Figure 20: Condition of AFM when brought to the AIC engineering lab for processing

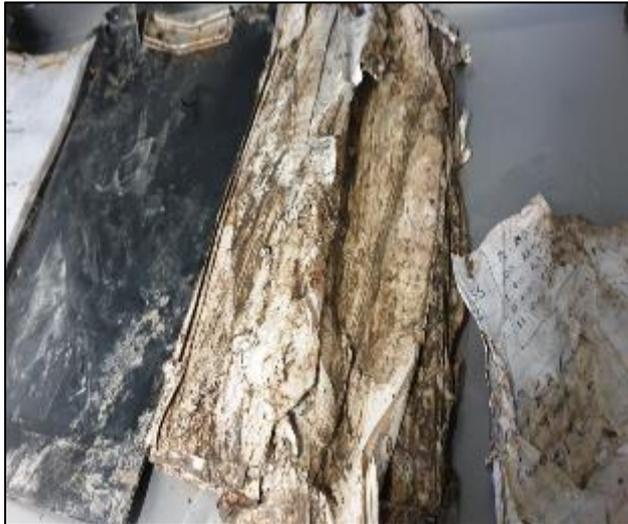
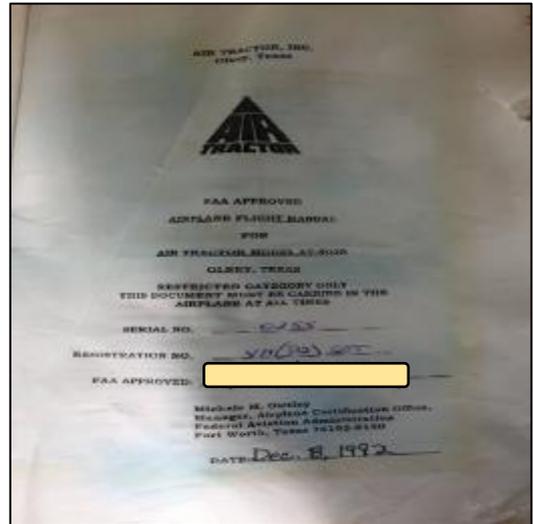
Figure 22: Before (left) and after the Biohazard treatment processing (right)
