FINAL REPORT

AIC 19-2001

Major Electrical Power Failure affecting Airport Facilities

Jacksons International Airport

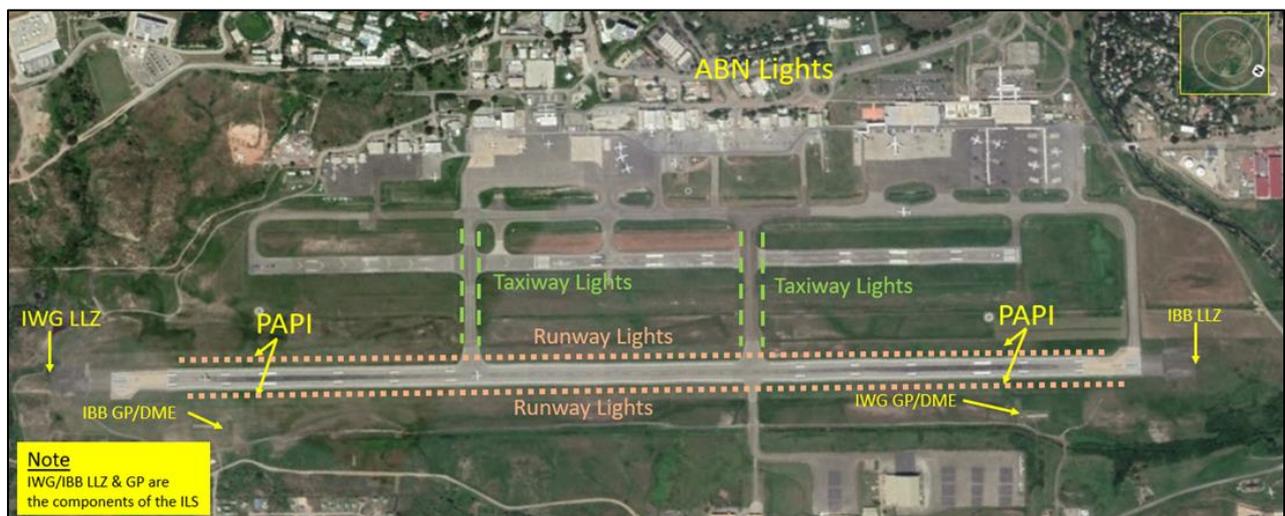
Figure 1: Some of the services were affected during the power outage

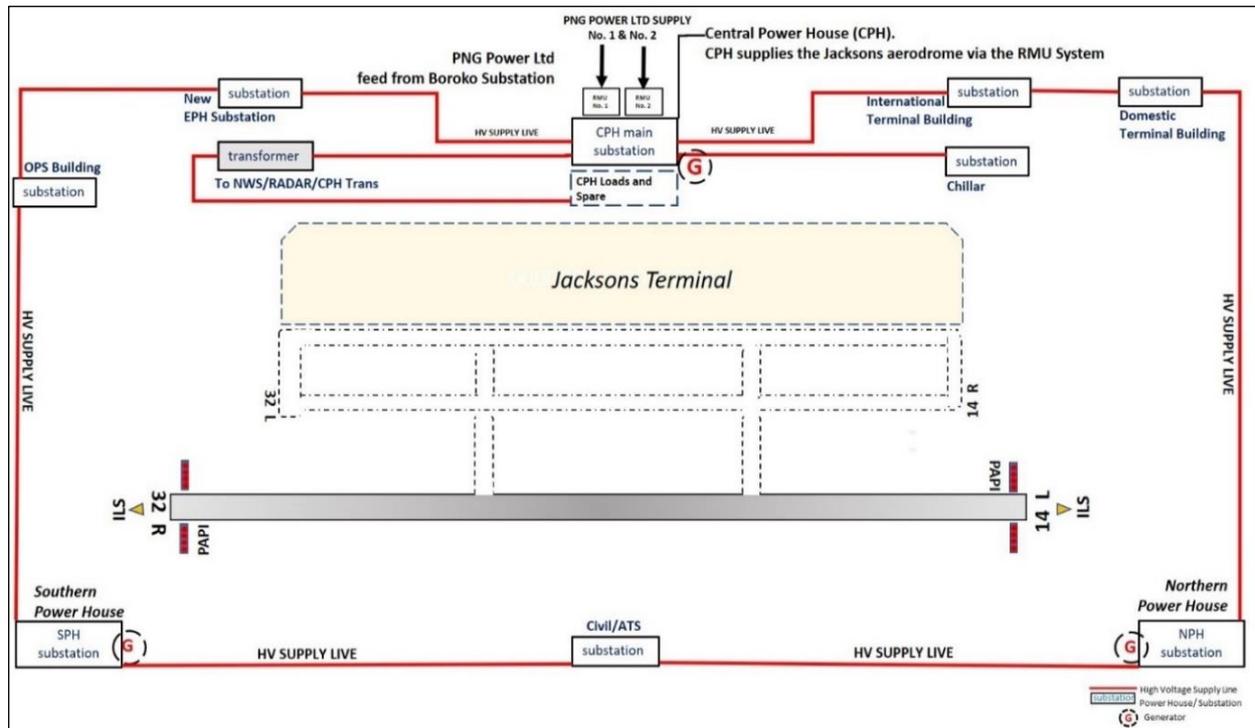
Figure 6: Schematic Diagram of the Existing power system at Jacksons

The loss of electrical power from the primary source (PNG Power Limited grid) caused a complete power loss to the airport facilities. The *PNG Aeronautical Information Publication (AIP)* for Jacksons *AYPY AD 2.15* (See Appendix C1) current at the time declared a Secondary Power Supply which fully conformed with *ICAO Annex 14 – Aerodromes* (see Appendix C2) and with *CAR Part 139 Aerodrome – Certification and Operation, Appendix H Electrical Systems* to immediately restore and maintain the provision of critical services.

Nevertheless, in the context of the occurrence the CPH and the generators located at the Northern and Southern sub-stations did not enter operation, which made it impossible to restore the power supply for the airport facilities and also for the critical services (ILS, PAPI, runway and taxiway lightings, etc.). According to NAC, there was no record of previous failures of the Secondary power source that would inhibit it to automatically initiate when required.

When the secondary power supply did not automatically initialize, a technical team from the airport operator NAC was sent to the power stations to manually activate the generators. However, they were unable to manually activate them and found issues that in the end required external contractors to get involved for the power restoration as detailed later in this report.
