FINAL REPORT

AIC 19 - 1001

Bell 427

Helicopter impact with water

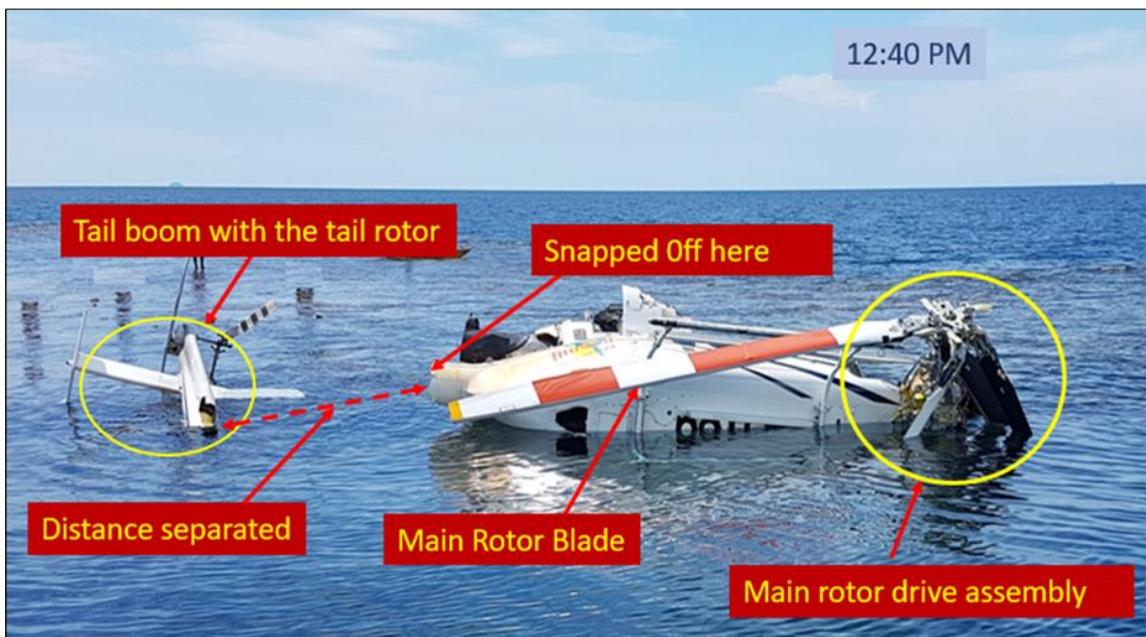
Figure 5: P2-HSG final resting position (Picture taken about an hour after the accident by Operators rescue team)

The helicopter wreckage was found on a reef located in the Satin Bay Area about 3.1 nm North West of Buluma township, partially submerged in the saltwater less than a meter deep, when rescuers arrived (see Figure 5).

The damage observed on the tail boom indicates that the helicopter impacted the reef on its left side. It protruded from the water adjacent to the fuselage (*see Figure 5*).

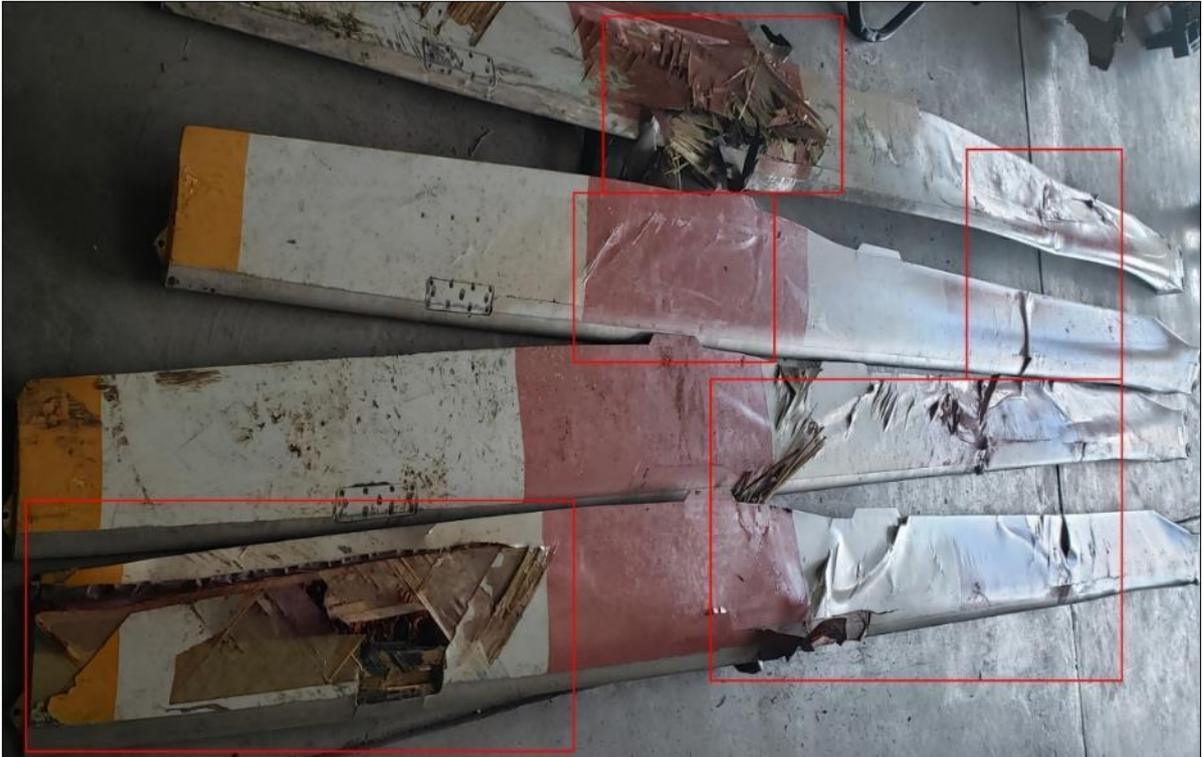
Figure 6: P2-HSG main rotor blades

The main rotor blades with the main rotor drive assembly were separated from the fuselage and rested adjacent to the helicopter main wreckage (see Figure 5). The damage of the main rotor blades suggests that they impacted the reef with significant engine power (see Figure 6).

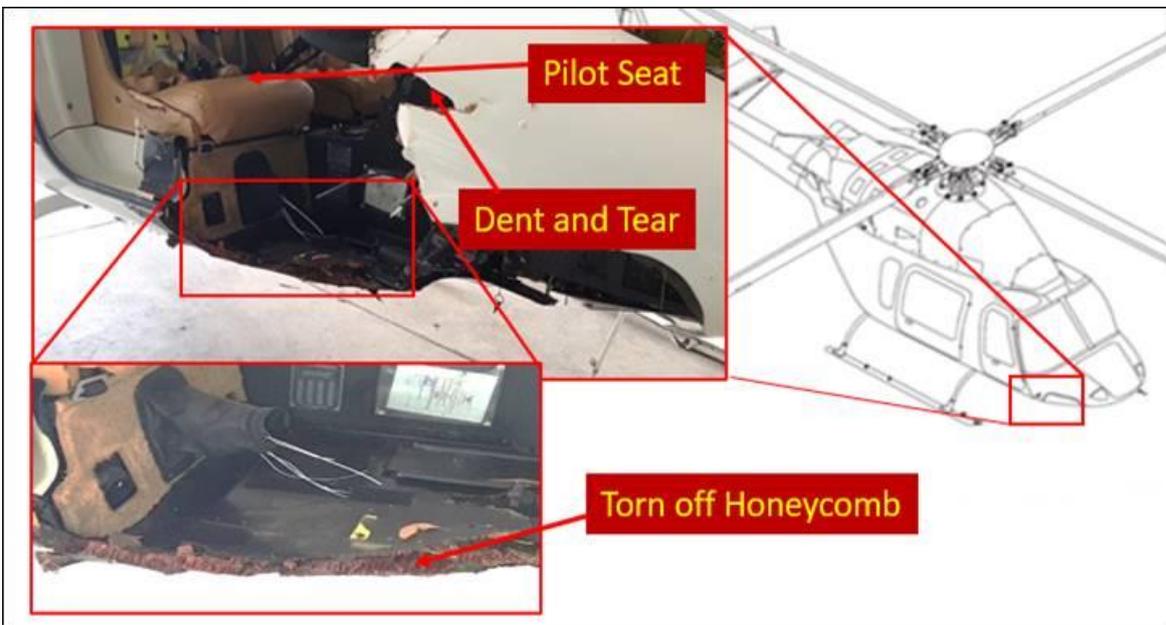
Figure: 7 Damage caused by the main rotor drive at the right side of the helicopter

The main rotor drive assembly separated from the helicopter, remaining attached to two elongated springs which swung it around into the pilot's foot area (see Figure 7).

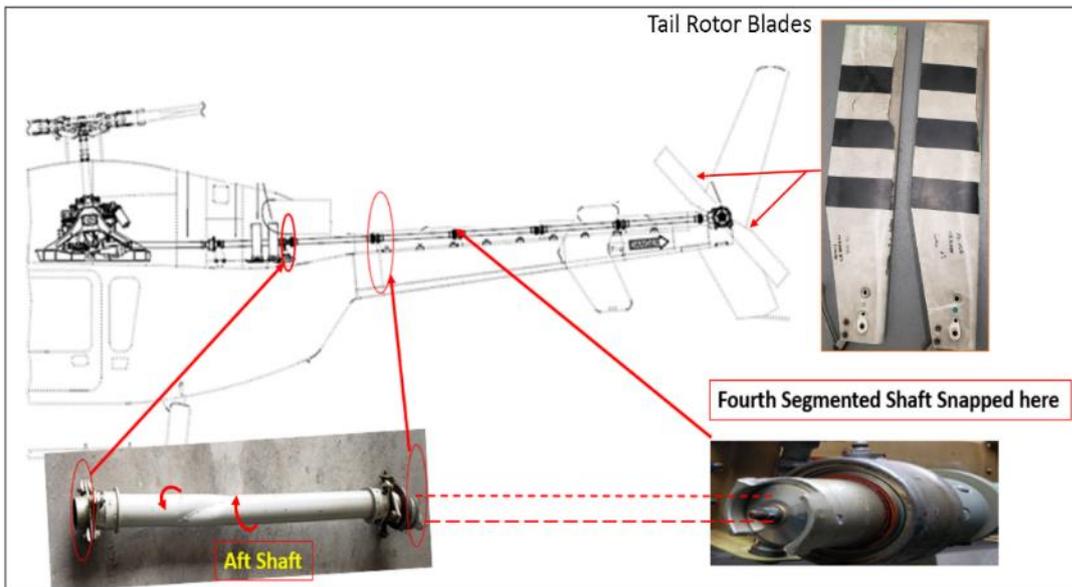
Figure 8: Tail rotor blades.

There was no chordwise damage observed on the tail rotor blades which suggests that the tail rotor stopped turning prior to the helicopter's impact with the reef (*see Figure 8*).

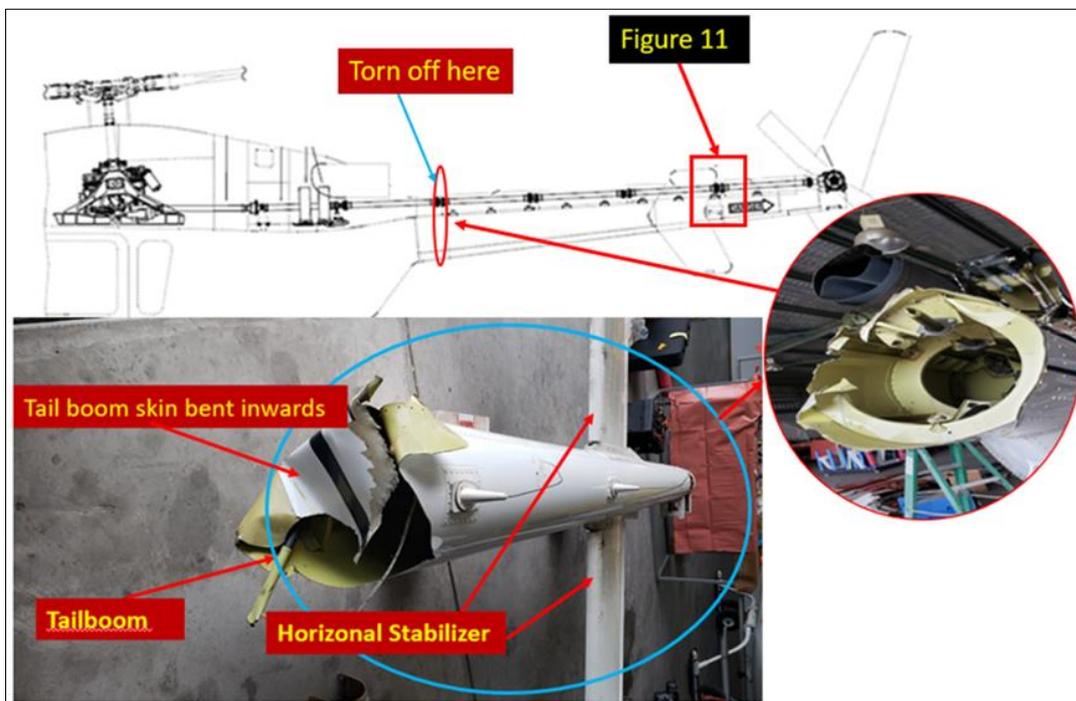
Figure 9: Snapped off tail boom

The damage observed to the torn-off tail boom suggests that the helicopter was steeply banked to the left when the tail impacted the reef (*see Figure 9*). The fuselage was found at rest on its left side. Impact damage to the fuselage was limited to its left side. This suggested that the helicopter came to rest upon initial impact with the reef.

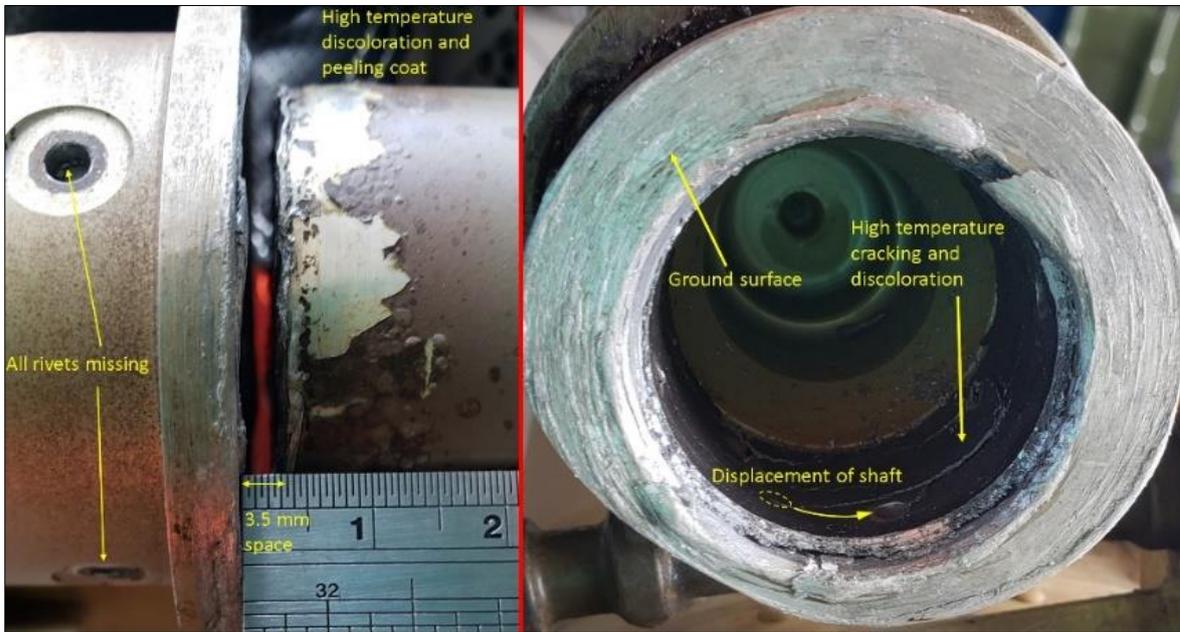
Figure 10: Failed tail rotor drive shaft

The 4th segmented shaft-hangar bearing joint rivets were missing. The aft section of the shaft, where it joins the hangar bearing, was discoloured and ground significantly due high temperature exposure (see Figure 10). This suggests that the tail rotor disconnected from the engine while the engine power was still being transmitted through the drive line.

- Upon contact with the sea, the tail rotor blades struck the water causing the drive shaft assembly failure resulting in the loss of tail rotor function. The fuselage and tail rotor were found on the reef about 2 m apart. The main wreckage was confined to Eastern edge of where it initially impacted. The nose of the helicopter was oriented towards the North West suggesting that the helicopter had spun around laterally.
- The main Rotor blades were destroyed during the impact with the reef. The main rotor gearbox subsequently separated from its mount and lodged itself into pilot's foot area.
- The tail boom was torn off the helicopter at the forward side. This occurred during the reef impact sequence.

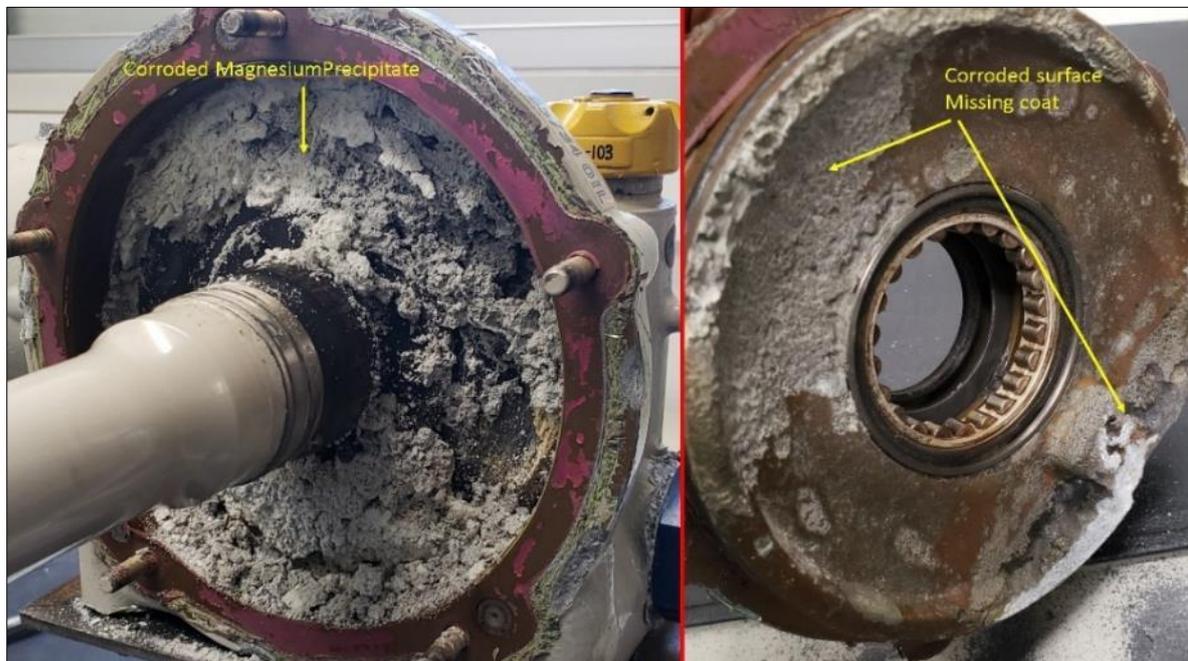
Figure 11: Corroded inner tail rotor gearbox housing

The tail rotor drive was removed for further examinations. When the tail rotor gearbox cap assembly was removed, extensive corrosion material was observed in the tail rotor gearbox housing (see Figure 11).

There was no evidence observed to suggest that the corrosion had occurred prior to the accident. The corrosion was formed by the housing material reacting with sea water. It is suspected that the water entered through the breather, a tube that allows air to and from the tail rotor gearbox for balanced atmospheric pressure.

- f) The aircraft was destroyed by the different forces involved in the accident.
- g) The significant amount of corrosion observed within the tail rotor gearbox was due to sea water contamination after the accident.

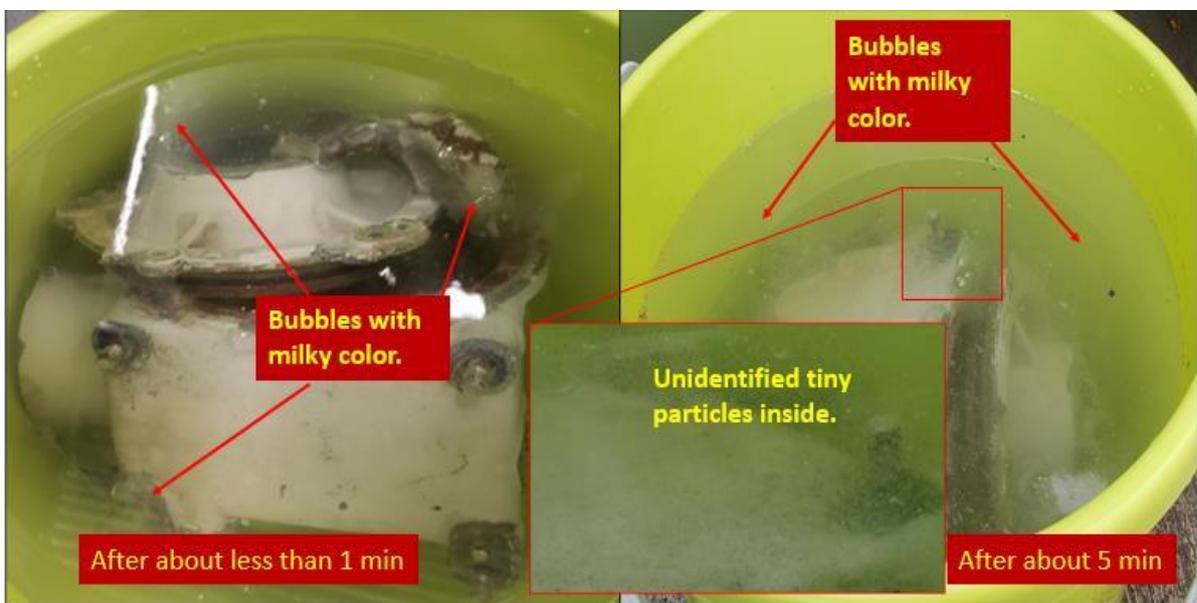
Figure: 13. Reaction of tail rotor gearbox housing with salt water at different times

The tail rotor gearbox housing was dipped into a bucket of salt water after the removal of the existing corrosion product. As soon as it was dipped in and in less than a minute there were bubbles with milky colour coming out. After about 5 minutes, the reaction rate was more than was before turning the sea water milky and forming bubbles with a precipitate.

After the 5 minutes observation, the tail rotor gearbox was then taken out and left in a room for one day at room temperature. After that, it was noticed that corrosion products similar to the ones initially found appeared in the gearbox housing.

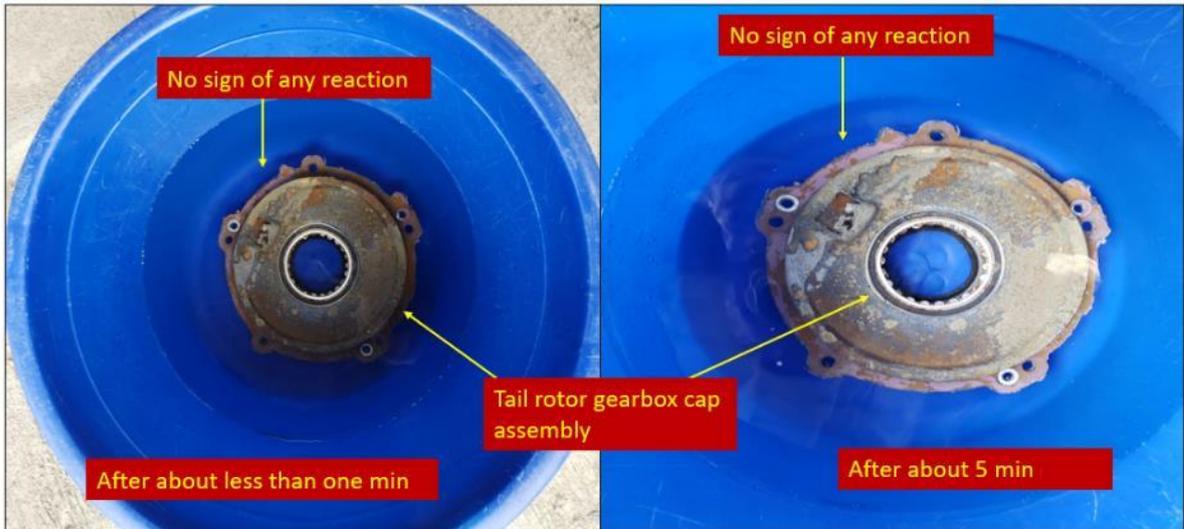
Figure: 15 Reaction of tail rotor gearbox cap assembly with fresh water at different times

Furthermore, the cap assembly was placed again in a bucket of fresh water and there was no form of reaction after the same time as above (*see Figure 15*).

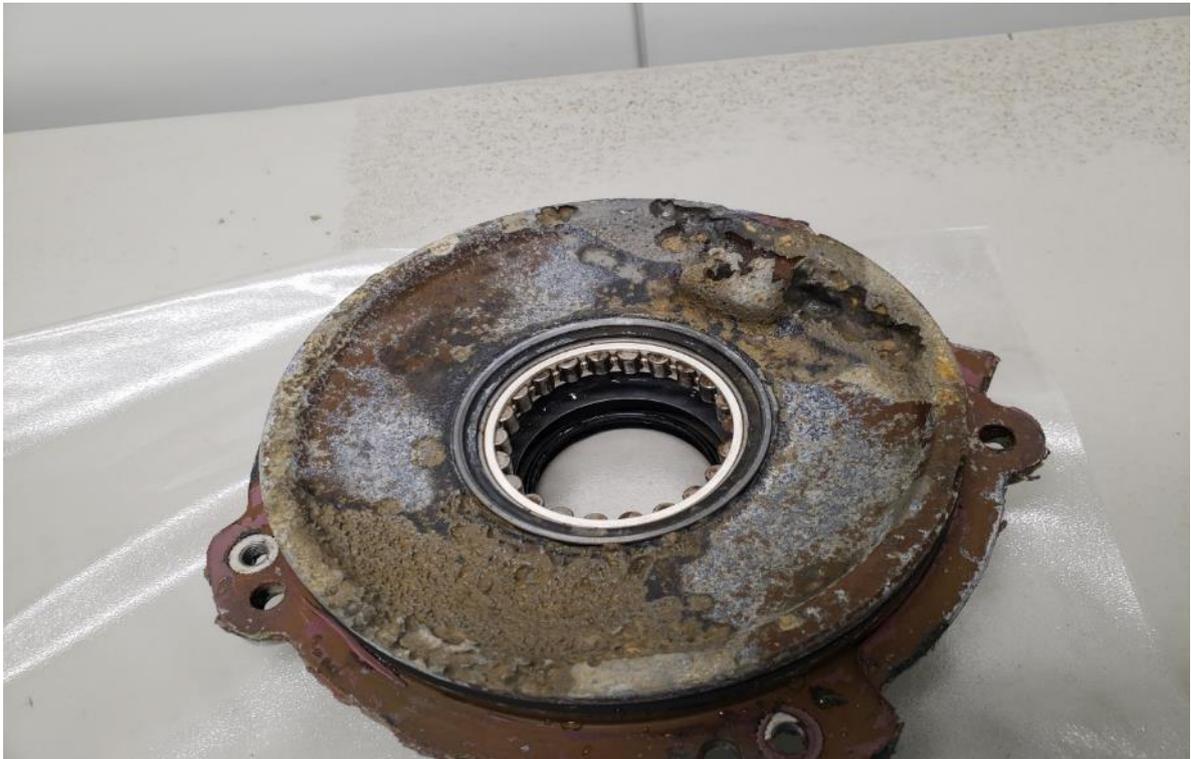
Figure 16. Tail rotor gearbox cap assembly

There were no corrosion products on the surface of the cap assembly, apart from the previous pitting corrosion as shown in Figure 16.
