**FINAL REPORT**

**AIC 20 -1005**

# Cessna 402C overran a non-certified field and collided with trees near Papa Lealea, about 16nm North – West of Port Moresby, Papua New Guinea

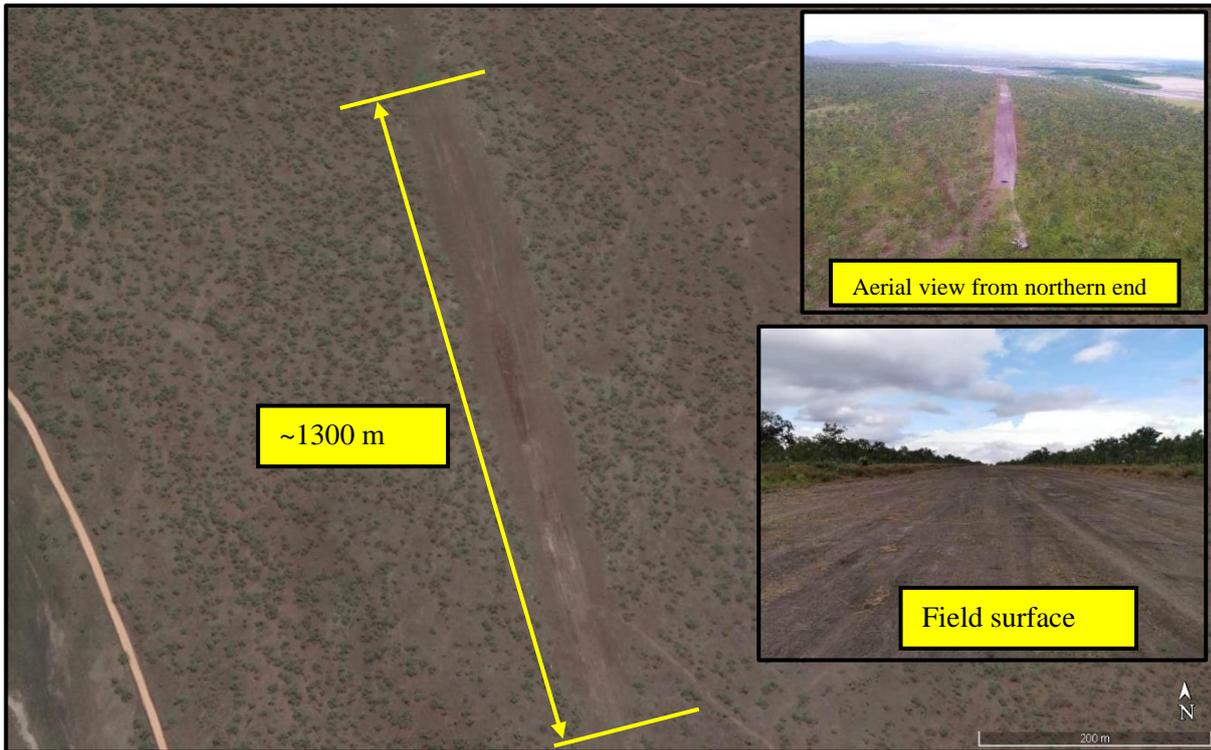
The field used for the operation was found to be an uncertified field built for to cater for aircraft landing and take-off. Locals from the surrounding villages informed the AIC that they were unaware that the land was being developed into a landing/take-off strip and that they were informed by person(s) building it that they were constructing a road.

The strip was approximately 1,300 m long and about 15 m wide, oriented in a North Northwest-South Southeast direction (see Figure 3).

**Figure 3: Uncommissioned field used for the operation of the aircraft.**

The evidence of tire marks found by the investigators on the uncommissioned field indicated that the aircraft touched down about 400 m before the end of the field, distance that was not enough for the aircraft to come to a stop, continuing its landing roll into the bushes and impacting trees until it got to its final position.

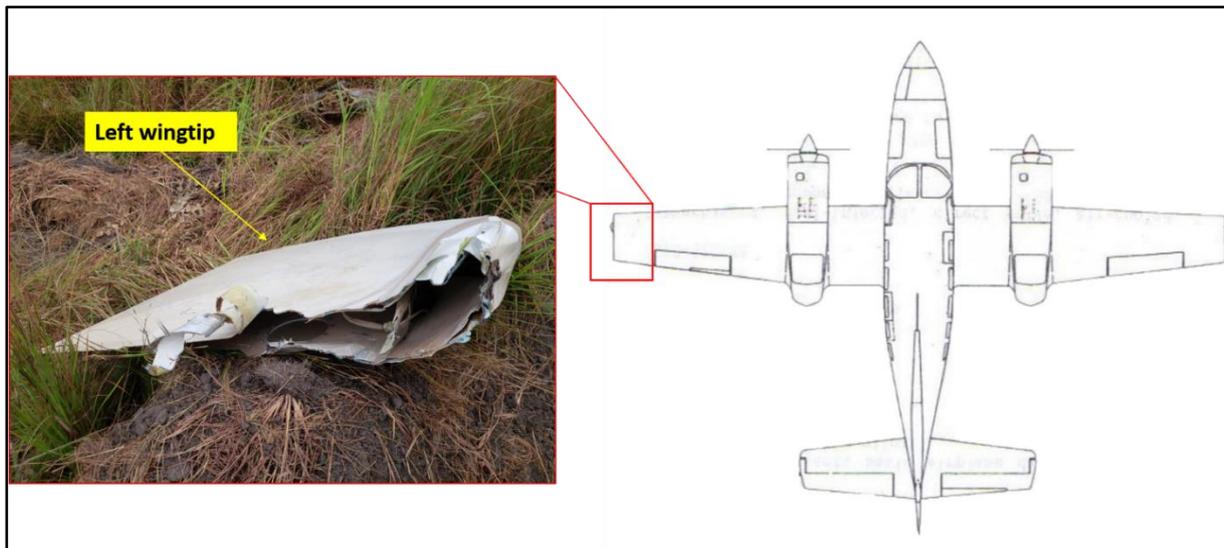
**Figure 3: Damage to left wingtip**

The outboard section of the left wing was clipped off by a protruding tree as the aircraft approached to land.

The investigation determined that the separation of the outboard section of the left wing, clipped by a tree during the approach to land phase, affected the ability of the left wing to produce lift.

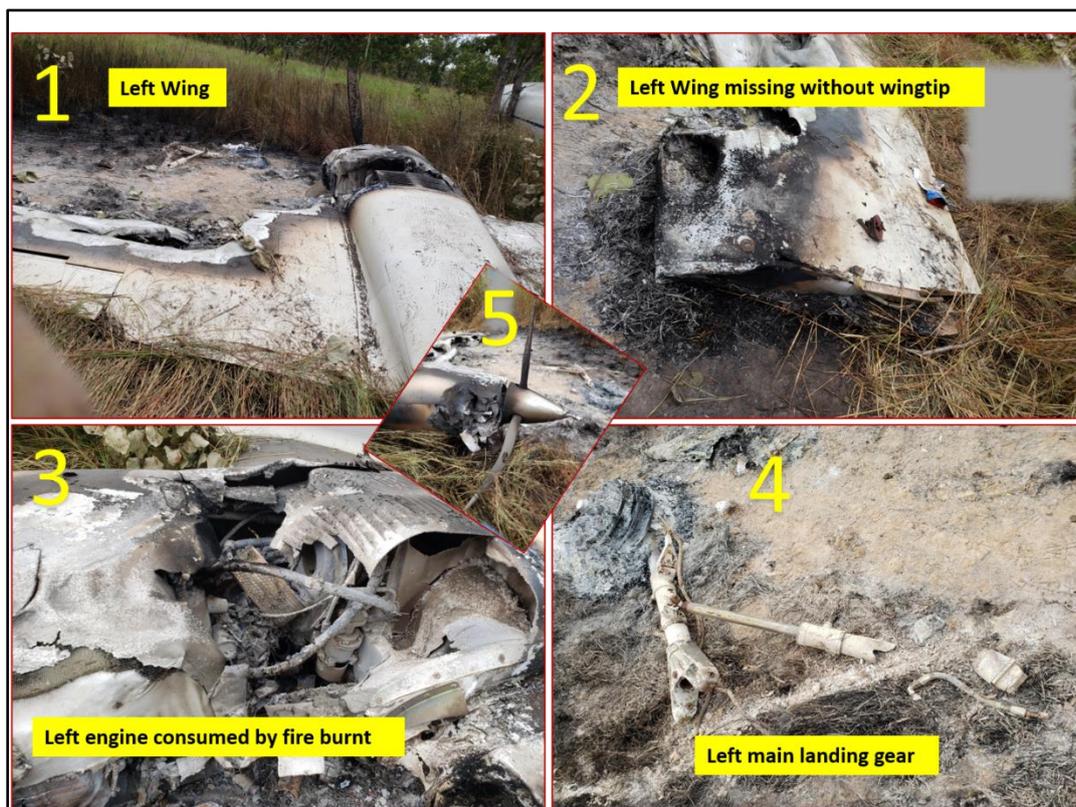
The aircraft was substantially damaged. The investigation confirmed that the fire to the left wing and engine was a post-accident event and was deliberate.

**Figure 4: Damage to left wing**

The investigation determined that there was no pre- or post-impact fire related to the occurrence. However, the left wing was set ablaze by third persons on the ground, after the aircraft over-ran the strip and collided with trees.

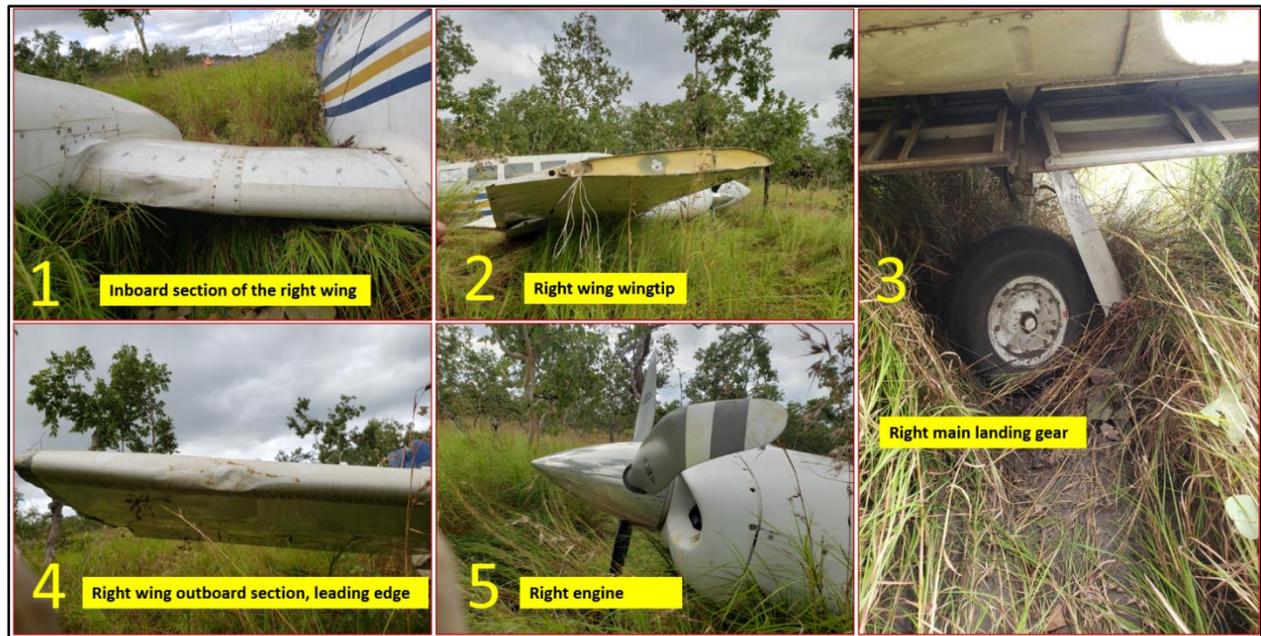
**Figure 5: Damage on the right wing**
