FINAL REPORT

AIC 19 - 2002

Fokker 70

Rapid depressurisation resulting in deployment of oxygen masks

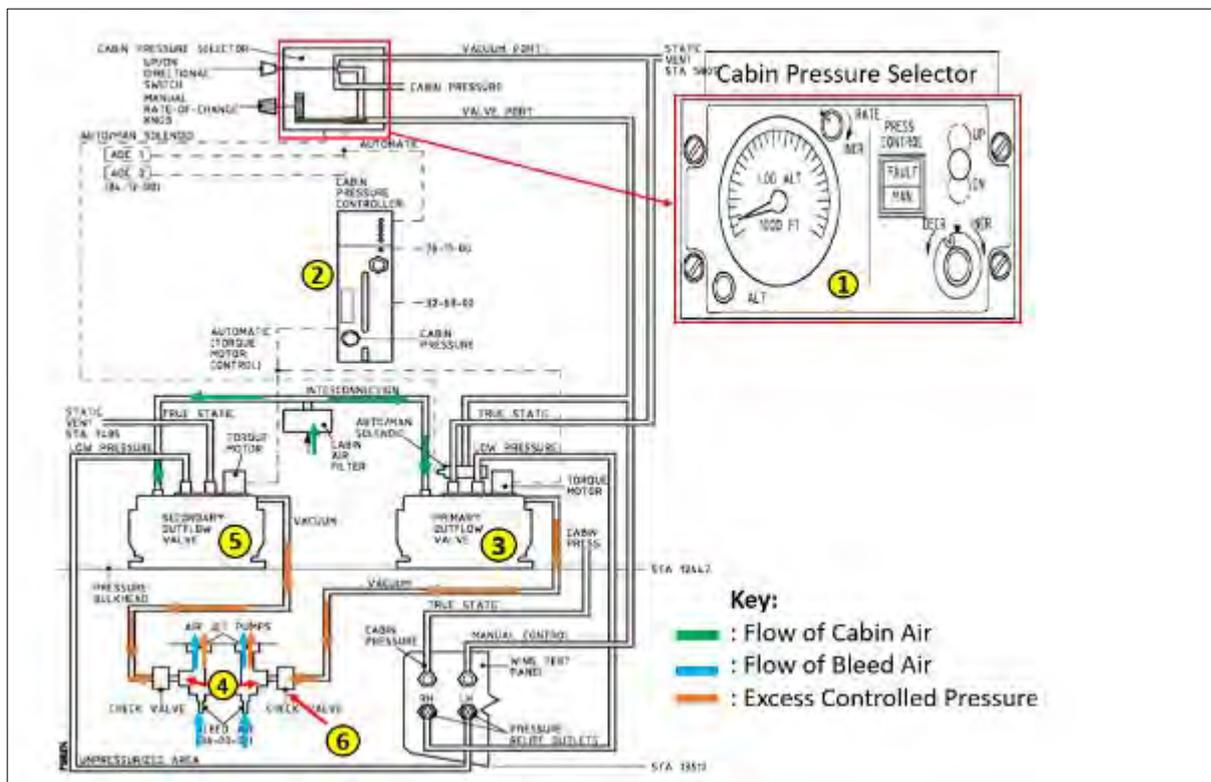
Figure 3: The Pressure Control system SOURCE: Fokker 70/100 AMM

As shown in Figure 3, the pressure control system is connected by pneumatic lines. During operation in automatic mode (normal), when pilots select pressure for a certain altitude (cabin altitude) on the *Cabin Pressure Selector (CPS)* (1), the signal is sent to the *Cabin Pressure Controller (CPC)* (2) which directly controls the *Primary Outflow Valve (POV)* (3). During operation in the manual mode, the CPC is bypassed by the CPS allowing it to send signals directly to the POV.

The investigation determined that the depressurisation emergency event occurred due to a defective component within the *Pressure Control System*. According to the post-occurrence maintenance record provided by the Operator, the POV, CPC and SOV Check Valve, were replaced during the troubleshooting (*Refer to section 1.18.4*).

According to the result of the post-occurrence maintenance, the investigation was able to determine that the POV was not defective. However, the investigation was unable to determine the actual component (defect) within the system which caused the outflow valves to operate abnormally.

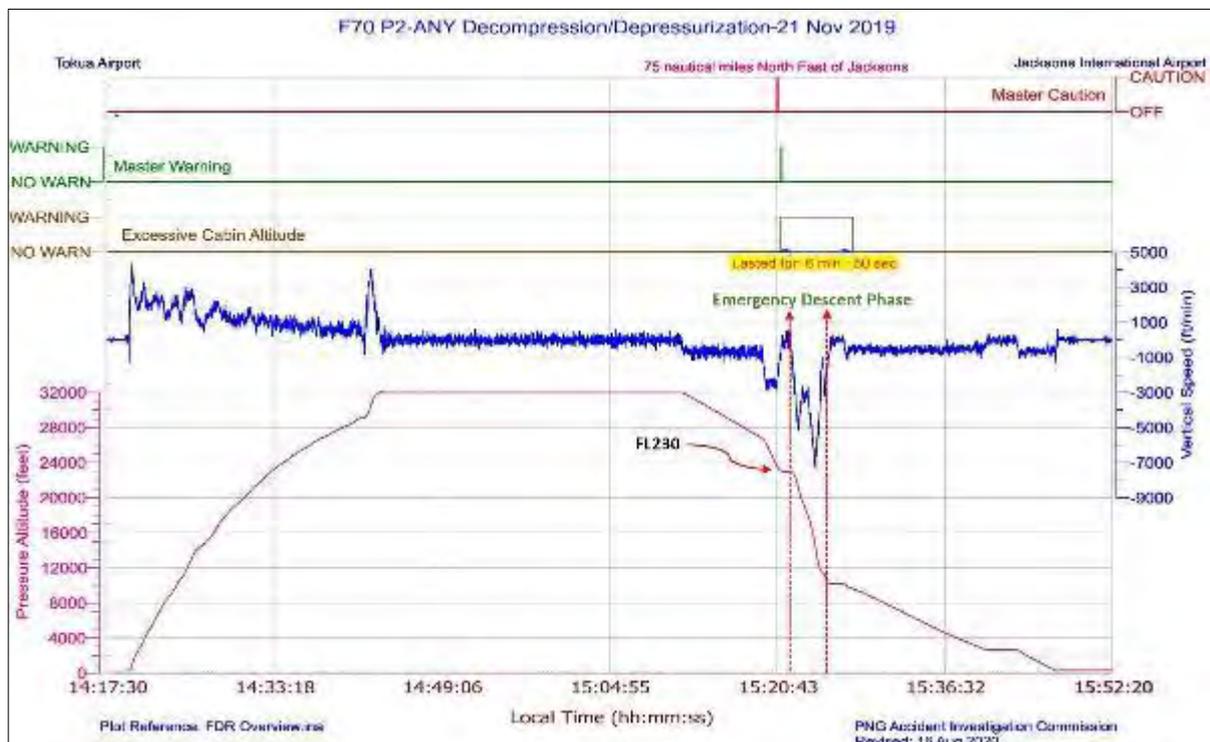
Figure 4: Overview of FDR data

The Flight Data Recorder (FDR) data retrieved during the investigation indicated that at 15:20:44, as the aircraft was passing 23,600 ft, the Master Caution⁴ (MC) alert activated. The flight crew confirmed during interview, that they then noticed a cabin pressurisation controller fault message on the Multifunction Display Unit (MFDU). The investigation determined that the fault observed and referred to by the crew was the 'CAB PRESS CTL' fault message.

The FDR had a recording duration of more than 25 hours and was recording data at a rate of 128 words per second. The FDR recorded parameters pertinent to the investigation were as follows; Master Caution, Master Warning, Excessive Cabin Altitude Warning, Vertical Speed and Pressure Altitude.
