FINAL REPORT

AIC 20 - 2002

Fokker 100

Loss of cabin pressure resulting in deployment of oxygen masks

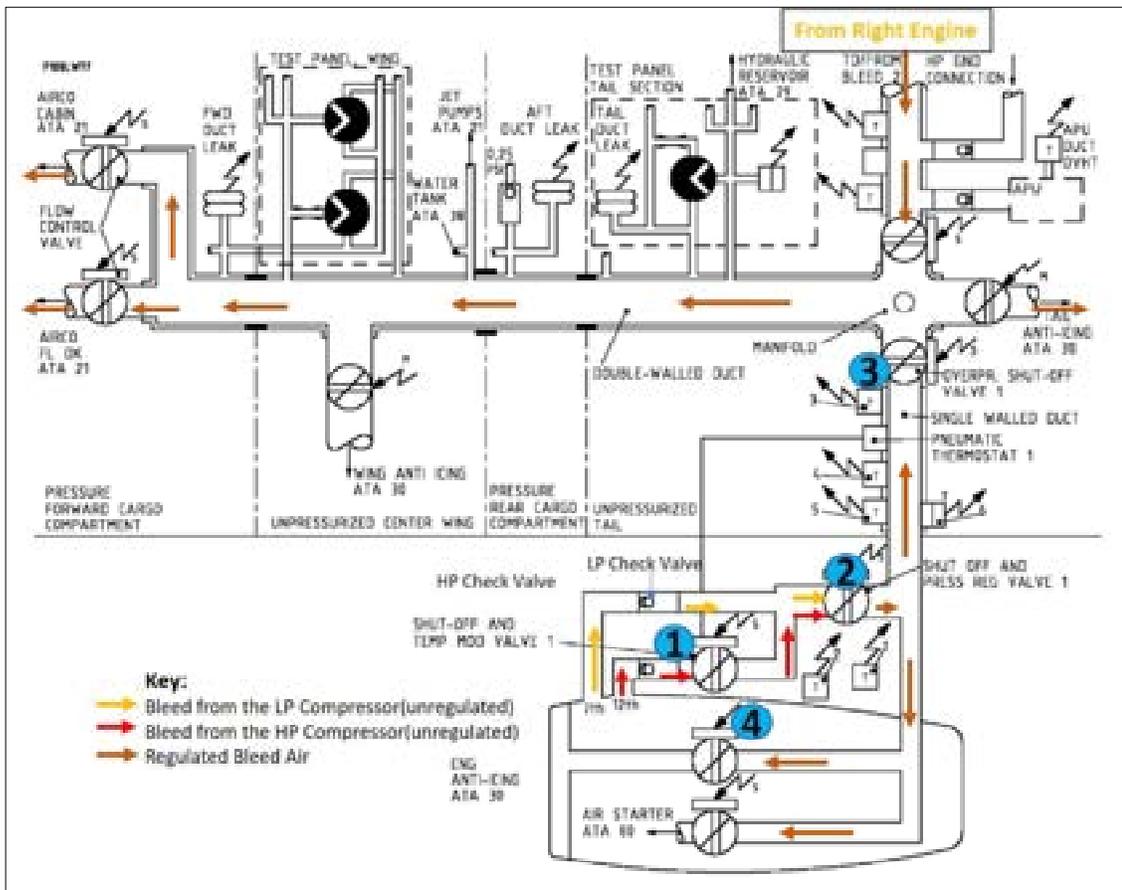
Figure 3: Bleed air schematics for No. 1 engine.

The Overpressure Shut-off Valve (OPSOV) allows bleed-air supply pressure between 67.5 and 72.5 psi and protects the system from over-pressurisation if the SOPRV fails in the open position. The pressurised (regulated) bleed air reaches the manifold where it is available to the anti-icing, air conditioning and pressurisation system.

According to the Operator's post-occurrence maintenance records¹², the right and left hand SOTMV and left hand SOPRV were found to be faulty and were subject to troubleshooting and replaced.

About a month after the occurrence, on 26 April 2020, two SOTMV's and one SOPRV were replaced, and a functional test was carried out. The aircraft was released back to service on 29 April 2020, after a return to service check and a post defect rectification verification flight were conducted.

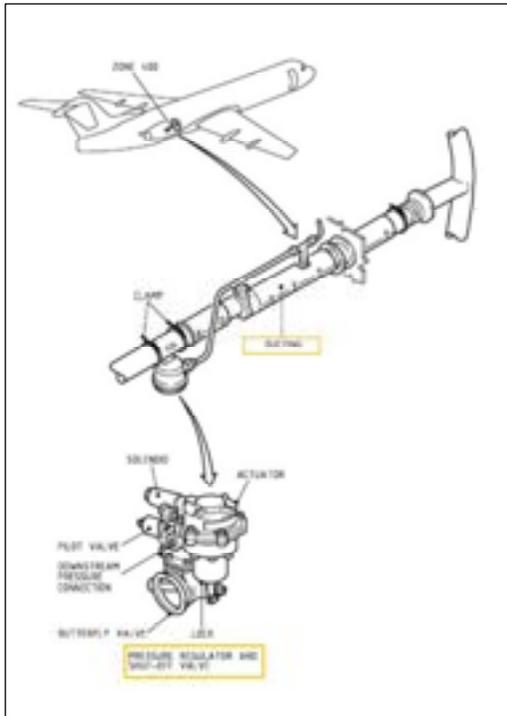
Figure 5: Engine anti-icing components

The engine anti – icing system includes the pressure regulator and shut-off valve (PRSOV) and ducting. The PRSOV installed on each engine controls the flow of engine bleed-air to the engine air intake and keeps the flow of bleed-air at a constant pressure.

When engine anti-icing is turned on, the PRSOV is opened, provided the engine is running and bleed-air pressure is sufficient. Pressure regulated bleed air is now routed through the nacelle leading edge. Low pressure will be detected, and an alert presented to the FWC. The air that is discarded from the nacelle flows back into the engine, thus providing anti-icing for the air intake.

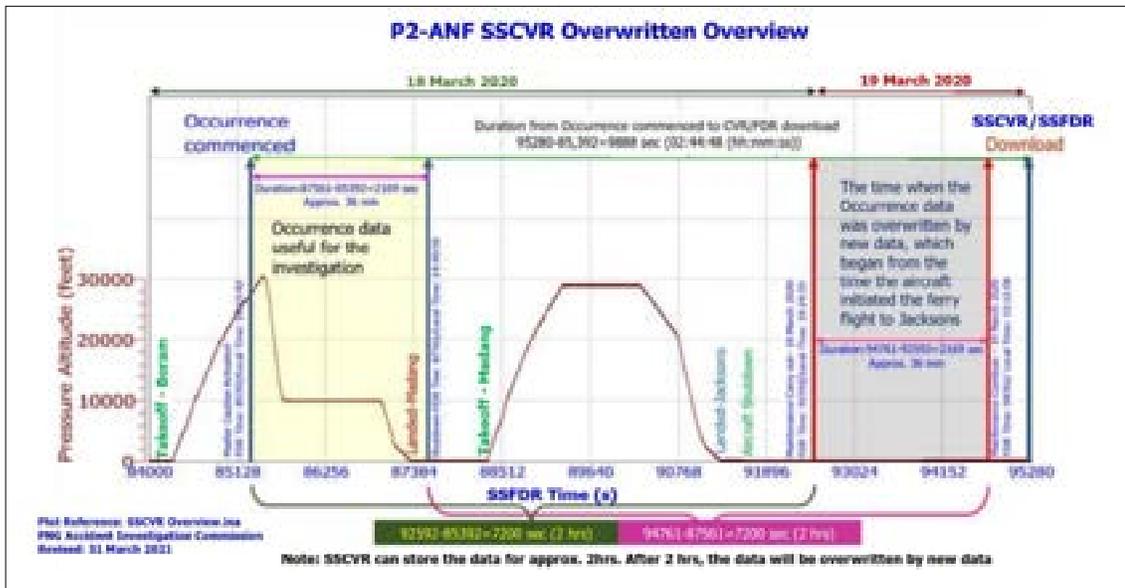
Figure 6: Overview of the SSCVR being overwritten.

The SSCVR and SSFDR were downloaded by AIC on 19 March 2020. The analysis of the data showed that since the Master Caution activation in-flight until the shut-down of the aircraft at Madang Airport, the time was about 36 minutes. However, this portion was not available in the SSCVR data retrieved as the subsequent operations to ferry the aircraft back to Jacksons International Airport and the maintenance activities conducted afterwards exceeded the maximum recording time and overwrote that data.

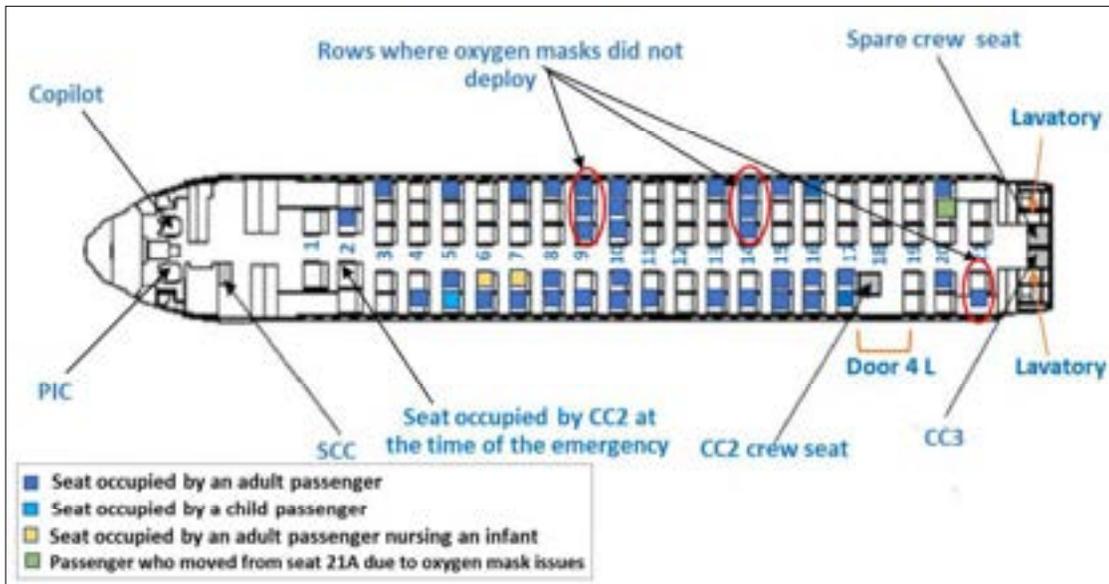
Figure 8: Cabin layout including crew and passenger seating arrangement.

The cabin crew also reported that oxygen units did not open/deploy above row seats 9 EFG, 14 EFG and 21 AB (Refer to *Section 1.15.2*).
