Final REPORT

AIC 21-1001

**Cessna TU206G**

**Nose landing gear collapse during landing roll**

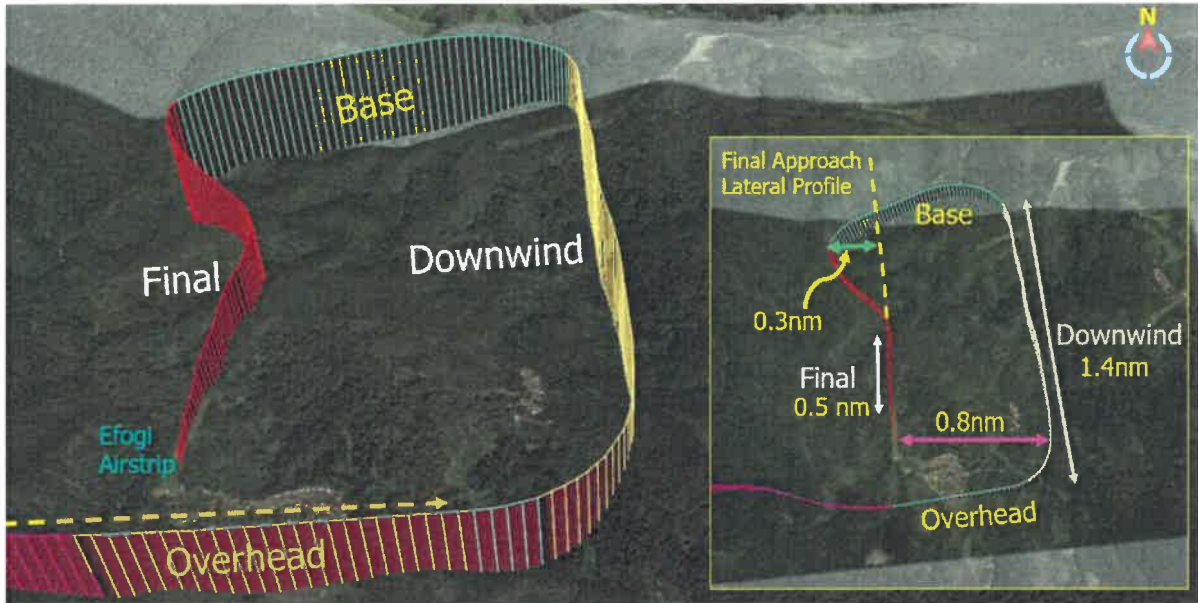
Figure 2: P2-ALP flown path at Efogi Airstrip

The data shows that during the turn from base onto the final approach, the aircraft overshot the final approach profile by 0.3nm. The aircraft heading was subsequently adjusted to intercept the final approach

path (see Figure 2). The aircraft established on the final approach 0.5 nm from the threshold, at about 500 ft AGL.

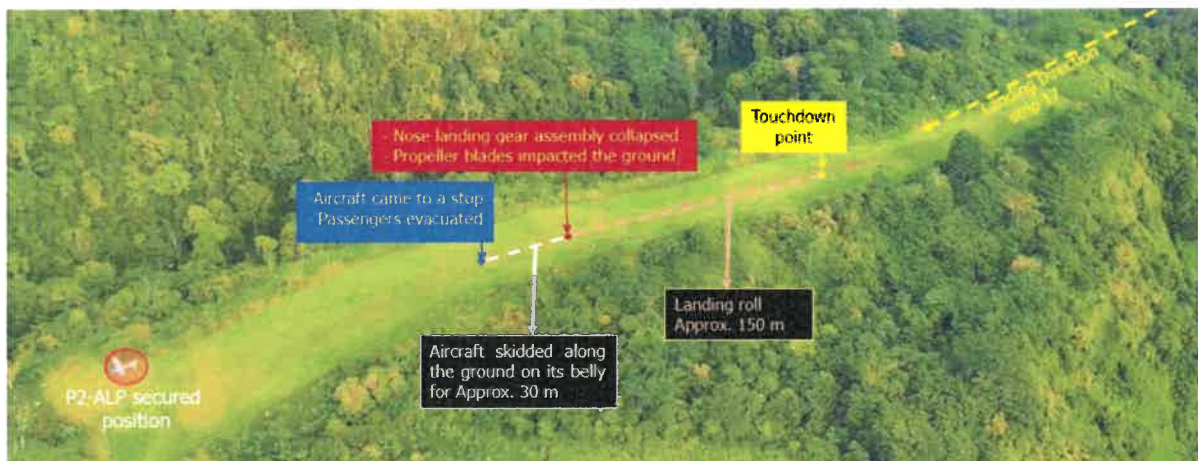
Figure 3: P2-ALP landing roll events at Efogi Airstrip

The PIC stated that during the landing roll, he could feel the aircraft running over the bumpy strip surface (surface undulations) and added that at some point, the aircraft appeared to have bounced off the ground. About 150 m from the touch-down point, the nose landing gear assembly collapsed. The nose of the aircraft subsequently dropped as the propeller blades causing the propeller blades to impact the ground while still rotating with engine power. The aircraft skidded along the ground on its belly approximately 30 m before it came to a complete stop.

The evidence gathered by the investigation is consistent with the scenario: The occurrence encountered by P2-ALP at Efogi Airstrip after the initial touchdown was due to the aircraft, upon landing, rolled over irregular undulated strip surface area which caused the aircraft to bounce. The aircraft nose landing gear encountered soft layer of the strip which caused the nose wheel to bog, causing the landing gear to collapse.

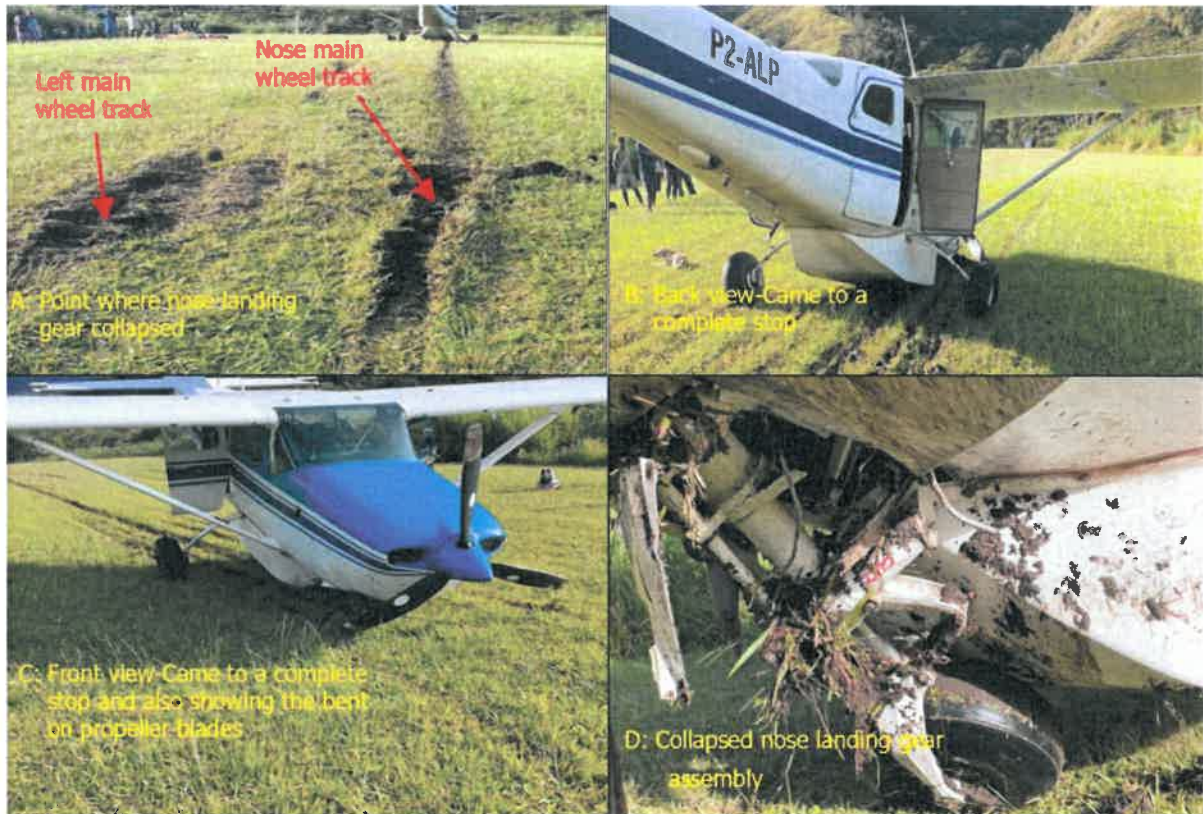
Figure 4: Impact and Damage overview

The AIC identified that the aircraft was serviceable at the time of the accident flight. The damage observed on the propeller blades was consistent with low power engine operations. Also, the investigation determined that there was nothing unusual with the aircraft and its performance during the approach and landing.

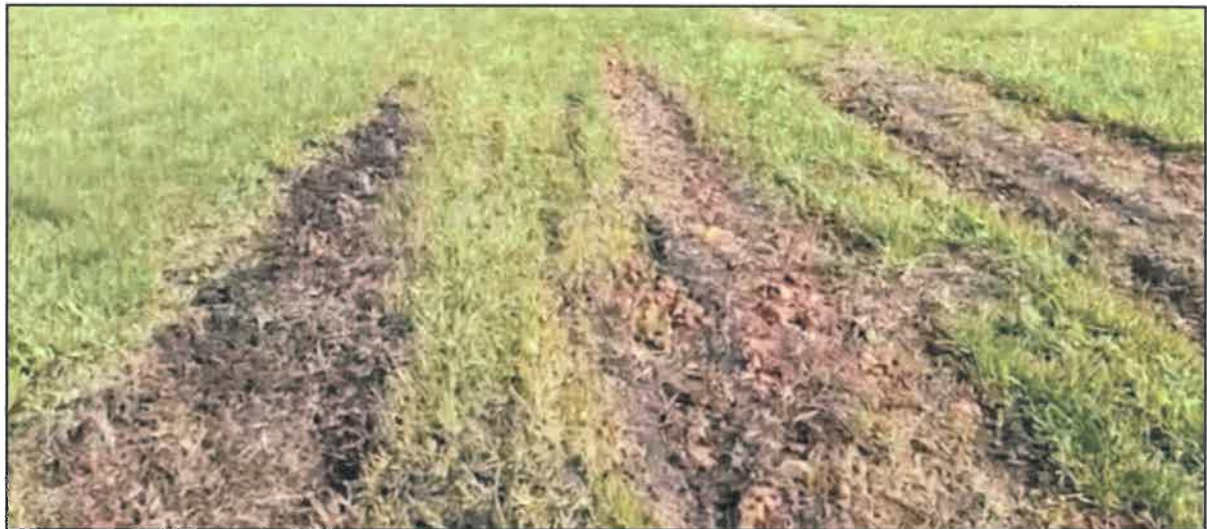
**Figure 5: Efogi airstrip damp wheel bogging track**

During the on-site investigation, it was observed that the grass had been cut. There was a significant amount of dead grass observed on the surface that appeared to have been left on the strip after it had been cut. The investigation also noticed irregular undulations along the length of the strip during the site visit.

The AIC determined that the pilots anticipated, during the accident flight, that the strip conditions they assessed on 14 February 2021 (the last flight before the accident flight) would remain the same. However, with heavy rain on the day before the accident, the strip conditions changed. The rain logged surface was hidden under grass covered surface.
