Final Report

AIC 20-1006

Viking DHC-6-300 Aircraft

Runway Excursion (RE) during takeoff roll

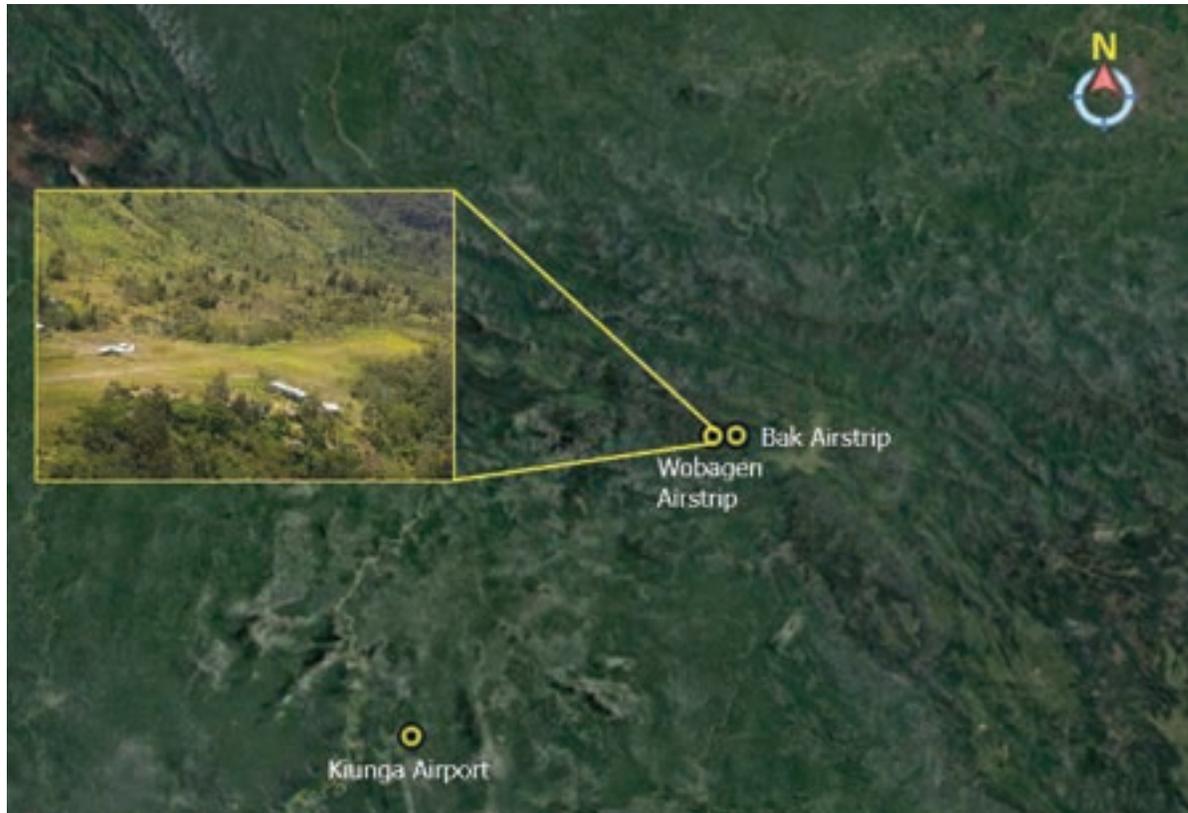
On 1 December 2020, at 09:13 local (23:13 UTC<sup>1</sup>), a Viking DHC-6-300 aircraft, registered P2-ASM, operated by Air Sanga Limited, was conducting a VFR<sup>2</sup> charter flight from Wobagen Airstrip, Sandaun Province to Bak Airstrip, Sandaun Province, when during the take-off, the aircraft ran off the side of the airstrip into a drainage ditch adjacent to the airstrip.

**Figure 1: Accident site**

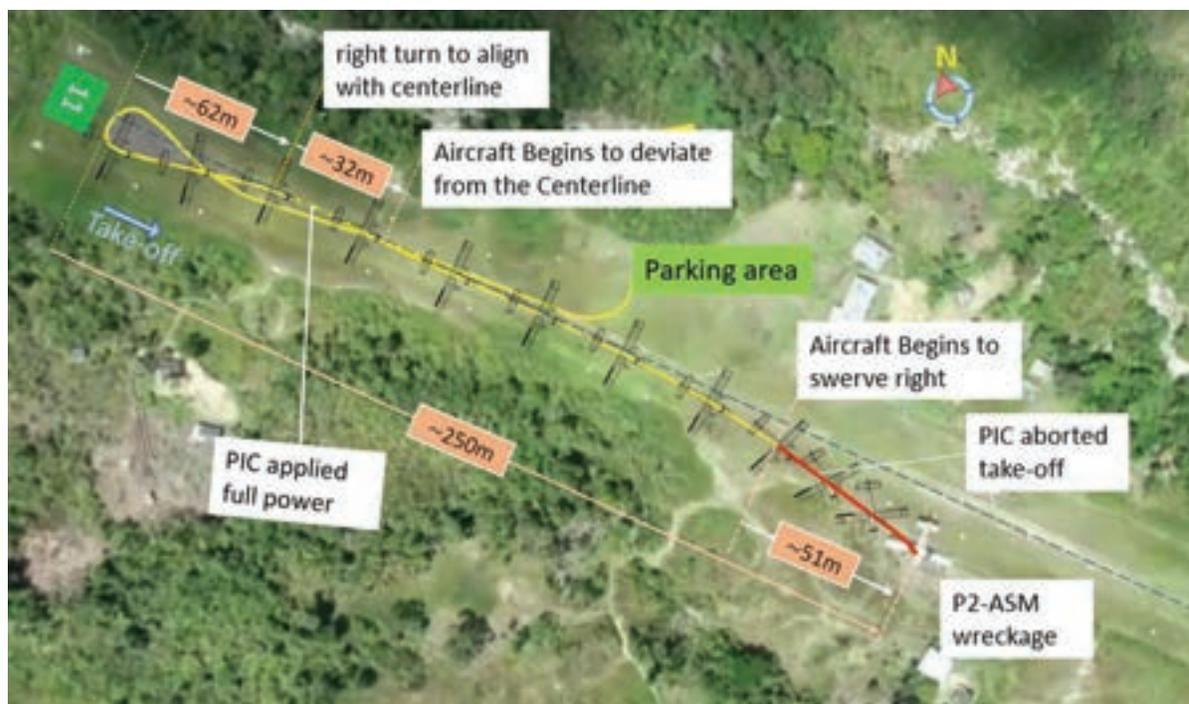
With full power applied, as the aircraft accelerated to about 33 kts, the aircraft started deviating from the centreline, towards the right side. The PIC stated that as soon as he realised that the aircraft was diverging from the centreline, he tried to steer it back towards the centreline using the asymmetric thrust, but the aircraft continued away from centre.

About 200 m down the strip, with a speed of 42 kts, the aircraft started swerving towards the right. The PIC quickly pulled both throttles into idle and applied full brakes. The aircraft continued sliding sideways in the direction of its momentum forward past and ran into soft patchy undulated surface (see Figure 3). The aircraft subsequently impacted a drainage ditch along southwestern edge of the airstrip.

Figure 2: Significant events from take-off to accident

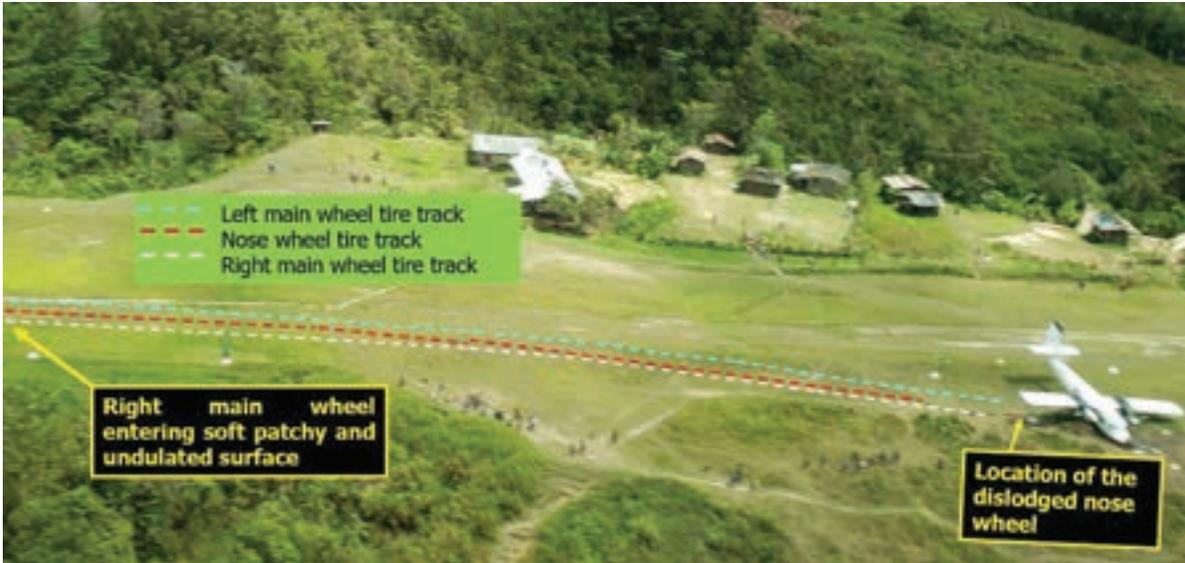
Figure 3: P2-ASM track when it began swerving to the right

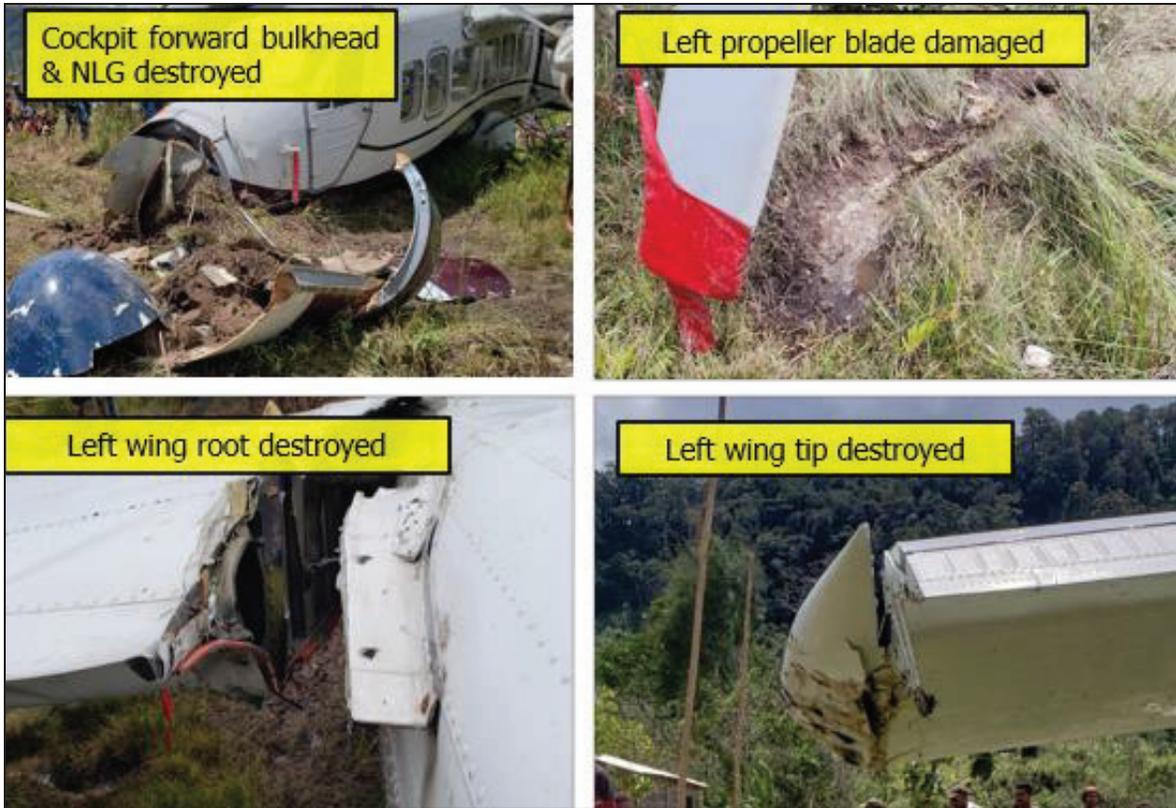
The aircraft sustained significant damage to the cockpit forward bulkhead, nose landing gear (NLG) assembly and the left propeller and wing.

Figure 4 Damage sustained by P2-ASM

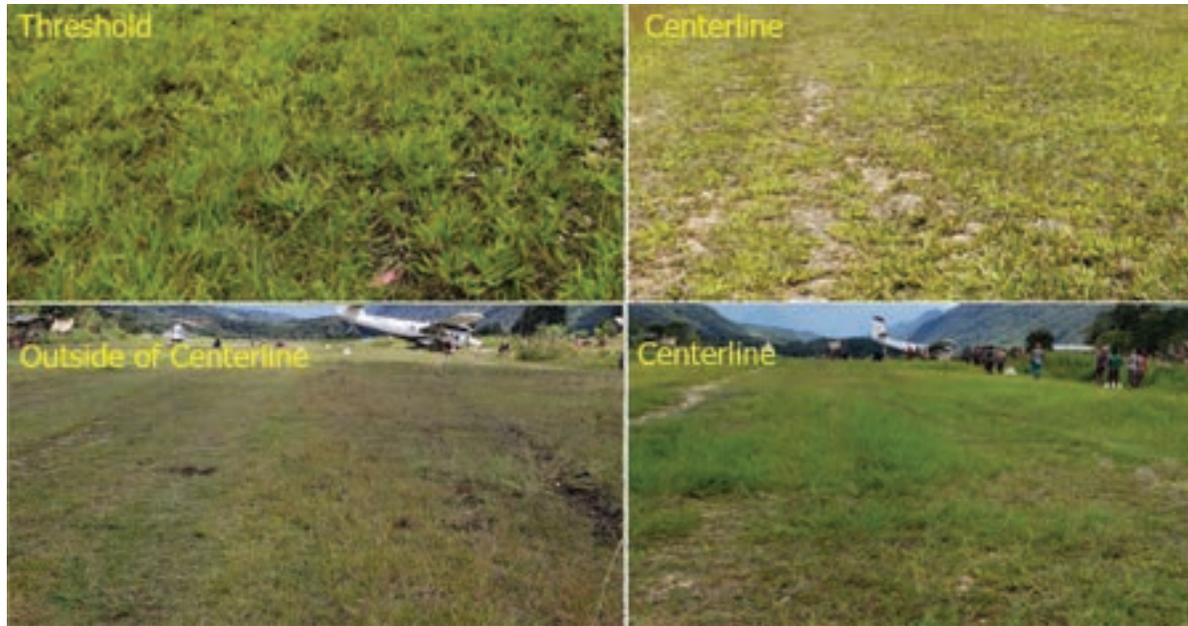
Terms of Description	Condition		
	Centre	Outside of Centreline (Approx. 5m)	Threshold
Surface Cover	Patchy grass & Bare	Short grass	Short grass
Soil Type	Course-grain soil (Limestone gravel)	Clay	Clay
Surface Hardness	Medium	Soft	Soft
Surface Roughness	Rough	Rough	Smooth
Surface Evenness	Undulation	Undulation	Undulation

Figure 5: Images of Wobagen Airstrip taken by on-site team

The wet deteriorated clay/silt surface did not allow aircrafts tires to gain sufficient traction to follow the control inputs of the PIC as he attempted to steer the aircraft back towards the centreline. As the aircraft accelerated towards the right, it ran over undulated surface. The aircraft continued veering right because the power was not reduced, and the asymmetric effect continued. With the asymmetric thrust, the undulated slippery surface, the aircraft swerved right. This prompted the PIC to pull power into idle and apply full brakes. After pulling power to idle, and applying full brakes, the aircraft continued with momentum over the significantly slippery surface and impacted the drainage ditch at the edge.
