PRELIMINARY REPORT

AIC 22-2001

P2-NTE

In-flight Structural Damage

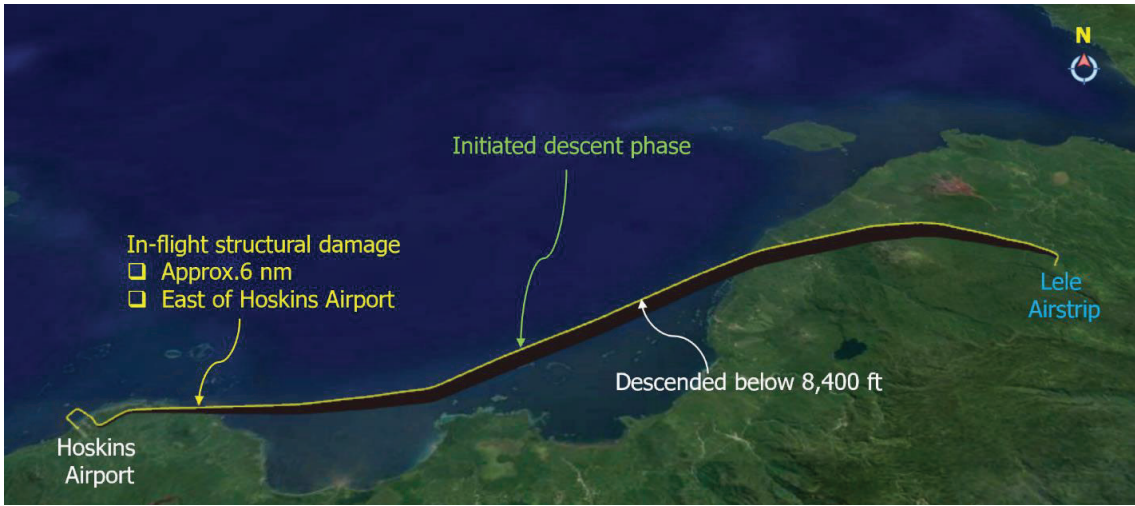
Figure 2: Flight track with the significant events

At 14:43, about 6 NM East of Hoskins Airport, on descent through 2,900 ft AMSL (2,700 ft AGL⁵), the aircraft's left upper wing root fairing detached from the aircraft and struck the leading edge of the left horizontal Stabilizer.

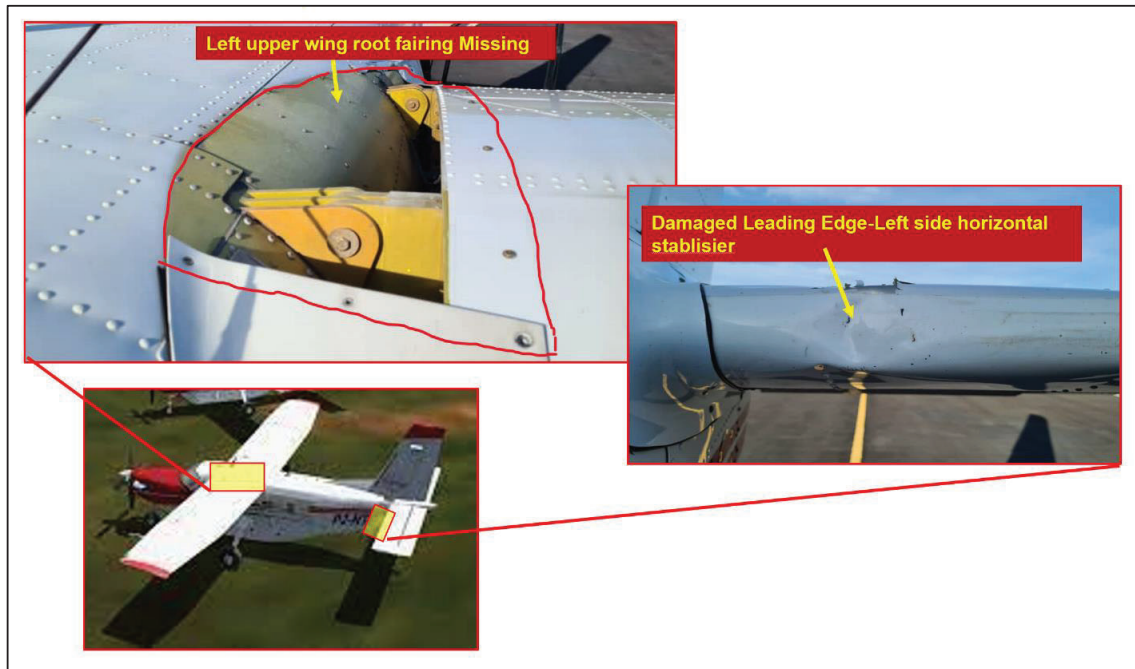
Figure 2: Overview of damage sustained

The left upper wing root fairing detached in-flight and struck the left horizontal stabilizer, causing damage to its leading edge.
