**ACCIDENT INVESTIGATION COMMISSION**  
**OFFICE OF THE CHIEF COMMISSIONER**

**Safety recommendation: AIC 19-R02/18-1004**

**Addressed to: Honeywell Aerospace**

**Investigation link: AIC 18-1004**

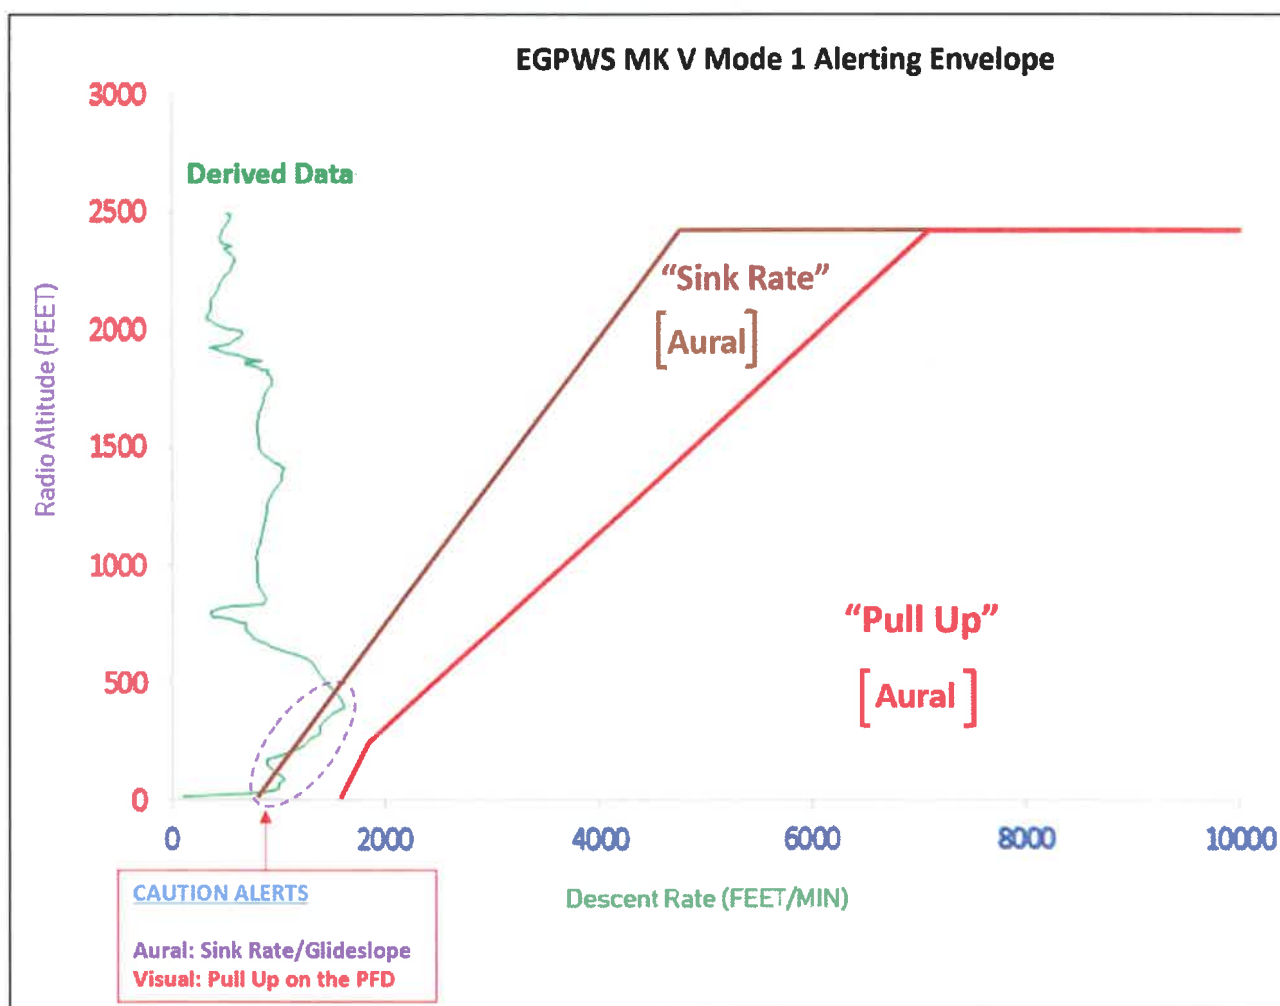
Figure 2: Derived Data plotted against Honeywell EGPWS MK V Mode 1 Graph

The aircraft was progressively flown below the glideslope, and from 23:24:00 to the time of impact at 23:24:19 the EGPWS issued eight *Glideslope*<sup>4</sup> Alerts (aural alert), and nine *Sink rate*<sup>5</sup> Alerts (aural alert). The first *Sink rate* Alert was issued at 23:24:00 when the aircraft was at a Radio Altitude of 367 ft with a vertical speed (rate of descent) of 1,616 ft per minute. The last *Sink rate* Alert occurred 2 seconds before impact at a Radio Altitude of 13 ft and a vertical speed (rate of descent) of 848 ft per minute. The Caution alerts (aural alerts) were ignored by the crew.

The investigation into this accident has found that the crew did not take any remedial action in response to the *Glideslope* and *Sink rate* Caution Alerts (aural alerts). The EGPWS issued these Caution Alerts (aural alerts) that included the words **PULL UP** appearing steady in red on the Primary Flight Display (*Electronic Flight Instrument System*) when the aircraft penetrated the Sink Rate Envelope of the Honeywell EGPWS MK V Mode 1 Graph. See Figure 2.

5 Sink rate Caution Alert is issued when the aircraft penetrates the zone shown on the Honeywell EGPWS MK V Mode 1 Graph (See Figure 2)

The PNG Accident Investigation Commission recommends that Honeywell Aerospace should ensure that the Honeywell EGPWS MK V Computer provides timely and continuous hard aural warning "*WHOOP WHOOP PULL UP*," simultaneously with the stable visual display of **PULL UP** on the Primary Flight Display, which requires immediate action from the crew, when encountering an excessive Rate of Descent at very low Radio Altitude, similar to that encountered by the crew of P2-PXE as shown in Figure 1.

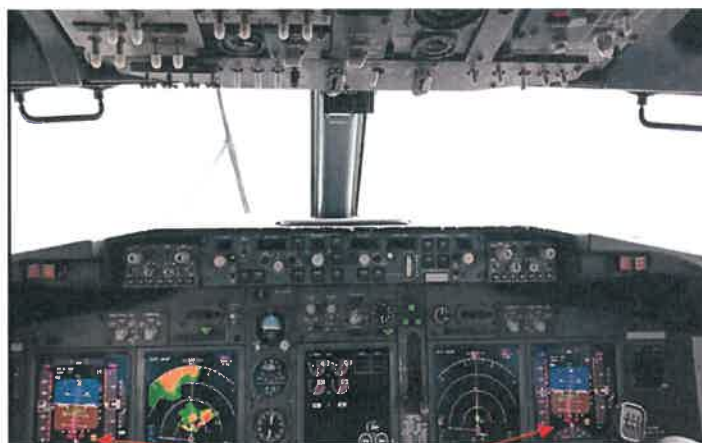
**Figure 3: Image from PXE cockpit video<sup>9</sup> showing steady **PULL UP** on PFD display**

A steady visual display of **PULL UP** on the Primary Flight Display (*Electronic Flight Instrument System*), was not noticed by either pilot, and therefore was not sufficient to alert them of the imminent danger.

The investigation determined that the crew of P2-PXE were fixated on the task of landing the aircraft and did not notice the steady visual ‘**PULL UP**’ caution alert at the bottom of their Primary Flight Displays (PFD). Therefore, they (crew) did not take any positive action to arrest the high rate of descent and avoid landing in the lagoon. In fact, neither of the pilots were aware of the rapidly unfolding unsafe situation.

In the seconds leading up to this accident at Chuuk, the pilots missed an important change of indication on their PFDs. **Why?** Could it have been that there were so many steady indications that the steady **'PULL UP'** visual alert just blended into them? Could it have been that the crew did not hear an alert worth reacting to?

The pilots' fixation on the task of landing the aircraft could have been significantly diverted if there was an attention-getter hard aural **'WARNING'** alert rather than peripheral reliance on a steady visual **'PULL UP'** caution alert at the bottom of the PFD which was associated with the *'Sink Rate'* caution aural alert as provided by the LAMP Format 1 setting.

The AIC therefore believes the inclusion of a **flashing visual 'PULL UP' WARNING** on the PFDs rather than reliance upon peripheral steady visual caution alerts would be a significant enhancement in terms of attention getting alert capability.

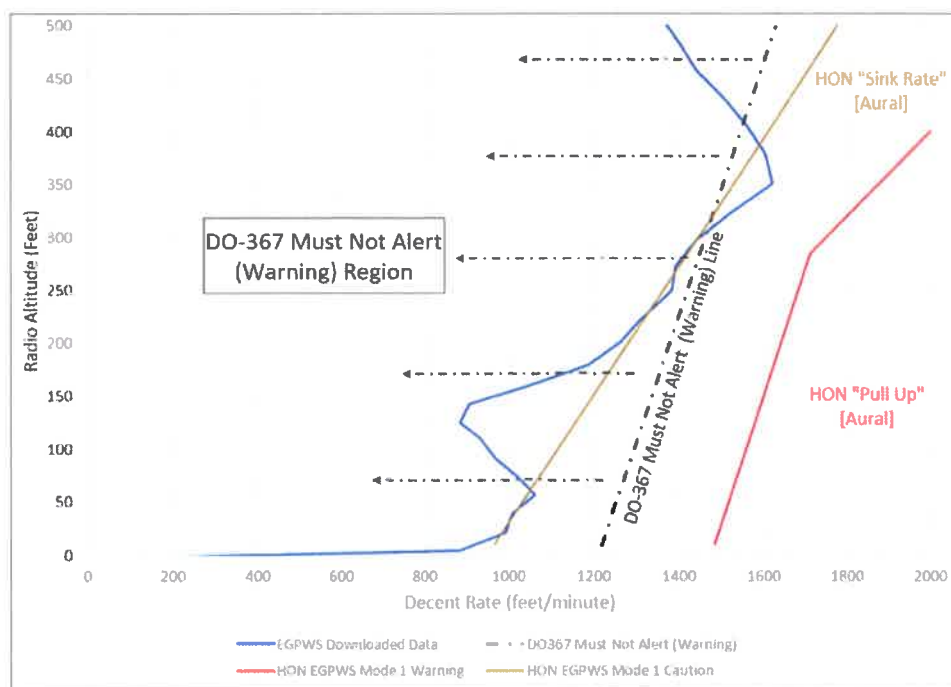
**Figure 3: Mode 1 Sink Rate Alert Curves with DO-367 "Must Not Alert (Warning)" Requirement<sup>11</sup>**

Figure 3 depicts the **HON "Pull Up" [Aural]** boundary of the HON EGPWS Mk V Mode 1 Warning. It shows:

At 275 feet Radio Altitude and 1,750 feet/min rate of descent the time to impact would be 9.4 seconds.

At 200 feet Radio Altitude and 1,650 feet/min rate of descent the time to impact would be 7.2 seconds.

At 100 feet Radio Altitude and 1,750 feet/min rate of descent the time to impact would be 9.4 seconds.

At 50 feet Radio Altitude and 1,500 feet/min rate of descent the time to impact would be 2.0 seconds.

As per *DO-367 'Must Not Alert (Warning)' requirement* region (as depicted in Figure 2), with the engine spool-up time and the time it will take to compensate for the loss of altitude for a positive rate of climb, there is insufficient time for pilots to react to an immediate time-critical situation if there is no 'WARNING' alert issued at low altitude after entering the *DO-367 'May Alert' and 'Must Alert' regions*. The rate of descent during the approach into Chuuk as shown in Figure 1, clearly shows that the crew were outside the safety margin.

It is therefore likely that a continuous hard aural warning '*WHOO WHOO PULL UP*', or a **flashing** visual display '**PULL UP**' warning on the Primary Flight Display, would have been effective in alerting the crew to the imminent danger, prompting a pull up and execution of a missed approach, that would have prevented the accident. A hard-aural warning alert or flashing visual warning, demanding an immediate flight crew response would clearly be desirable in the interest of safety enhancement.

The PNG Accident Investigation Commission recommends that Honeywell Aerospace, in consultation with the Federal Aviation Administration, should re-evaluate *TSO's 151b and 151d* and *DO-367* related to EGPWS warnings and cautions, and ensure that the Honeywell EGPWS MK V Computer provides a **timely warning** in the form of a continuous **flashing** visual display of '**PULL UP**' at the bottom of the Primary Flight Displays, as an absolute minimum standard. The **flashing** visual display '**PULL UP**' warning, simultaneously with the aural caution 'SINK RATE', would require immediate action from the flight crew when encountering an excessive Rate of Descent at very low Radio Altitude, similar to that flown by the crew of P2-PXE as shown in Figure 1.
