Safety recommendation: AIC 19-R17/18-1004

Addressed to: Federal Aviation Administration

Investigation link: AIC 18-1004

On Friday 28th September 2018, a Boeing 737-8BK aircraft, registered P2-PXE, was being operated by Air Niugini Limited, on a scheduled passenger flight from Pohnpei to Chuuk, Federated States of Micronesia.

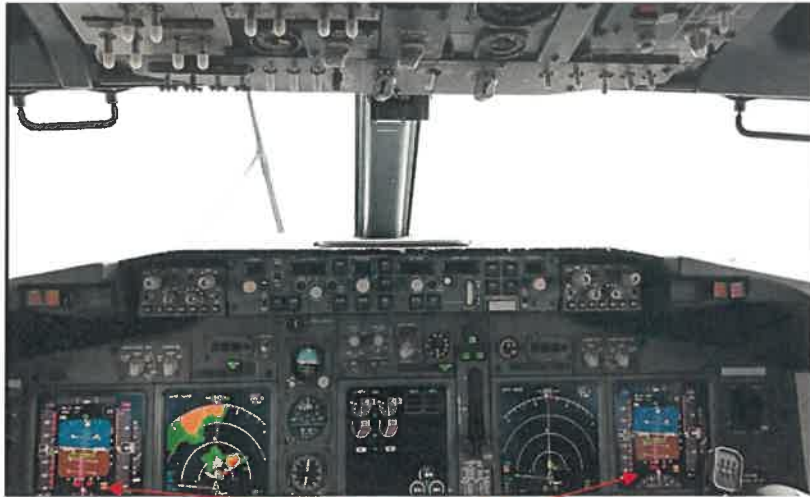
The investigation determined that the pilots of P2-PXE were fixated on the task of landing the aircraft and did not notice the steady visual **PULL UP** caution alert at the bottom of their Primary Flight Displays (PFD). Therefore, they (pilots) did not take any positive action to arrest the high rate of descent and avoid landing in the lagoon. In fact, neither of the pilots were aware of the rapidly unfolding unsafe situation.

Figure 1: Image from PXE cockpit video⁸ showing **PULL UP** on PFD display

A recommendation was issued to Honeywell Aerospace to ensure that the Honeywell EGPWS MK V Computer provides timely and continuous hard aural warning “**WHOOP WHOOP PULL UP**,” simultaneously with the visual display of **PULL UP** on the Primary Flight Displays, which would require immediate action from the crew, when encountering an excessive Rate of Descent at very low Radio Altitude, similar to that encountered by the crew of P2-PXE as shown in Figure 1. (Refer to recommendation *AIC 19-R02/18-1004* to Honeywell Aerospace) on the 31st January 2019.

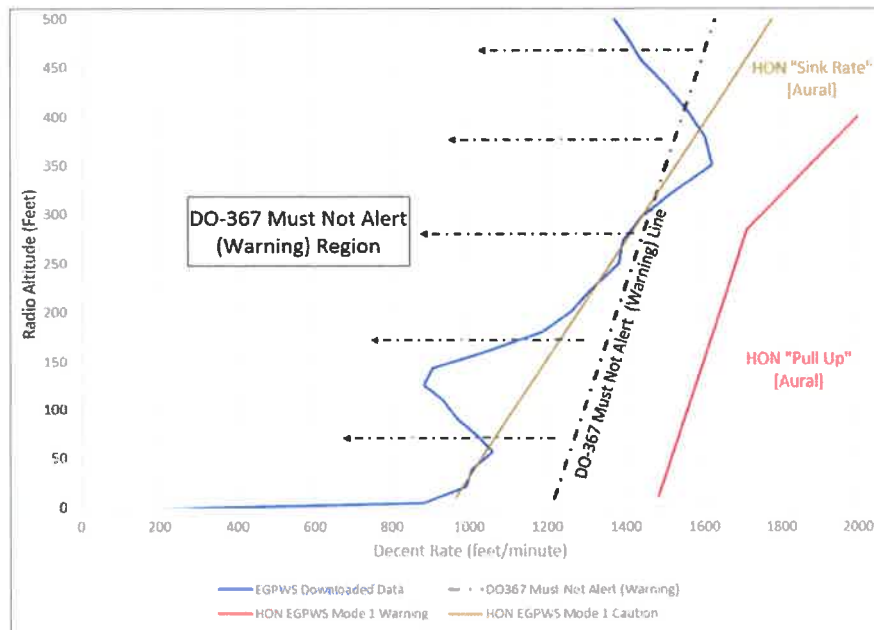
Furthermore, the minimum operational standards set out in DO-367 (MOPS) as depicted in **Figure 1** below shows the DO-367 'Must Not Alert' (Warning) Region, plotted against the Honeywell EGPWS Mode 1 Alerting Envelope. It is precisely in this region, at very low altitude and excessively high rate of descent that PXE was flown.

Figure 2. Mode 1 Sink Rate Alert Curves with DO-367 "Must Not Alert (Warning)" requirement¹⁰

The PNG Accident Investigation Commission recommends that the Federal Aviation Administration should re-evaluate TSO's 151b and 151d and DO-367 related to EGPWS warnings and cautions, and ensure that the Honeywell EGPWS MK V Computer provides a **timely warning** in the form of a continuous **flashing** visual display of '**PULL UP**' at the bottom of the Primary Flight Displays, as an absolute minimum standard. A **flashing** visual display '**PULL UP**' warning, accompanying an aural 'SINK RATE', would require immediate action from the flight crew when encountering an excessive Rate of Descent at very low Radio Altitude, similar to that flown by the crew of P2-PXE.
