PRELIMINARY REPORT

AIC 23-1005

Beechcraft King Air B200C

Nose Landing Gear Collapse During Landing Roll

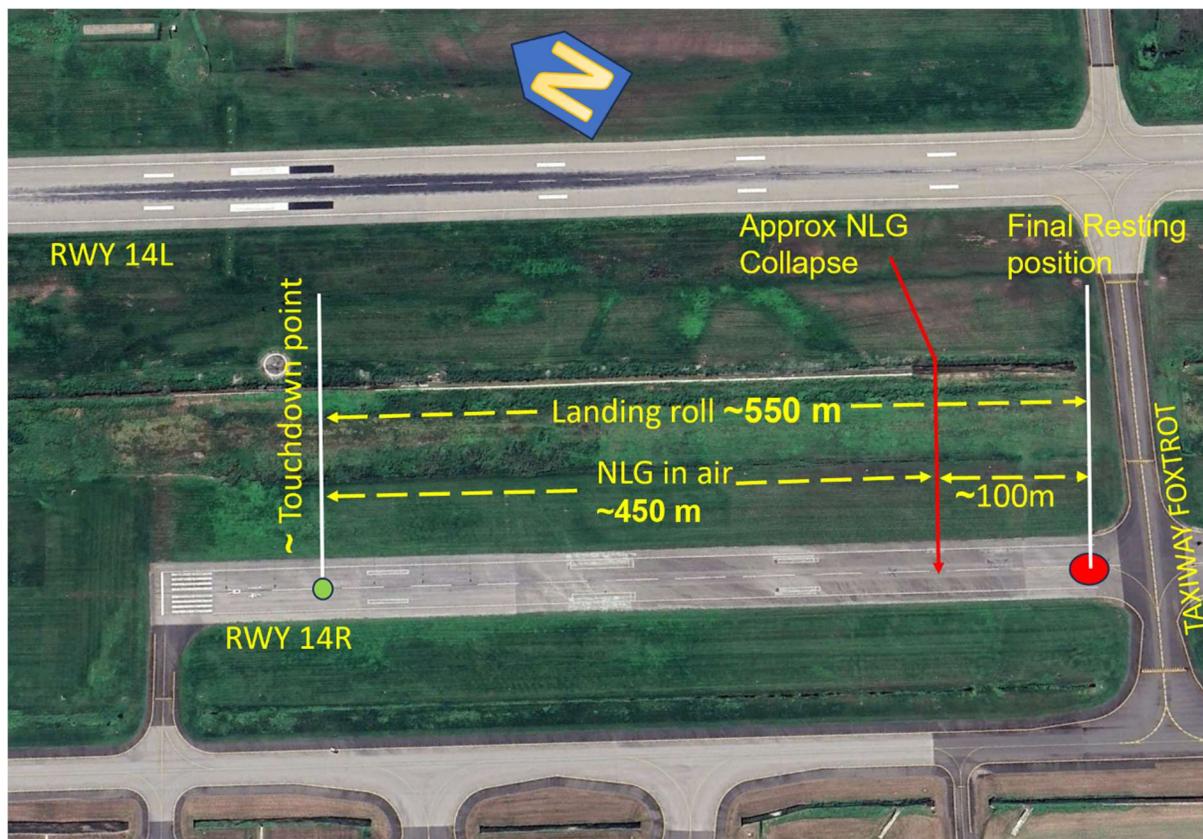
Figure 2: P2-JAU landing roll on Runway 14R.

At 02:49, ATC cleared the aircraft for landing on runway 14R. The flight crew conducted the approach for runway 14R. The aircraft touched down at 02:51. The aircraft rolled for about 450 m before the NLG collapsed and the nose dropped to the ground. The aircraft continued forward with momentum for another 100 m before coming to rest adjacent to taxiway foxtrot where ARFF were standing by for emergency assistance.

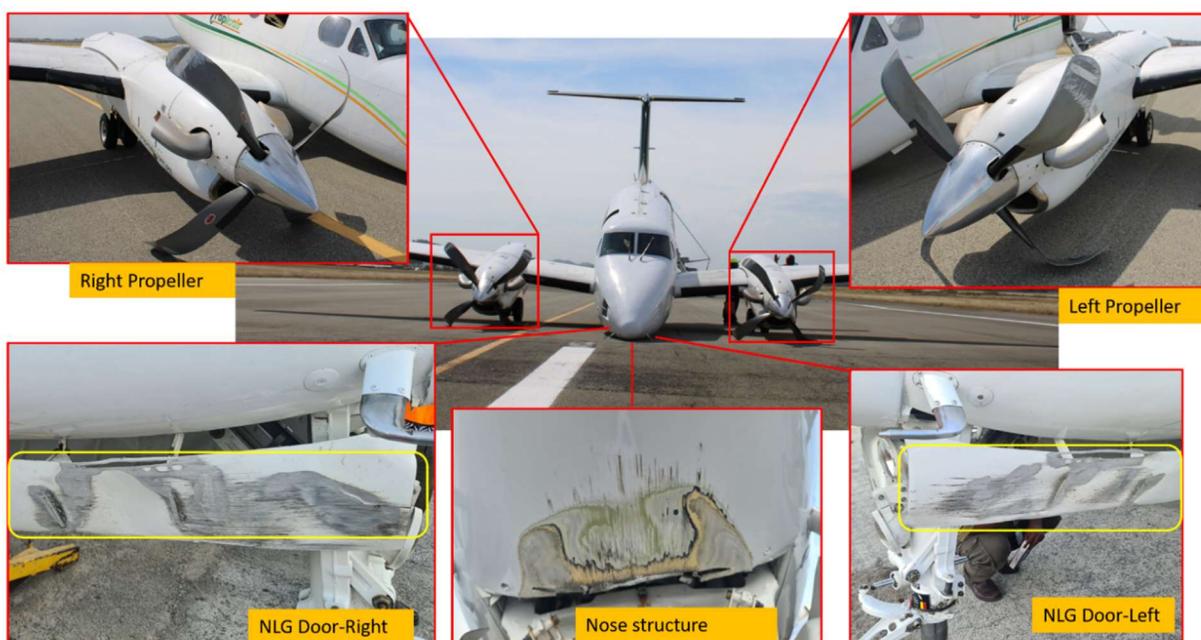
Figure 3: P2-JAU observed damage at occurrence site

The aircraft sustained substantial damage to both left and right propeller assemblies, nose structure and left and right nose landing gear (NLG) doors.
