Preliminary Report

AIC 24-1001

North Coast Aviation

Runway excursion

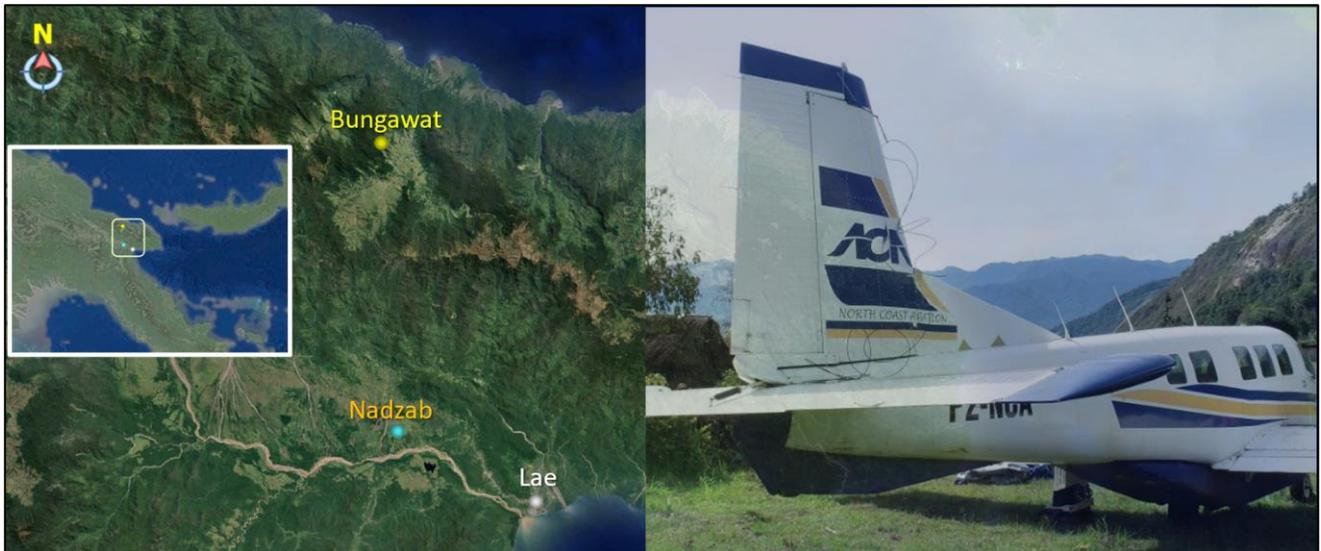
Figure 1: Depiction of P2- NCA accident site

On 8 January 2024, at about 09:26 local (23:26 UTC¹), a PAC 750XL aircraft registered P2-NCA, owned and operated by North Coast Aviation (NCA), was conducting a VFR² passenger flight from Nadzab Tomodachi International Airport to Bungawat Airstrip, Morobe Province, Papua New Guinea, when during landing, the aircraft experienced a loss of directional control on touchdown and subsequent runway excursion.

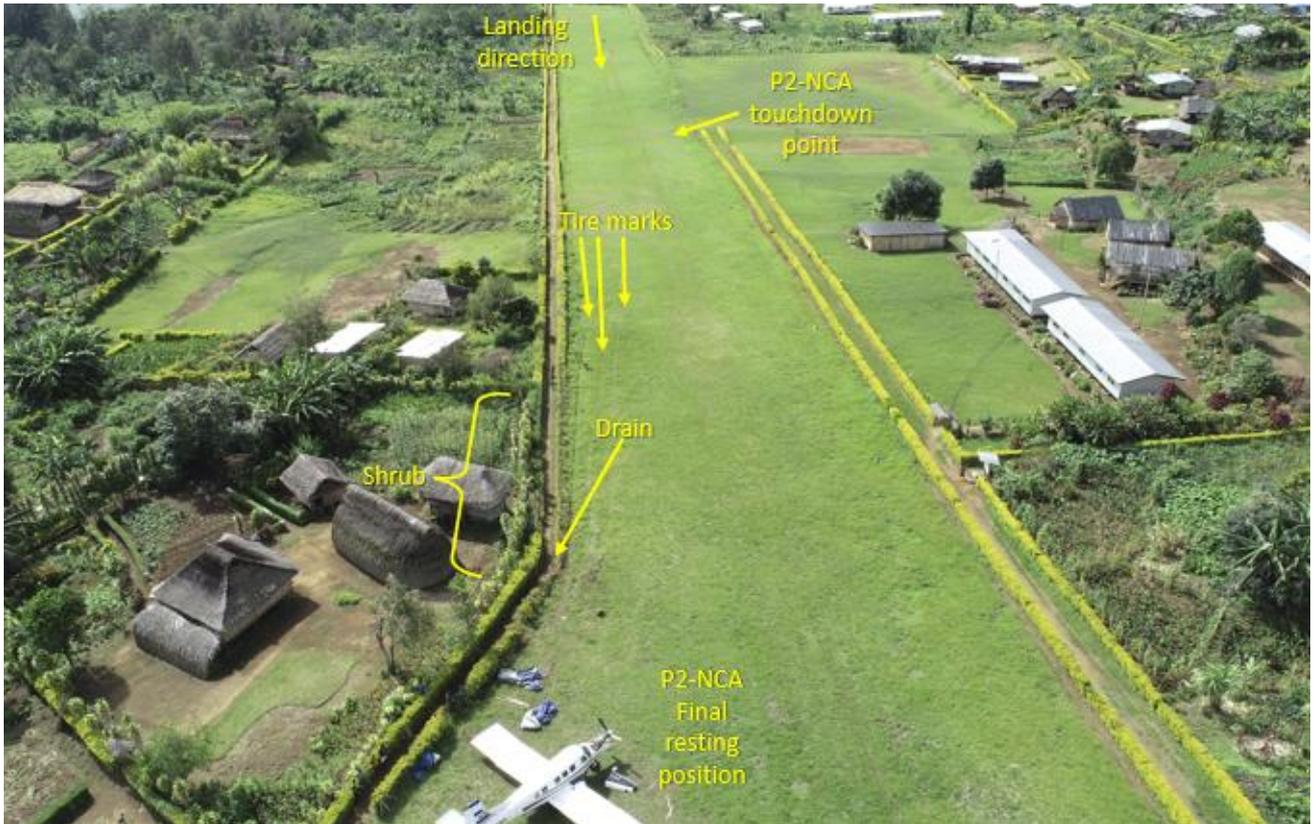
Figure 4: Overview of P2-NCA from touchdown to the final resting position

The flight crew stated that they experienced a hard landing. The aircraft touched down at about 230 m beyond the displaced threshold of runway 36, towards the left of centerline. The pilot subsequently applied full right rudder to bring the aircraft back onto the centerline, however the pilot overcorrected, resulting in the aircraft veering to the right side of the strip.

To prevent the aircraft from veering further right, the pilot applied left rudder to bring the aircraft back towards the centerline. However, the aircraft's right main wheel and the right wing made contact with the drain and hedges respectively, that ran along the side of the runway, causing the aircraft to resist the left rudder input by the pilot.

Once the aircraft's right main wheel and the right wing were clear of the drain and the hedges, the aircraft subsequently made more than 180 degrees turn and came to a stop. In that position, the Check and Training pilot shut down the aircraft while the ICUS pilot evacuated the passengers through the main door.

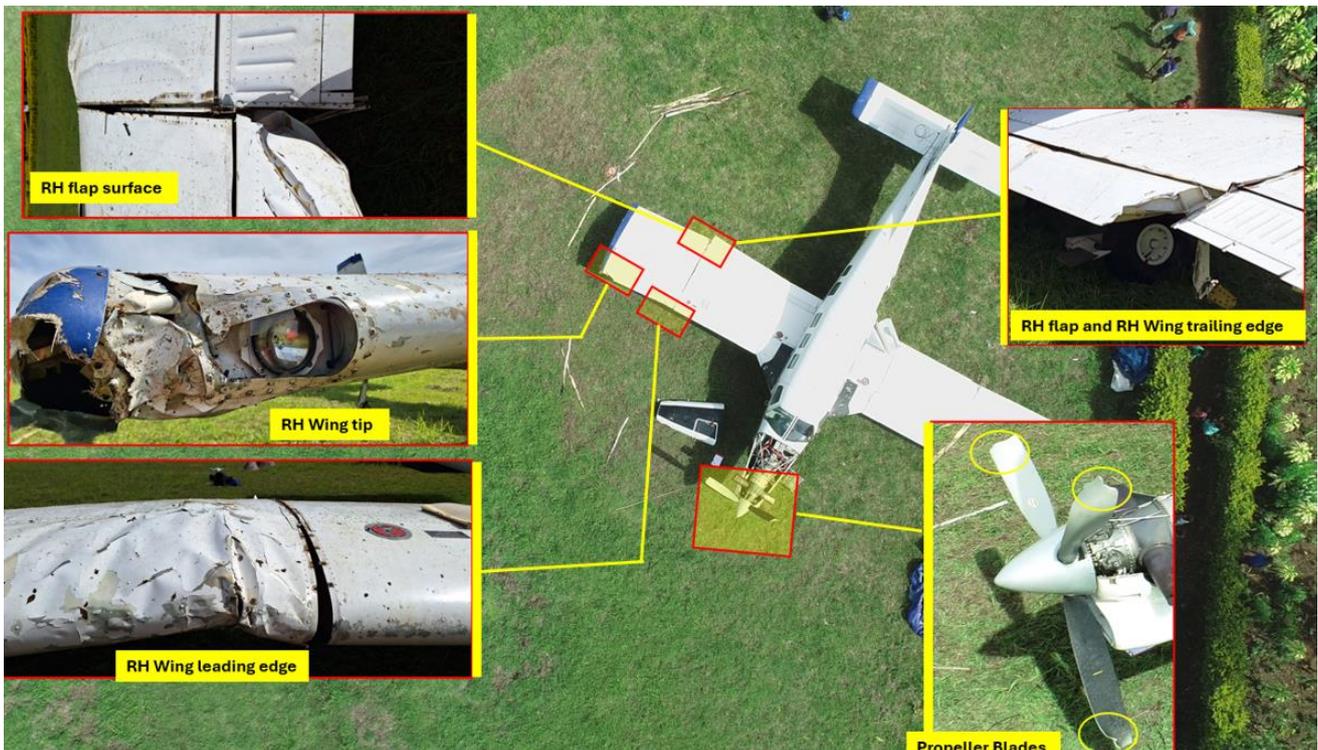
Figure 5: Overview of the damage sustained on the aircraft

The right-wing tip and the leading edge sustained substantial damage. The flap hinge was detached from the aircraft wing structure and the tip of the propeller blades were also damaged.
