PRELIMINARY REPORT

AIC 24 - 1002

De Havilland DHC6-300 Aircraft

Runway Excursion During Take Off

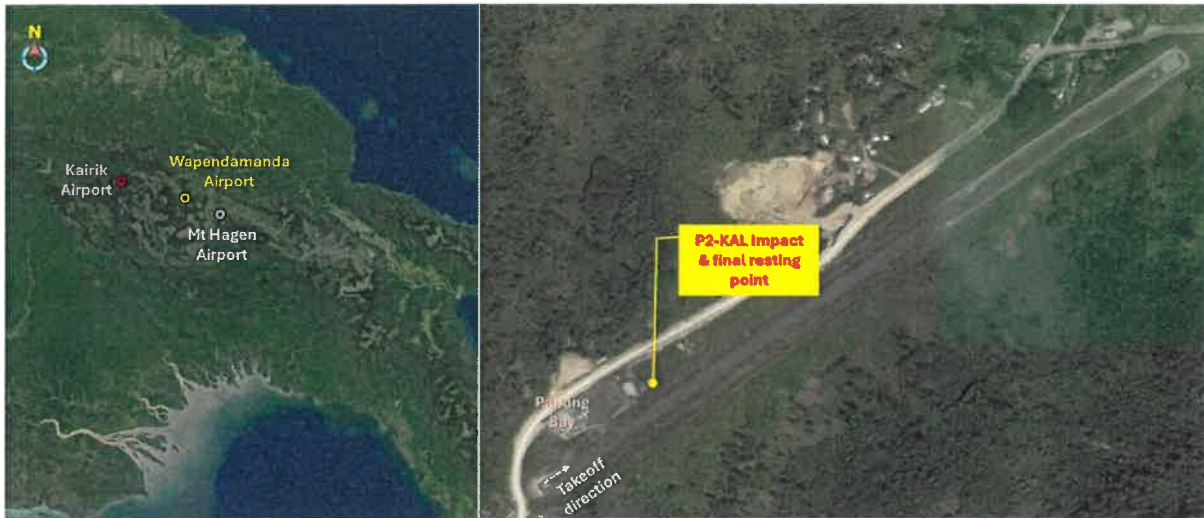
Figure 1: Depiction of P2-KAL Accident site

On 19 October 2024, at about 15:00 local, (05:00 UTC¹) a De Haviland DHC6-300 aircraft, registered P2-KAL, owned by ASHE Aircraft Enterprises Limited and operated by Kobio Aviation Limited, was conducting a VFR² charter flight from Kairik Airport, Enga Province to Mt. Hagen Airport, Western Highlands Province, Papua New Guinea, when during the takeoff roll, the aircraft ran off the side of the runway into a drainage ditch.

The PF stated that the left wingtip then clipped the side of the airport fencing, which runs along the edges of the strip. The contact between the wingtip and fence caused the aircraft to turn further left towards the drainage ditch at the edge of the strip, where the nose wheel rolled into the drainage ditch and came to rest.

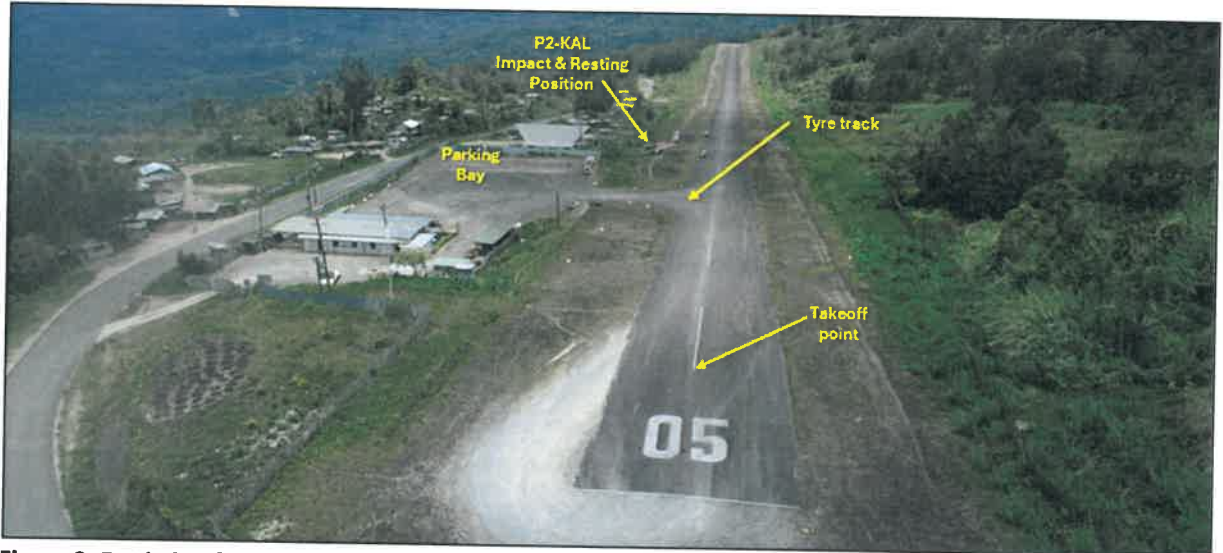
Figure 2: Depiction from takeoff to impact point

The crew reported that after aligning the aircraft on Runway 05 and configuring it for takeoff, they began the takeoff roll. During the takeoff roll, they observed the aircraft tracking to the left of the centerline. In an attempt to correct the tracking to the left, the PF applied asymmetric thrust and right rudder, however, the aircraft continued veering left towards the runway's edge and continued onto the grass surface. Consequently, the crew decided to abort the takeoff.

The PF then applied full reverse thrust and brakes in an effort to slow the aircraft and bring it to a stop. However, due to the wet and slippery grass surface, caused by rain on the day of the accident and in the days prior, the aircraft continued to skid further left, towards the ditch adjacent to the runway.

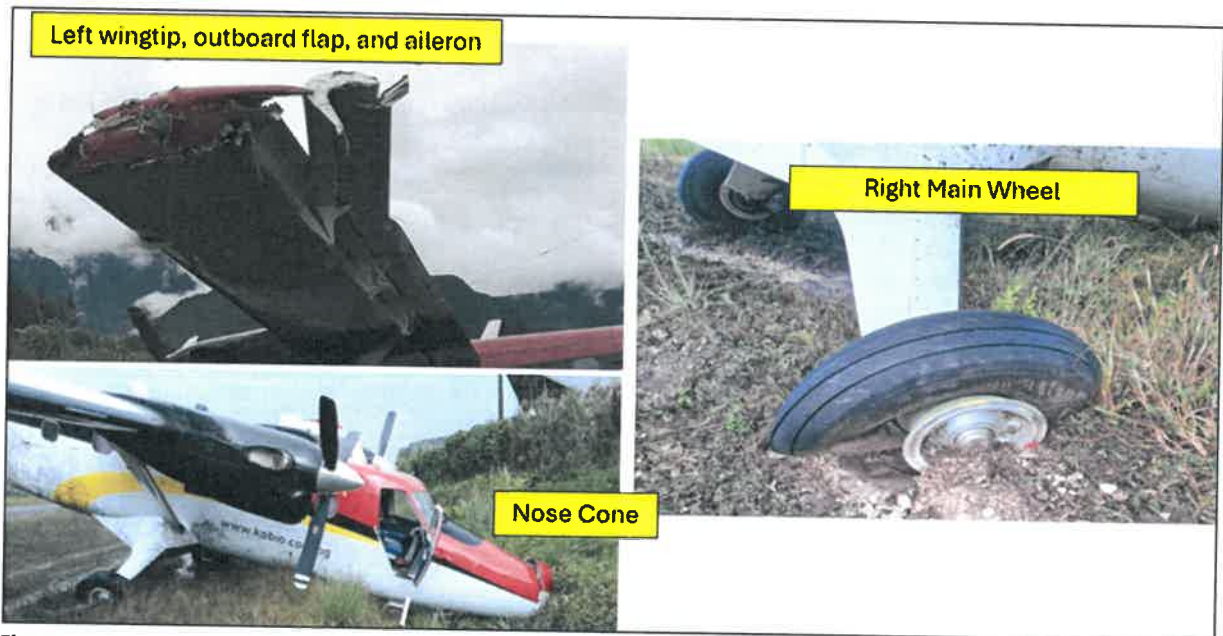
Figure 3: Damaged sustained by P2-KAL

The aircraft sustained substantial damage to the left-wing outboard flap and aileron, nose cone and a punctured right-hand mainwheel tyre on impact (refer to Figure 3).

Type of operation	VFR Charter Flight	
Persons on Board	Crew: 2 Pilots	Passengers: 3
Injuries	Crew: Nil	Passengers: Nil
Damage	The aircraft sustained substantial damage to the left wingtip, left outboard flap, left outboard aileron, and nose cone. The right mainwheel tyre was punctured.
