**FINAL REPORT**

**AIC 24-1001**

**P2-NCA**

**Runway Excursion**

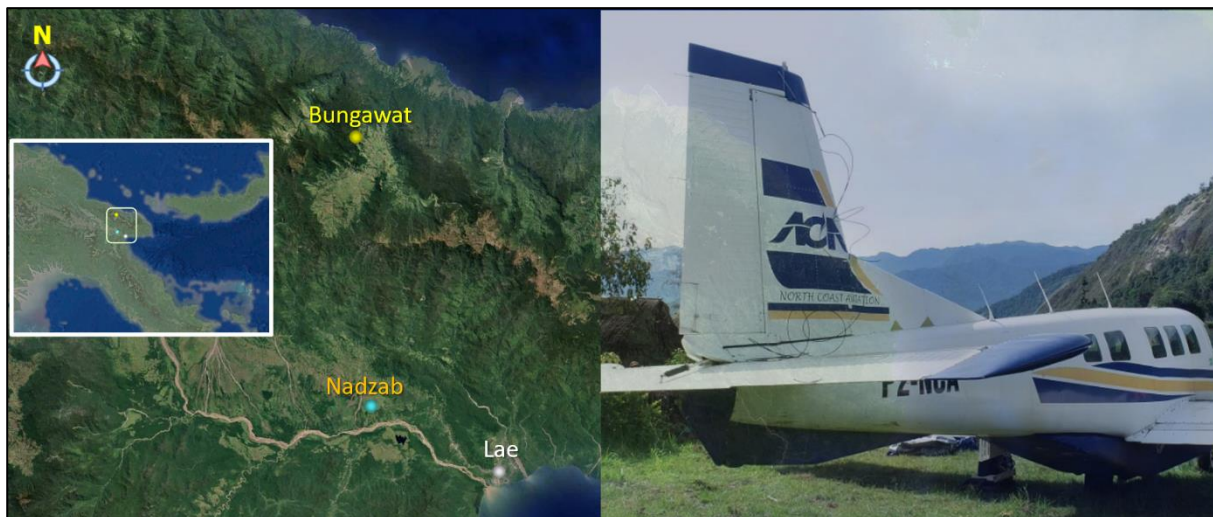
**Figure 1: Depiction of P2-NCA Accident Site**

On 8 January 2024, at 09:26 local (23:26 UTC<sup>3</sup>), a PAC 750XL aircraft registered P2-NCA, owned and operated by North Coast Aviation Limited (NCA) was conducting a VFR<sup>4</sup> unscheduled passenger flight from Nadzab Tomodachi International Airport to Bungawat Airstrip, Morobe Province, Papua New Guinea, when during landing, the aircraft experienced a loss of directional control on touchdown and subsequent runway excursion.

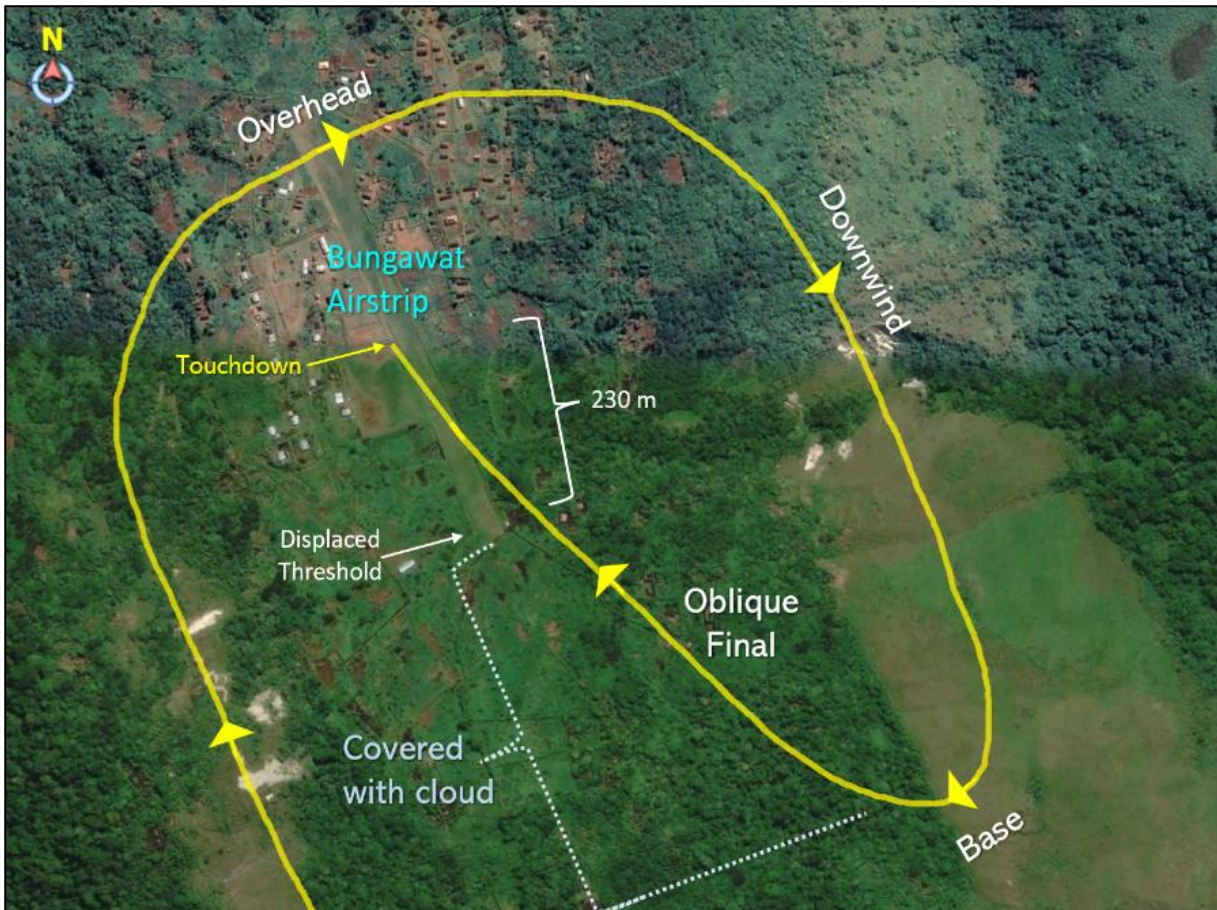
**Figure 4:P2-NCA Circuit flown at Bungawat Airstrip (Source:V2 Track recorded data and pilot interview)**

The IP initiated the approach by tracking for a right circuit from overhead and continued approach. Due to cloud buildup along the final approach path, the crew flew an oblique pattern from the start of right base, straight to short finals and touchdown. The aircraft had to be flown further right of the normal finals track, which was clear of clouds, before heading<sup>9</sup> adjustments were made to the aircraft tracking to line up with runway heading for touchdown.

The IP stated that the approach speed was maintained between 80 and 85 knots due to the aircraft being overweight, based on their calculations of the landing weight for Bungawat. He added that he configured the aircraft by fully extending the flaps and maintained an airspeed of 65-75 kts during the final approach and on short final and touchdown, he reduced the speed to 60 - 65 kts.

The aircraft touched down about 230 m beyond the Runway 32 threshold, left of centerline and experienced a bounce. The IP stated that on touchdown, full right rudder was applied to get the aircraft tracking to the right onto centerline. When the aircraft got back onto the ground after being in the air momentarily, it immediately turned right and overshot the centerline and veered further right towards the runway edge. The IP attempted to turn the aircraft back to the left by applying left rudder to get it back onto centreline, however, the aircraft continued to track further towards the right edge of Runway 32.

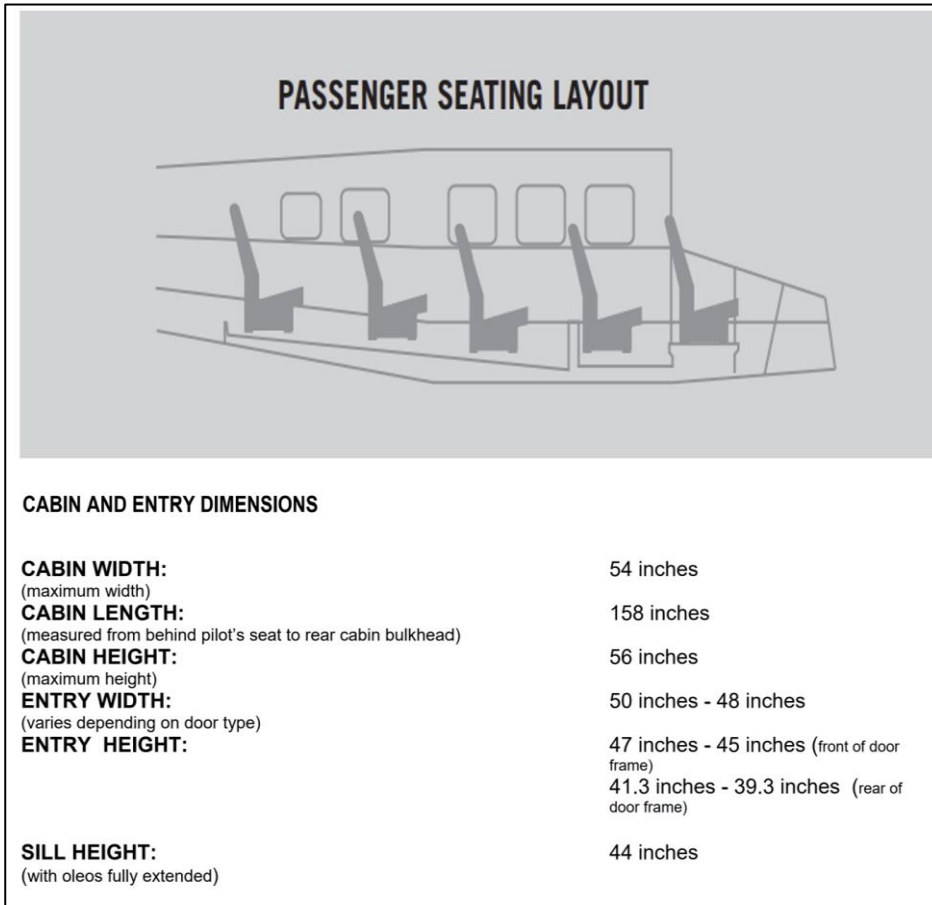
**Figure 5: Seating Layout and Cabin and Entry Dimensions PAC 750XL** (Source: *Utility Aircraft Corporation and PAC 750XL Pilot Operating Handbook and approved Flight Manual 2825* )

The investigation found from the manufacturer's PAC 750XL *Pilot Operating Handbook* and approved *Flight Manual 2825* that the maximum seat capacity in the cabin is eight (8) ; two (2) seats in each row. There are two (2) seats in front; left seat for the pilot and right seat adjacent to the pilot's seat, may be occupied by a passenger (Refer to Figure 5).

The investigation also found that the number of passengers in the cabin exceeded the manufacturer's maximum allowable, which is eight (8). Since the minimum crew for the PAC 750XL is one pilot who occupies the left seat in front, the right front seat, adjacent to the pilot's seat may be occupied by a passenger. The right seat in the front, adjacent to the left seat was occupied by the IP who was monitoring the pilot ICUS.

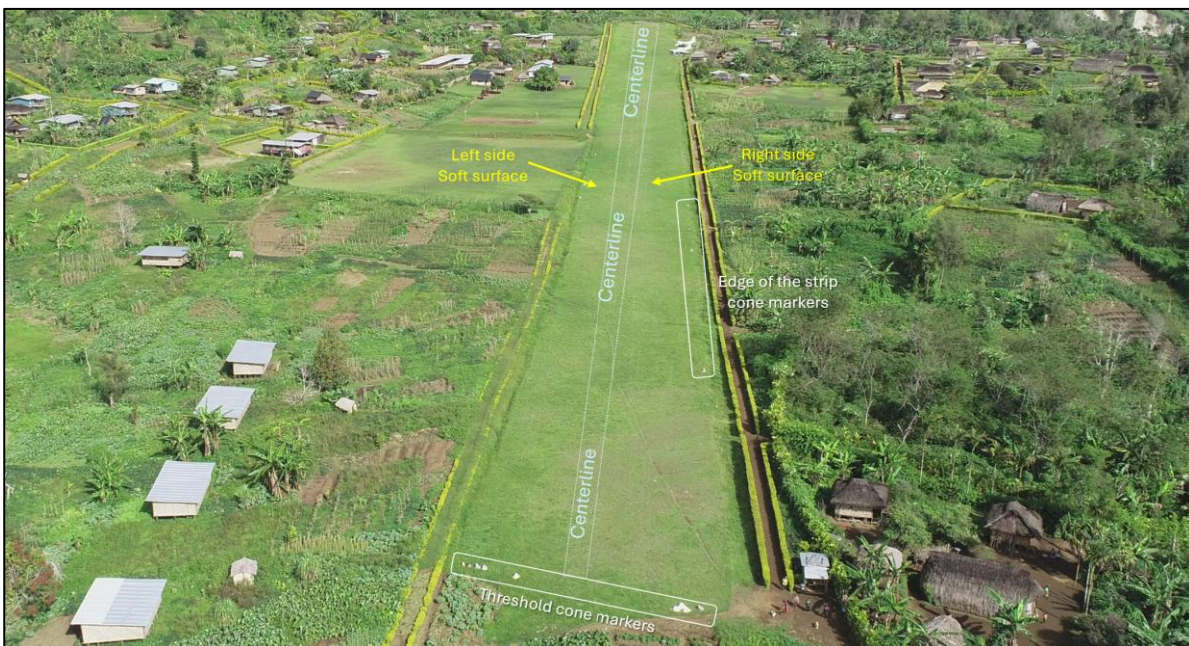
**Figure 8: Bungawat Airstrip with indications of the on-site team observation**

During the onsite investigation, it was observed that the runway surface was covered with light overgrowth of grass. The runway centreline had a hard surface, however, the left and right sides of the runway centerline had soft surfaces.

The team also observed that the windsock was unserviceable and the cone markers at the threshold and along the edge of the strip on each side of the runway were not in a good condition nor were they clearly visible.

Considering the strip surface condition being wet and damp at the time of the accident, it is highly likely that the condition of the strip surface on the day of the occurrence would have made it challenging to maintain directional control on the ground following touchdown, and the excessive control input by the IP directly resulted in an over correction that led to the loss of directional control.

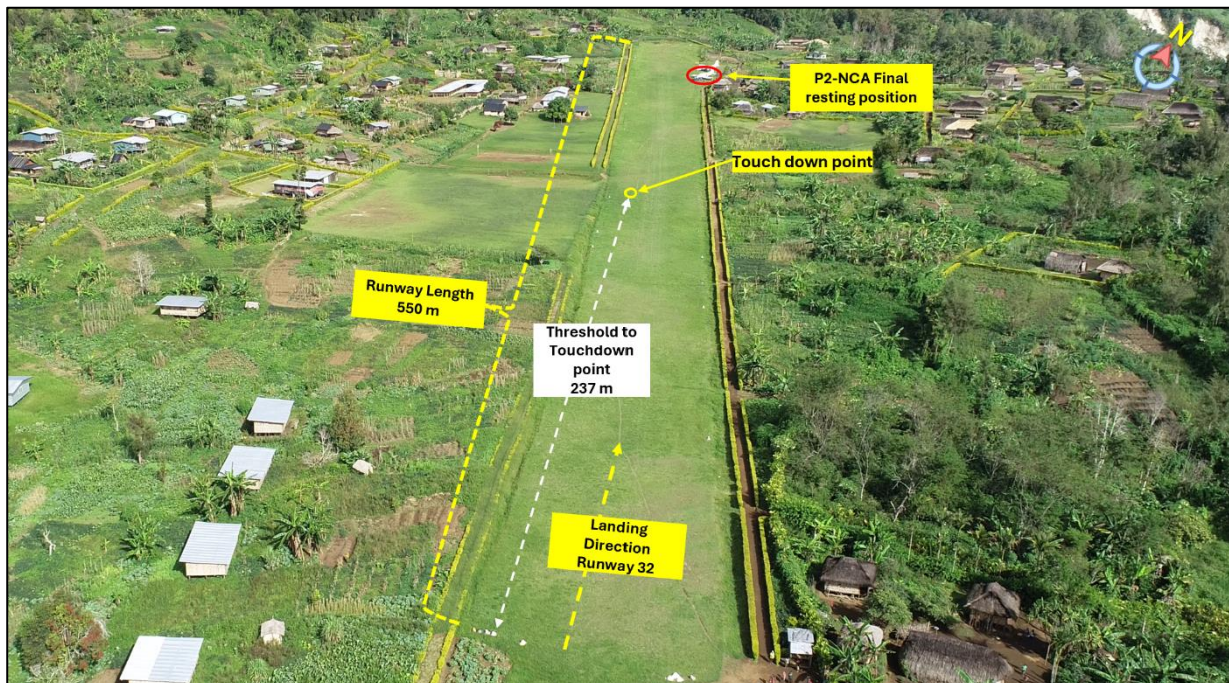
**Figure 9: Accident Site Overview**

During the on-site investigation, it was observed from tyre markings that the aircraft initially touched down about 237 m past the Runway 32 threshold and to the left of the centerline.

The right main wheel was the first to contact the runway upon touchdown.

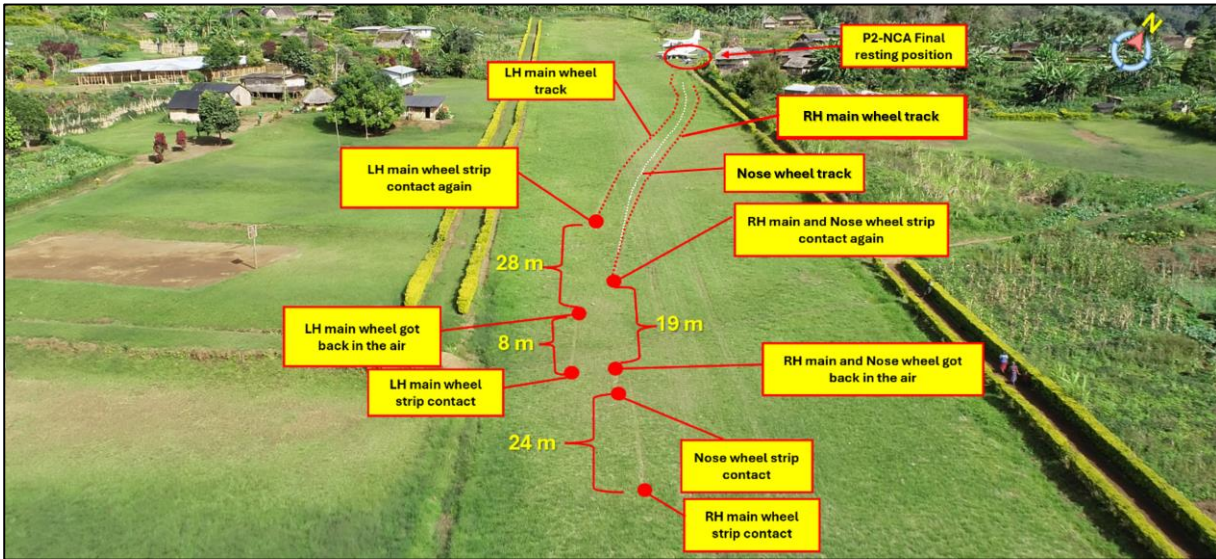
**Figure 10: Tyre markings and indications from touchdown**

The right main wheel subsequently contacted the runway again, followed by the nose wheel, which was airborne for about 19 meters. The nose wheel remained closer to the right wheel as they continued forward and began to veer to the right. The left main wheel stayed in the air for about 28 meters before getting back on to the runway and began to veer to the right.

As the aircraft neared the centreline, the right main wheel and nose wheel started to separate, resulting in a noticeable gap between them. The tyre markings prior to the aircraft's final position indicated that the nose wheel and left main wheel were moving closer together.

It is the view of the AIC that this was a result of pilot input to arrest the overcorrection initially made on touchdown. However, due to the airstrip surface condition, coupled with the aircraft's momentum, the aircraft tracked past centerline and drifted towards the right edge of Runway 32.

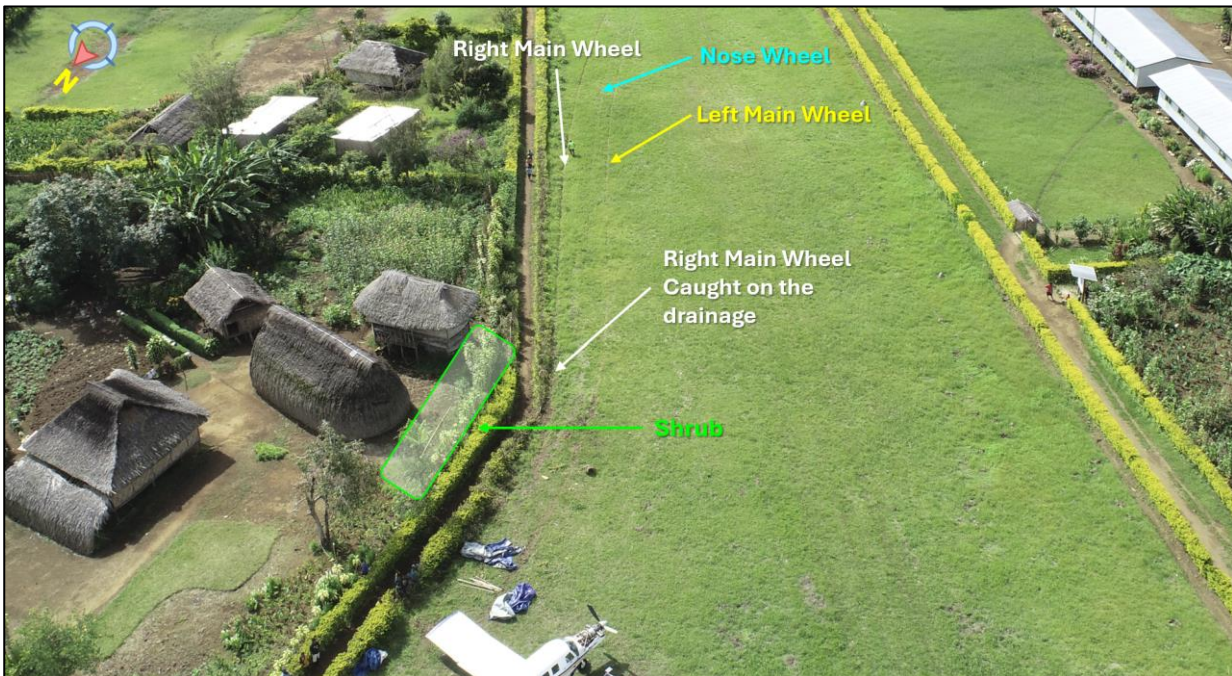
**Figure 11: Final Resting Position of P2-NCA**

The tyre markings showed that the aircraft continued to veer right past the centreline and towards the right edge of the runway and the right wing contacted the shrubs on the runway edge. The tyre markings also indicated that the right main wheel dropped into the drainage ditch, and this resulted in the aircraft's belly lowering closer to the ground, causing the propellers to strike the ground. The propellers continued to strike the ground as the aircraft tracked along the strip edge up to the parking bay, where the aircraft's right main wheel contacted the edge of the parking bay.

Upon the right wheel contacting the edge of the parking bay, the aircraft's nosewheel and right main wheel momentarily raised off the ground, resulting in the aircraft pivoting around on the left main wheel as it spun about 130 degrees to the left while continuing to drift into the parking bay, where it came to rest.

The onsite team also observed mud deposits on the aircraft's tyres and underbelly, indicating that the strip surface was wet and damp at the time of the accident.

Upon the right wheel contacting the edge of the parking bay, the aircraft's nosewheel and right main wheel momentarily raised off the ground, resulting in the aircraft pivoting around the left main wheel as it spun to the left while continuing to drift into the parking bay, where it came to rest. The left spin was noted to be a change of heading of about 130 degrees to the left, and this in the view of the AIC was a result of the IP continuing to apply left rudder pedal input as the aircraft tracked along the runway edge.

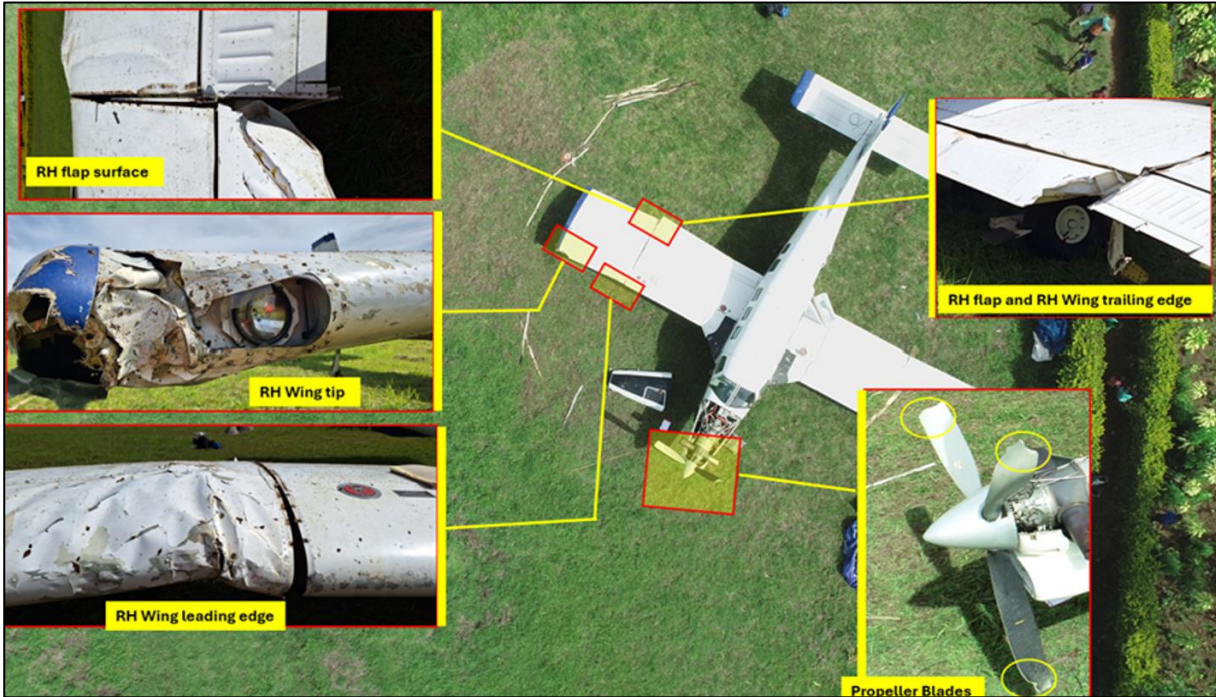
Figure 12: Overview of Damage Sustained by the Aircraft

During the onsite investigations, it was observed that the aircraft sustained substantial damage to its structure and certain components. The right-wing tip and the leading edge sustained substantial damage. The flap hinge was detached from the aircraft wing structure and the tips of all the propeller blades were also damaged.

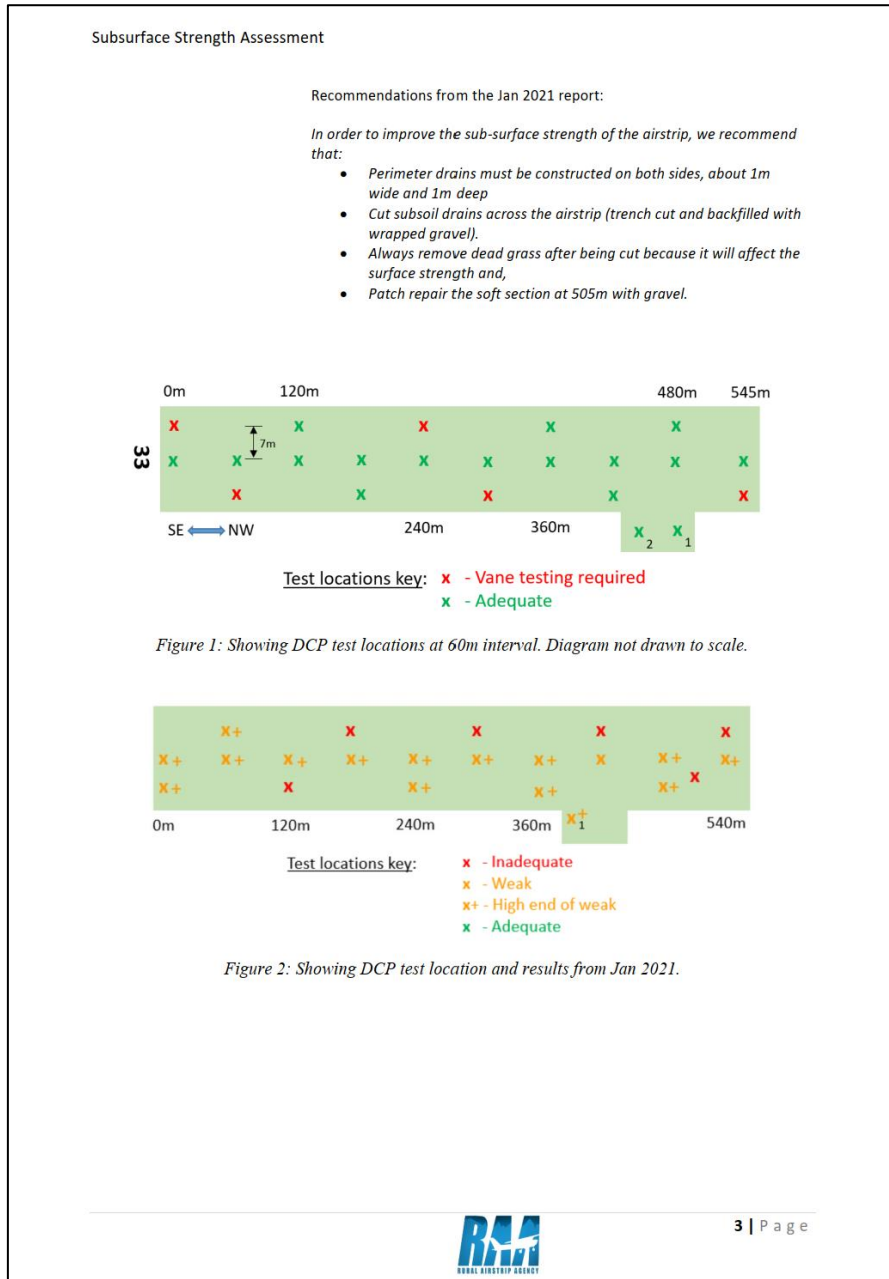
## 5.4 Appendix D: Rural Airstrip Agency Bungawat Airstrip Subsurface Strength Assessment

RAA also provided records for a Subsurface Strength Assessment conducted at Bungawat Airstrip on October 4, 2022 (Refer to Section 5.4, Appendix D). The assessment indicated that the subsurface strength on both sides of the runway was deemed inadequate at that time.
