PRELIMINARY REPORT

AIC 25-1002

23 MAY 2025

OPERATOR	: Liddle's Aerial Spraying Pty Ltd
REGISTRATION	: VH-SOY
MANUFACTURER	: Cessna Aircraft Company
MODEL	: T188C
OCCURRENCE DESCRIPTION /CLASS/CATEGORY	: Impacted Terrain During Low Altitude Operations (LALT)
LOCATION	: Sangkiang Village, Ramu, Madang Province
OCCURRENCE DATE	: 23 April 2025

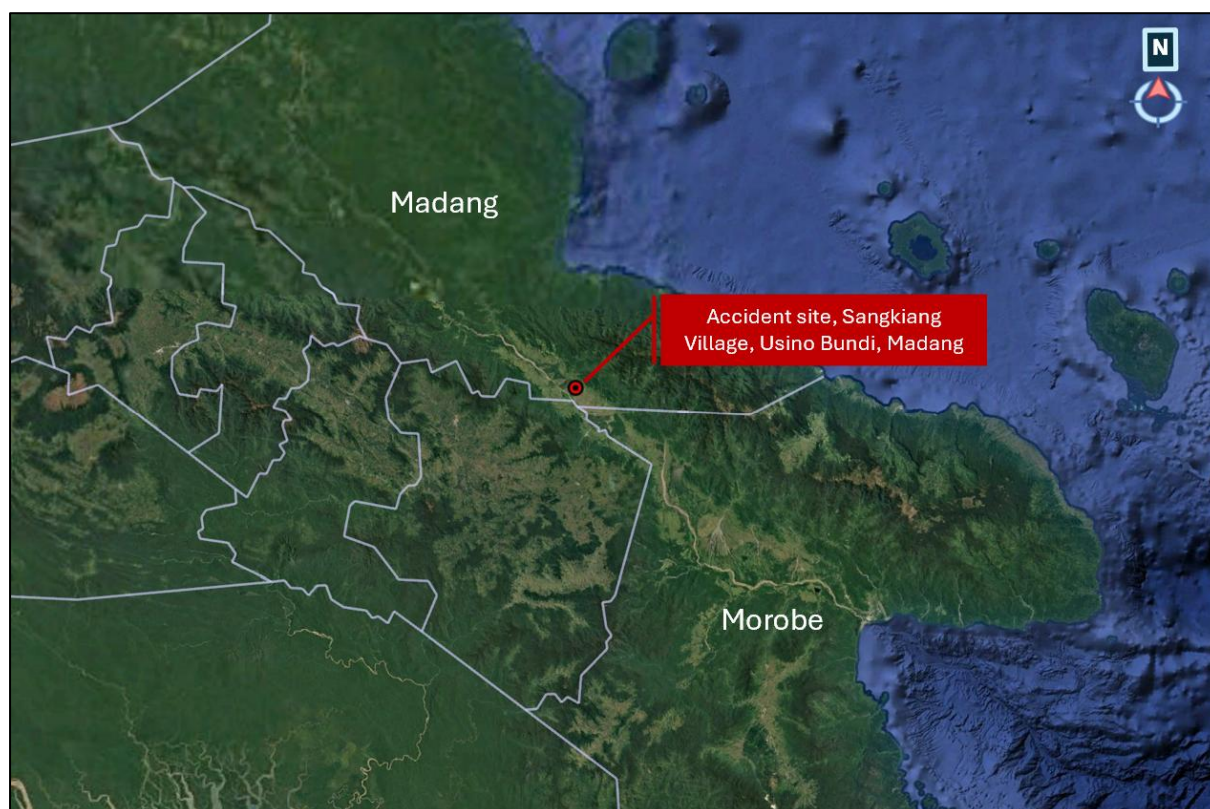
Figure 1: VH-SOY accident site, Sangkiang village.

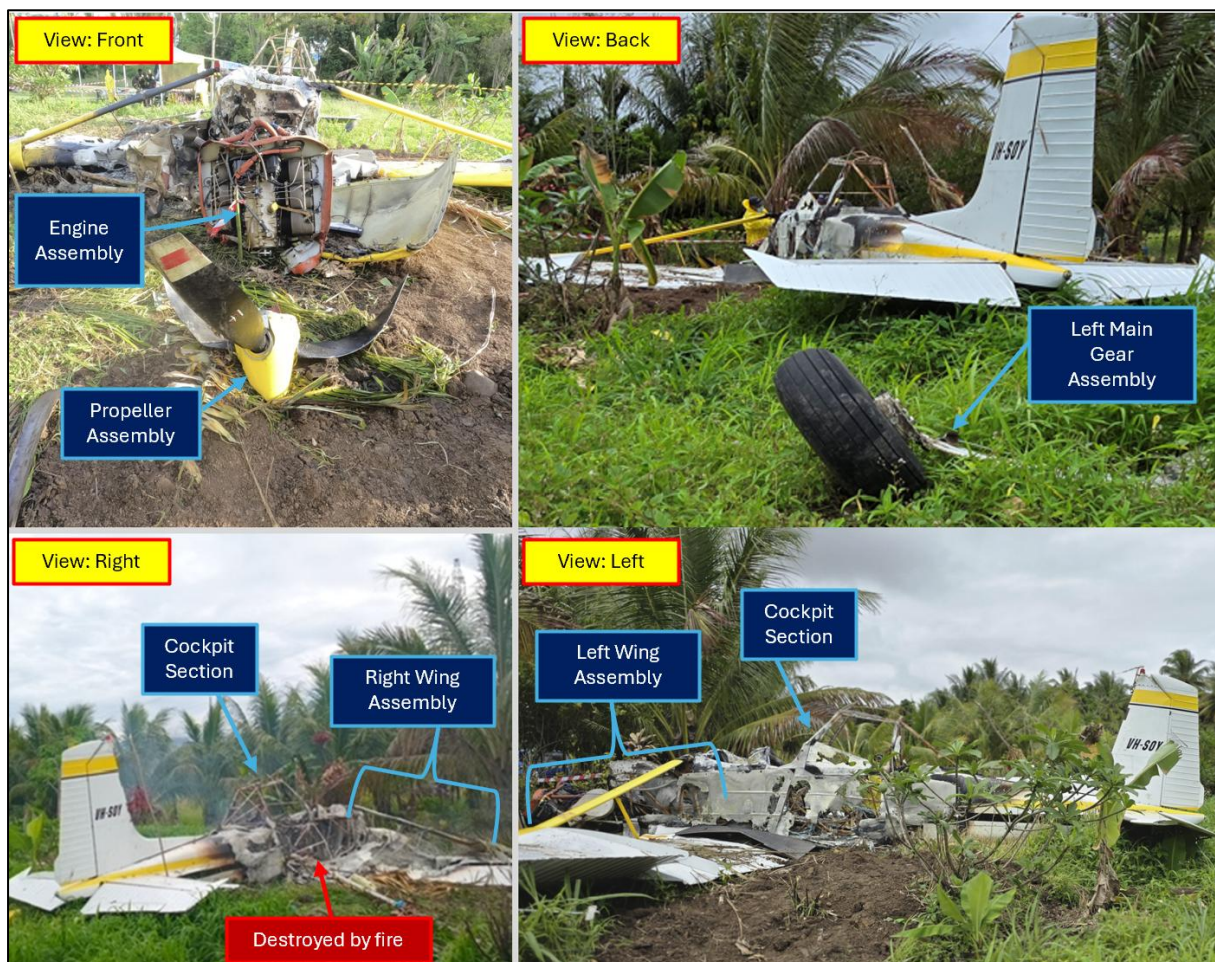
The aircraft sustained significant damage as a result of impact forces and a severe post-impact fire. A summary of the damages is as follows:

- Propeller: Detached from the engine
- Engine: Dislodged forward from its mounting
- Left Main Landing Gear Assembly detached from the undercarriage
- Right Wing:
 - Severe fire damage from the wing root to the fuel tank
 - Mainwheel assembly destroyed
- Fuselage/Cockpit: Extensive fire damage to the cabin area
- Left Wing: Wingtip snapped off upon impact

Figure 3: Aircraft Wreckage

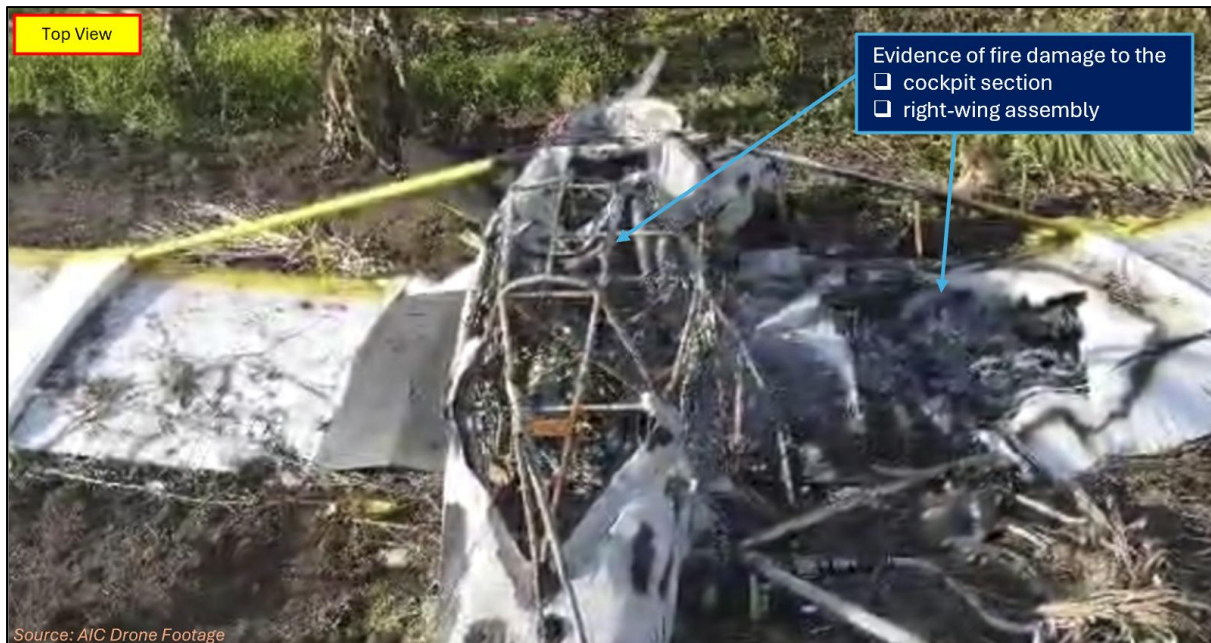
Figure 4: Evidence of fire
