**Final Report**

**AIC 24-1002**

**DHC-6-300 Twin Otter**

**Runway Excursion During Take-off**

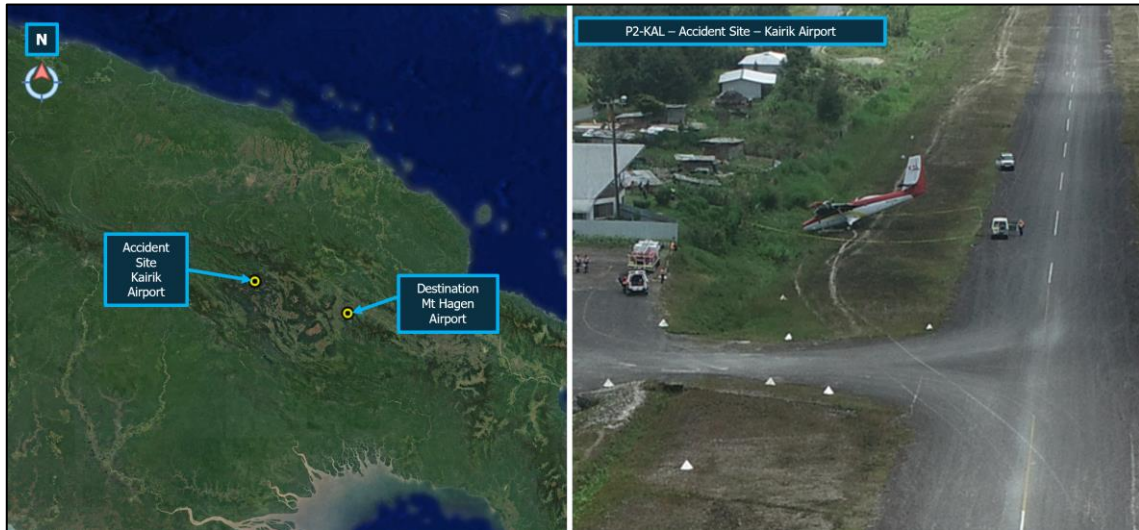
**Figure 1: Depiction of P2-KAL Accident site.**

On 19 October 2024, at about 15:00<sup>1</sup> local, (05:00 UTC<sup>2</sup>), a De Havilland Aircraft of Canada Ltd DHC-6-300 Twin Otter aircraft registered P2-KAL, owned by ASHE Aircraft Enterprises Limited, and operated by Kobio Aviation Limited, was conducting a VFR<sup>3</sup> charter flight from Kairik Airport, Enga Province to Mt. Hagen Airport, Western Highlands Province, Papua New Guinea, when during the take-off roll, it experienced a runway excursion and rolled into a drainage ditch which runs along the left side of the runway and impacted an embankment.

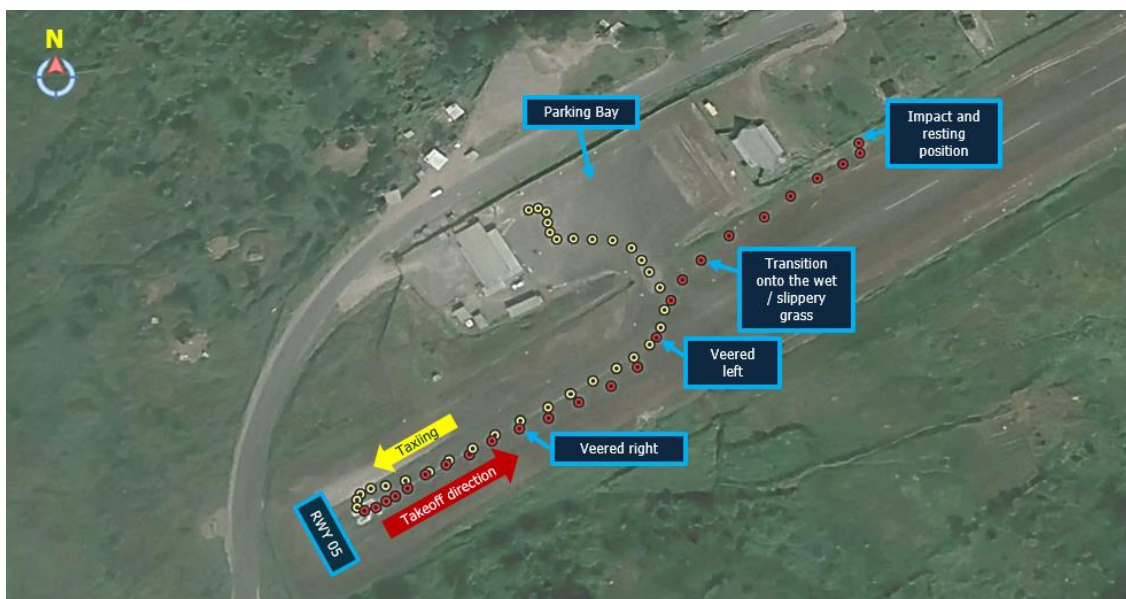
**Figure 2: Illustration of the sequence from taxiing, take-off and to the point of impact.**

The crew further added that, upon realising that the corrective actions were ineffective, they subsequently applied full reverse power and engaged the brakes in an attempt to bring the aircraft to a stop. Despite these efforts, the aircraft continued to swerve towards the left until it impacted the drainage ditch adjacent to the runway, along the edge of the airstrip.

The crew stated that the left wing struck the edge of the drainage ditch, resulting in the aircraft making a sharp left turn, after which the nose impacted the drainage ditch.

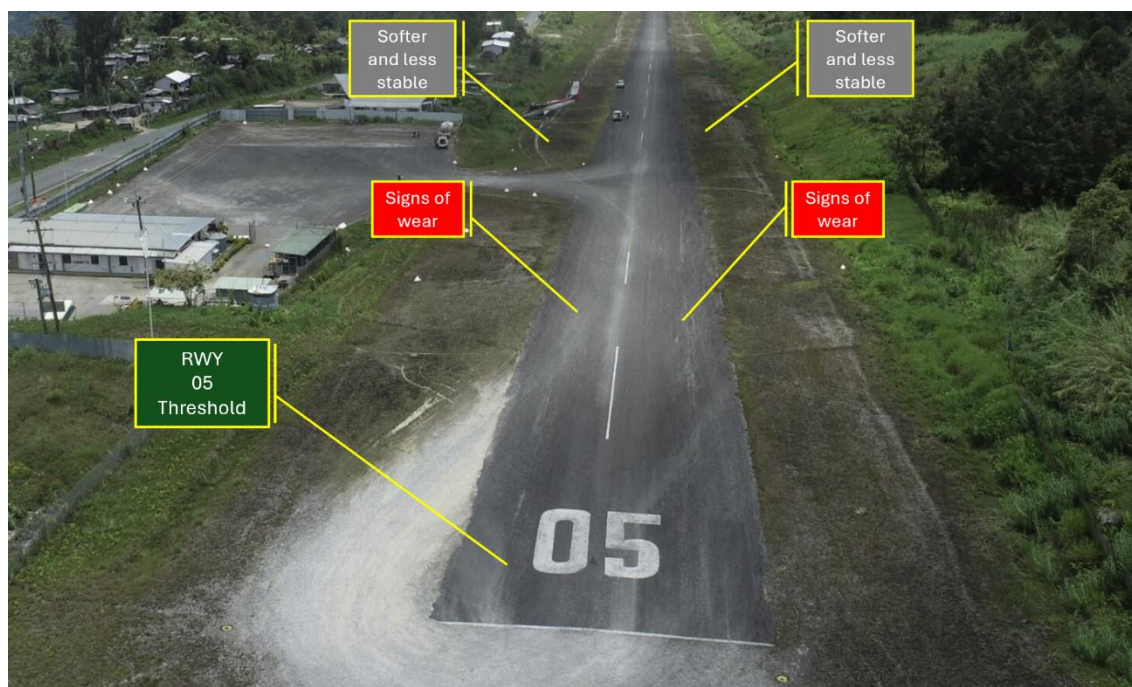
**Figure 4: Kairik Airport with indications of the observation by the investigation**

The investigation identified visible wear on Kairik Airport's runway surface, particularly to the left and right of the centerline. Soft patches adjacent to the runway edges were observed due to recent rainfall.

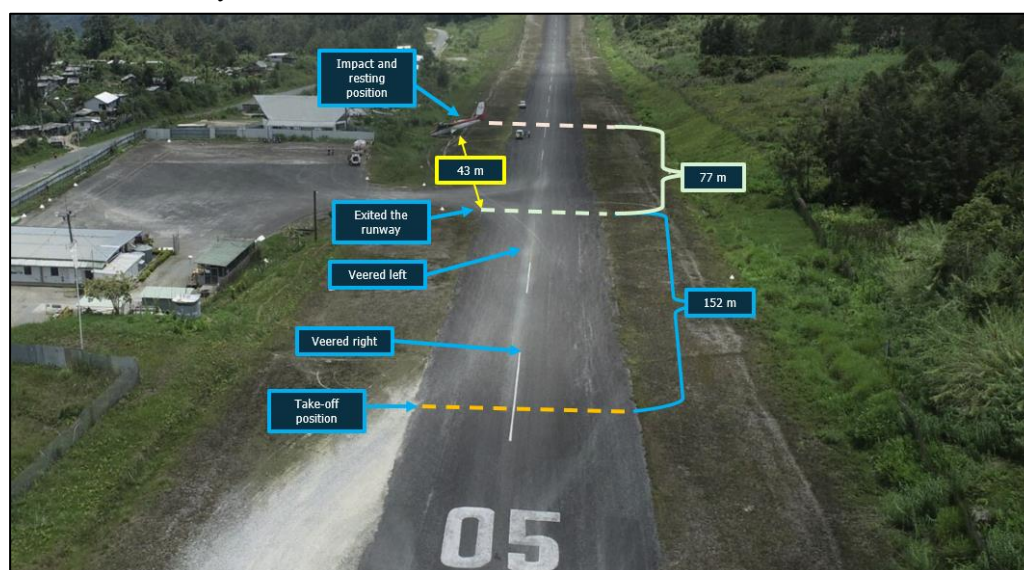
**Figure 5: Accident Site Overview: From Take-off Roll to Impact**

According to post-accident images provided to the AIC by the operator, it was observed that the aircraft initially travelled approximately 152 metres from the take-off position before exiting the runway onto the adjacent wet, soft, and slippery grass surface. The aircraft then continued for another 43 metres along the soft area before coming to a complete stop.

In total, the aircraft travelled 195 metres from the start of the take-off roll to its final resting position. Additionally, when measured along the runway axis, the distance from the take-off position to the point where the aircraft came to rest was approximately 229 metres.

Observations of the tyre markings on the runway surface indicated that the aircraft initially veered to the right of the centerline during the take-off roll. It then crossed the centerline and began veering to the left, continuing further left until it exited the runway and entered the soft grass area adjacent to the runway.

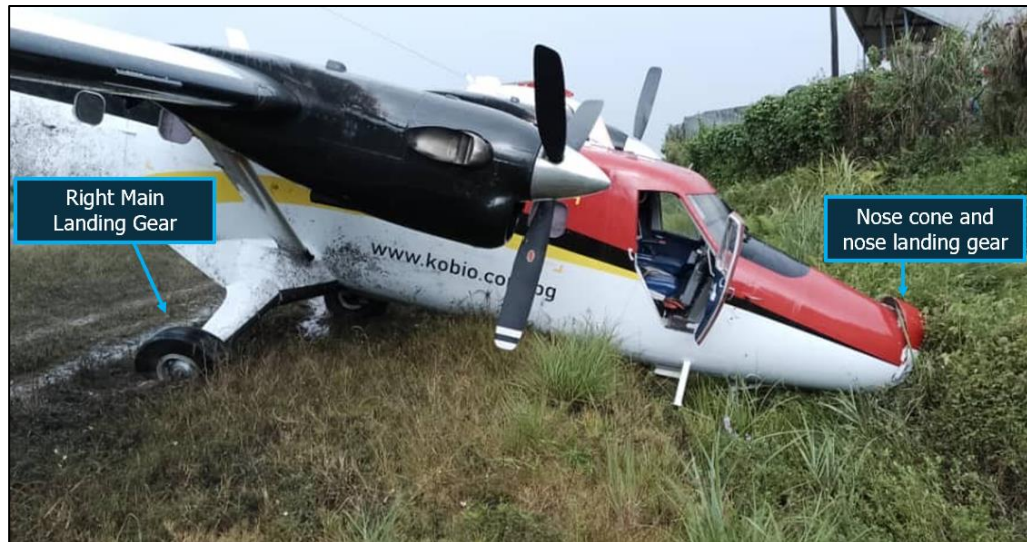
Figure 6: Damage to the nose area

The nose cone sustained damage, and the right main wheel was punctured during the accident. Additional damage was observed on the left-wing tip, left-wing outboard flap, and its aileron. These observations align with the trajectory and impact details captured in the drone image taken at the site post-accident, confirming the sequence of events and the extent of the damage.

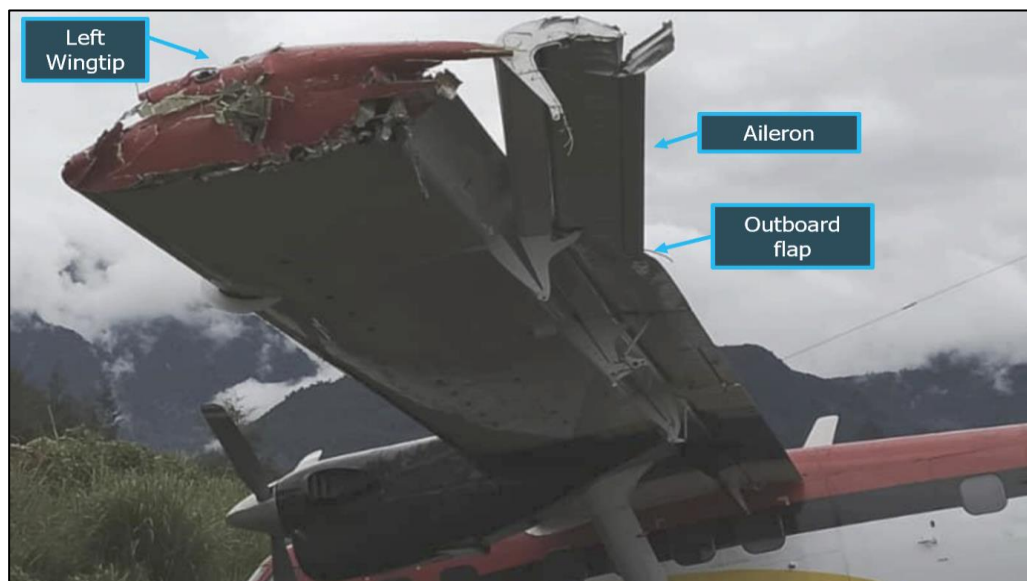
Figure 7: Damage to the Left wingtip, outboard flap, and outboard aileron

A post-maintenance inspection conducted by the operator's maintenance team revealed significant damage to the aircraft resulting from the runway excursion. The left-hand wing tip assembly was crushed, with parts of the composite structure torn off, and the navigation lights assembly detached. The left-hand outermost wing rib exhibited bending, with surrounding skins showing ripples and cracks. The left-hand flap-aileron assembly was fractured and bent, requiring replacement, while the nose assembly sustained major structural damage, including crushing and punctures forward of STA 20.0. Additionally, the nose baggage compartment access door was torn, and the left-hand main wheel assembly hub showed scuffing and gouging.

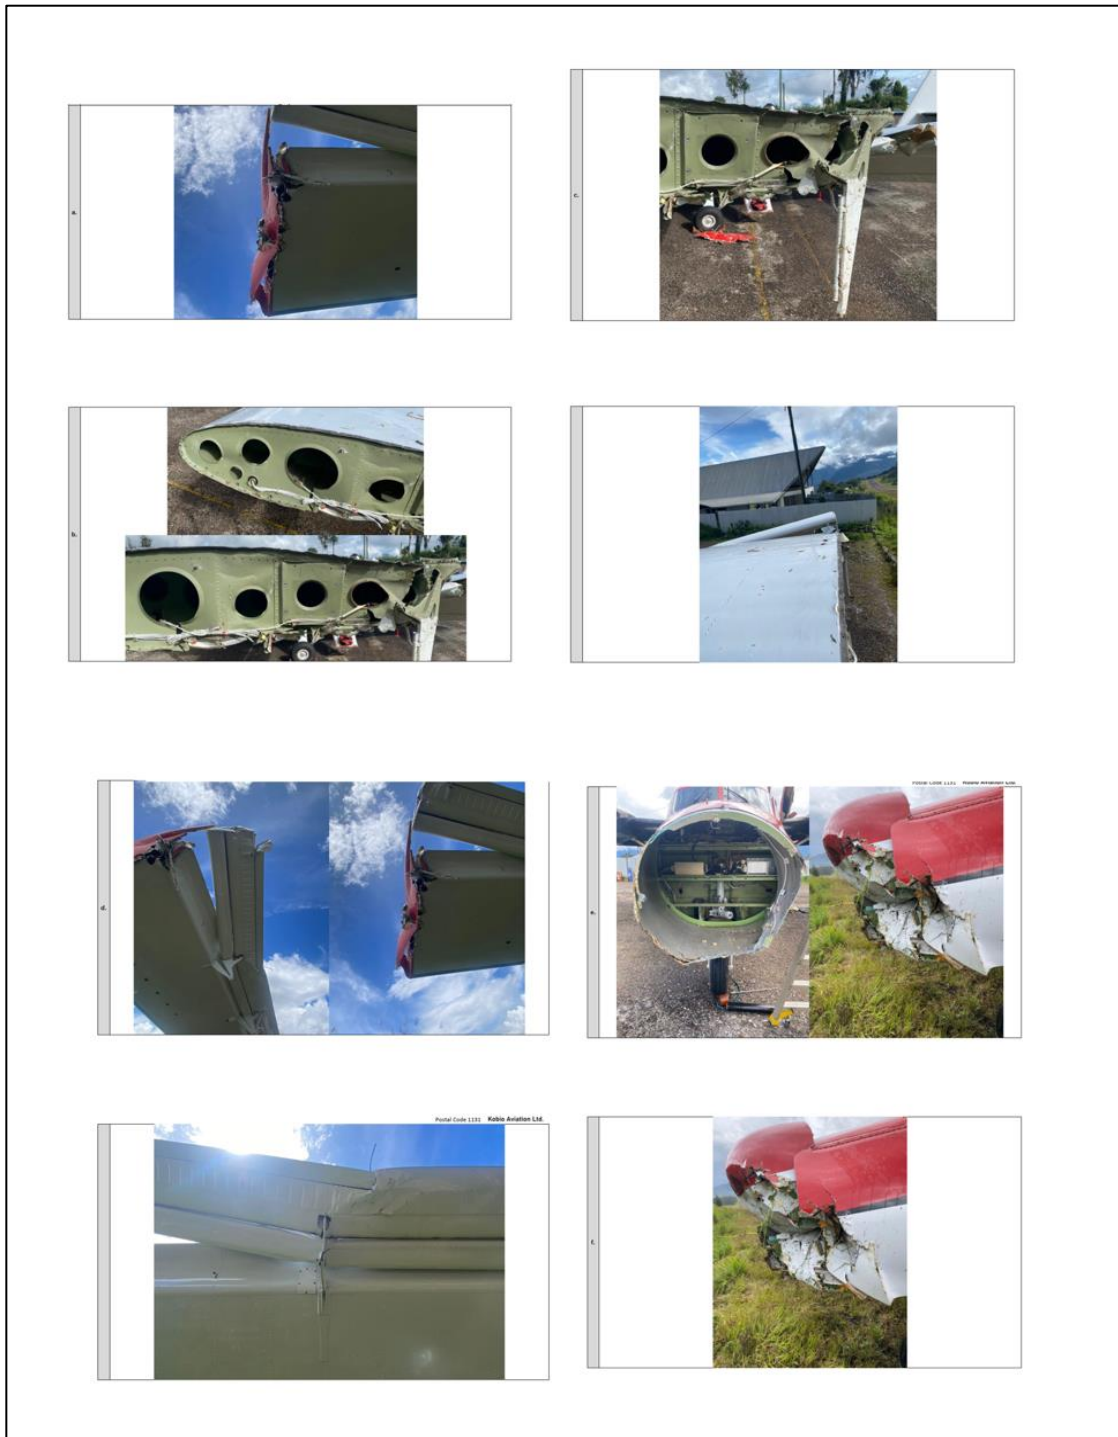
### 5.1 Appendix A: Extracts of Kobio Aviation Ltd Post-accident aircraft defect report.

Section 5.1 Appendix A of this report contains the operator's post-accident aircraft defect report.
