Final Report

AIC 24-1002

DHC-6-300 Twin Otter

Runway Excursion During Take-off

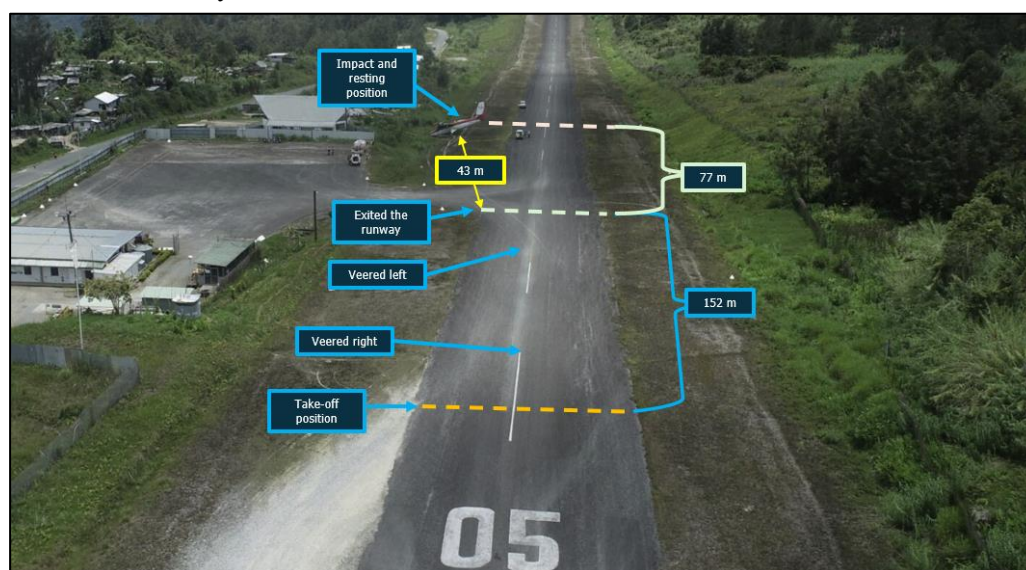
Figure 5: Accident Site Overview: From Take-off Roll to Impact

According to post-accident images provided to the AIC by the operator, it was observed that the aircraft initially travelled approximately 152 metres from the take-off position before exiting the runway onto the adjacent wet, soft, and slippery grass surface. The aircraft then continued for another 43 metres along the soft area before coming to a complete stop.

In total, the aircraft travelled 195 metres from the start of the take-off roll to its final resting position. Additionally, when measured along the runway axis, the distance from the take-off position to the point where the aircraft came to rest was approximately 229 metres.

Observations of the tyre markings on the runway surface indicated that the aircraft initially veered to the right of the centerline during the take-off roll. It then crossed the centerline and began veering to the left, continuing further left until it exited the runway and entered the soft grass area adjacent to the runway.

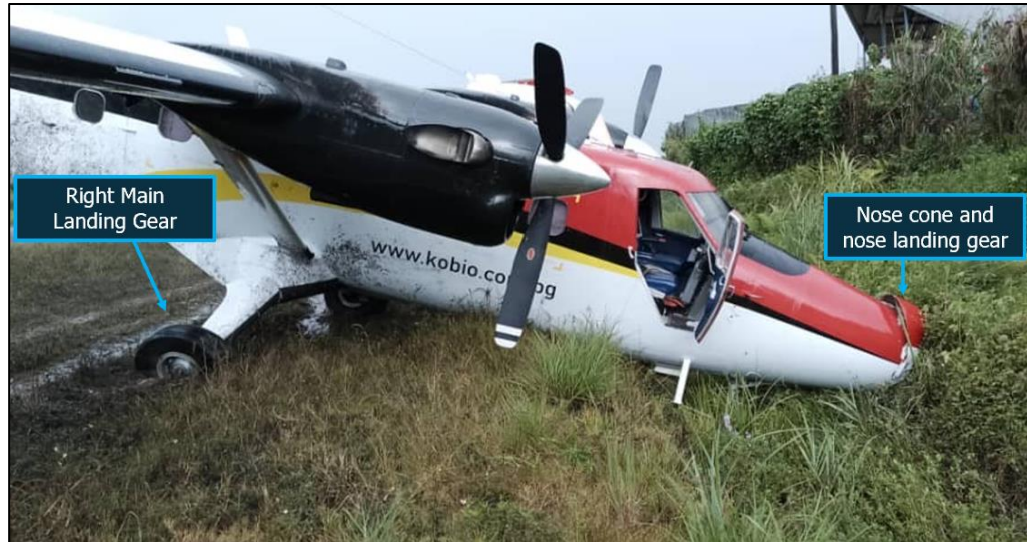
Figure 6: Damage to the nose area

The nose cone sustained damage, and the right main wheel was punctured during the accident. Additional damage was observed on the left-wing tip, left-wing outboard flap, and its aileron. These observations align with the trajectory and impact details captured in the drone image taken at the site post-accident, confirming the sequence of events and the extent of the damage.
