## FINAL REPORT

AIC 24-1003

OPERATOR	: North Coast Aviation Limited
REGISTRATION	: P2-SAM
MANUFACTURER	: Pilatus Britten-Norman
MODEL	: BN2B-26 Islander
CLASS/CATEGORY	: Controlled flight into terrain
LOCATION	: 32 nm Northeast of Nadzab Airport, Morobe Province
OCCURRENCE DATE	: 22 December 2024

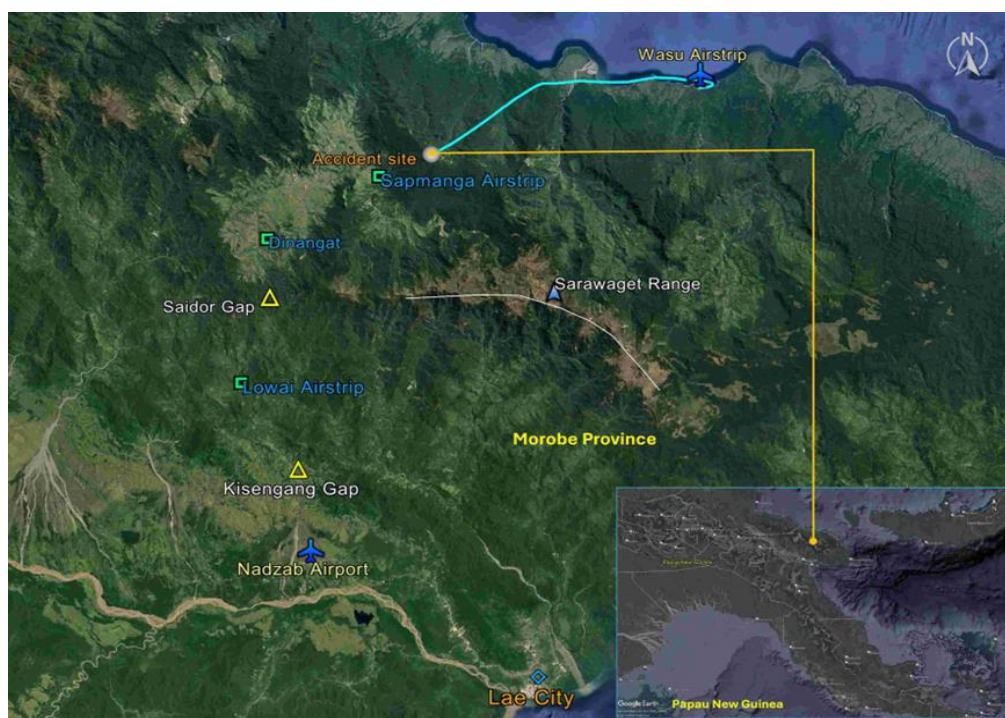
**Figure 1: P2-SAM Accident recorded flight track from departure to accident**

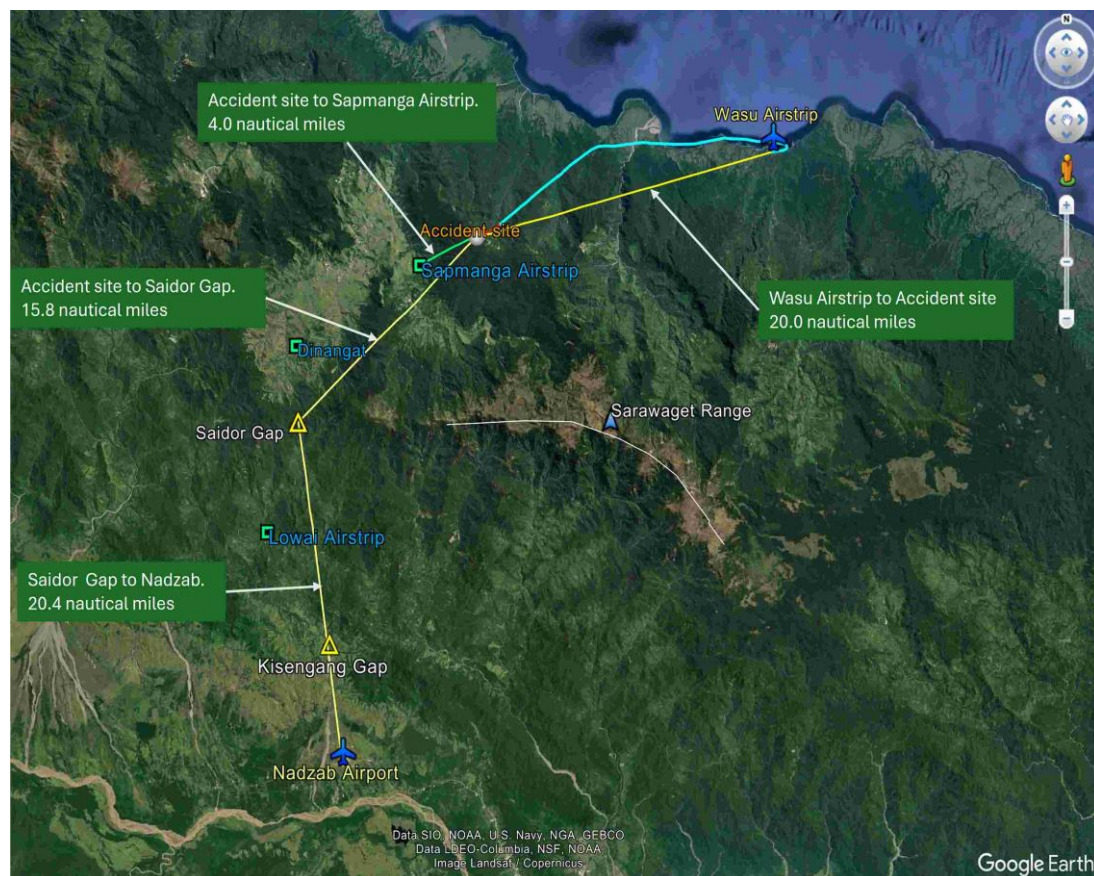
According to the *V2-Track Software* used by NCA, after departure from Wasu SAM tracked west along the coast. Ten minutes after departure the aircraft commenced tracking southwest while climbing through 5,500 ft. The south-westerly track was maintained until the last recorded position at 10:26:59 when it turned 5 deg right. The aircraft was 5.7 nm northeast of Sapmanga, climbing through 8,002 ft at 433 ft per min and with a groundspeed of 85 kts. The GPS coordinates for the wreckage location was 1.68 nm southwest of the V2 Track last interrogation point.

Figure 2: P2-SAM track with distances between Wasu and Nadzab depicted

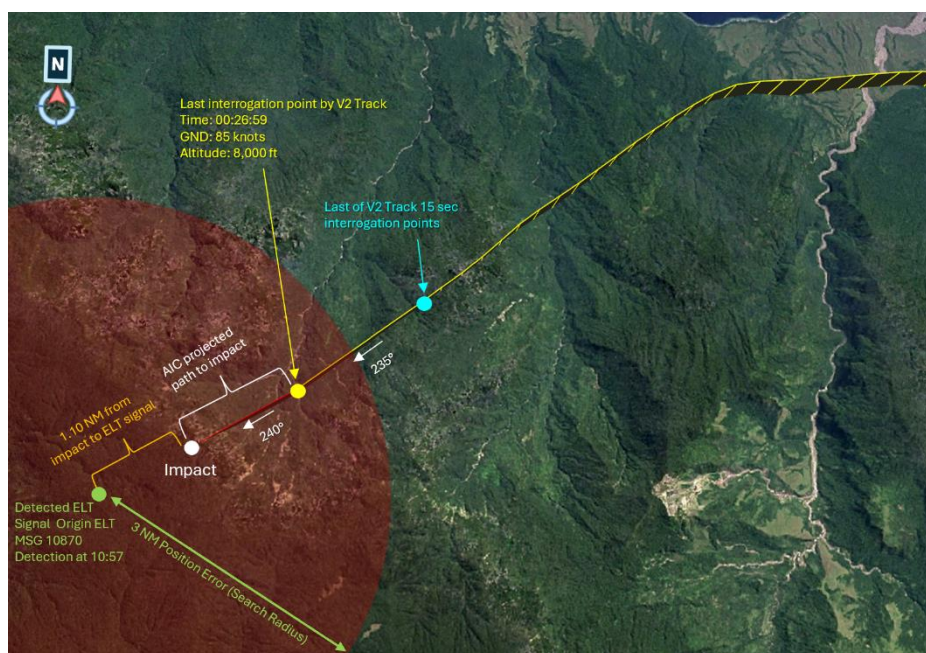
At 11:30, the distress message, including the estimated coordinates of the ELT signal, was sent by ATC Port Moresby to Nadzab ATC. That message stated that the ELT signal was located 20 nm north of Nadzab. The Search and Rescue Coordinator contacted Manolos Aviation to commence a search. There was a delay in resolving the confusion of where the ELT was located. It was subsequently determined to be 32 nm north of Nadzab in the Sapmanga area, and therefore north of the Sarawaget Range.

Figure 3: SAM final track and ELT error. Plot by PNG AIC

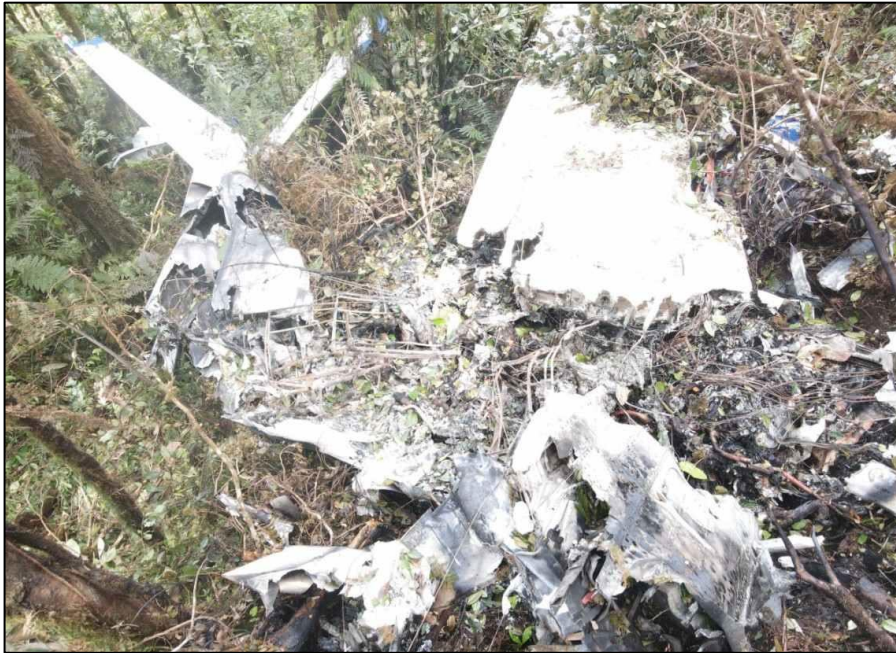
The aircraft was destroyed by impact forces and an intense post-impact fire.

Figure 4: Aircraft destroyed by impact forces and fire. View looking back along final track

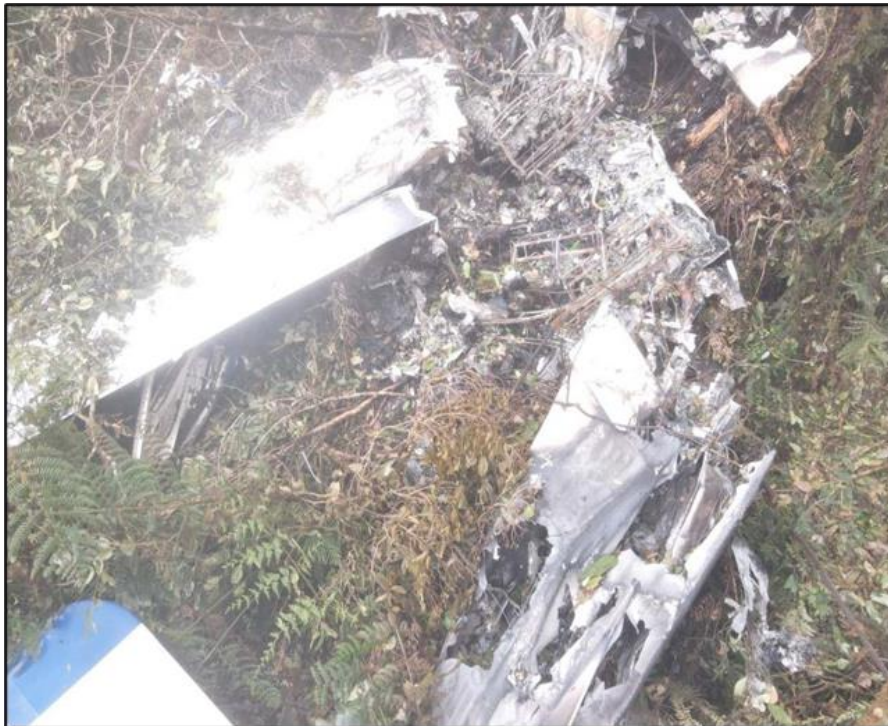
Figure 5: Wreckage viewed towards point of impact

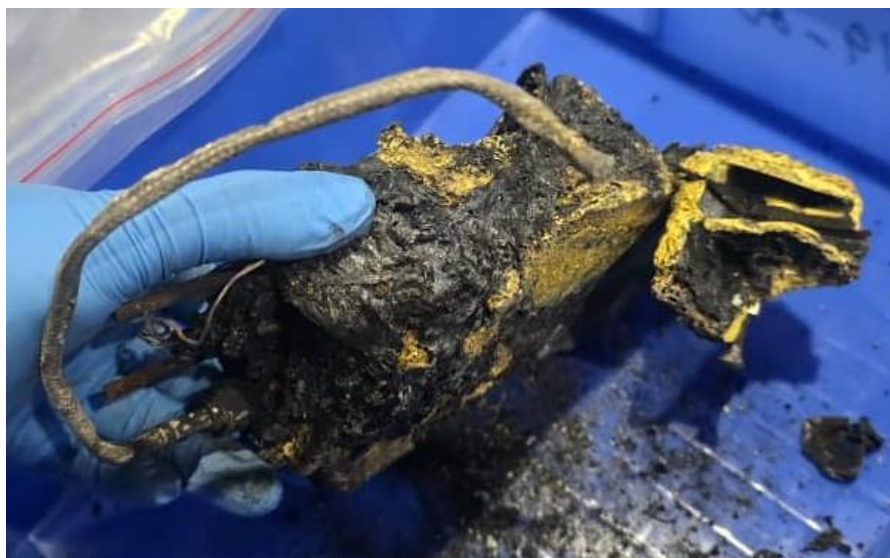
The ELT was fitted in the aircraft in accordance with in accordance with PNG *Civil Aviation Rule (CAR) 91.529*. The ELT activated following the impact and transmitted on 406 MHz until it was consumed by the post-impact fire.

Figure 7: ELT destroyed by post-impact fire

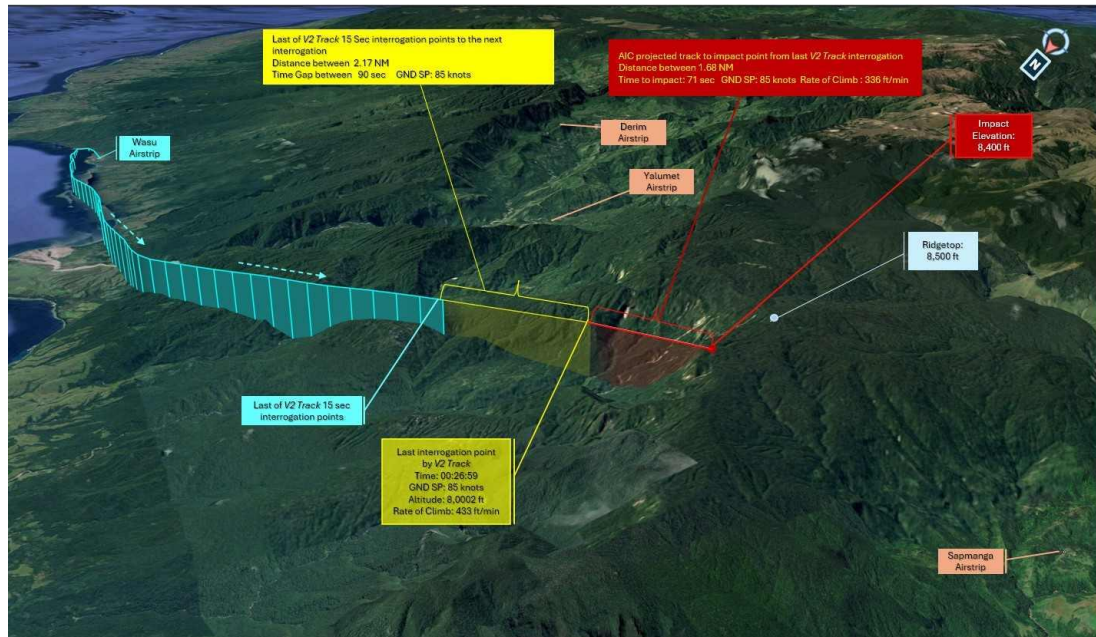
Figure 8: Aircraft track sourced from V2 Track data overlaid on terrain mapping<sup>16</sup>

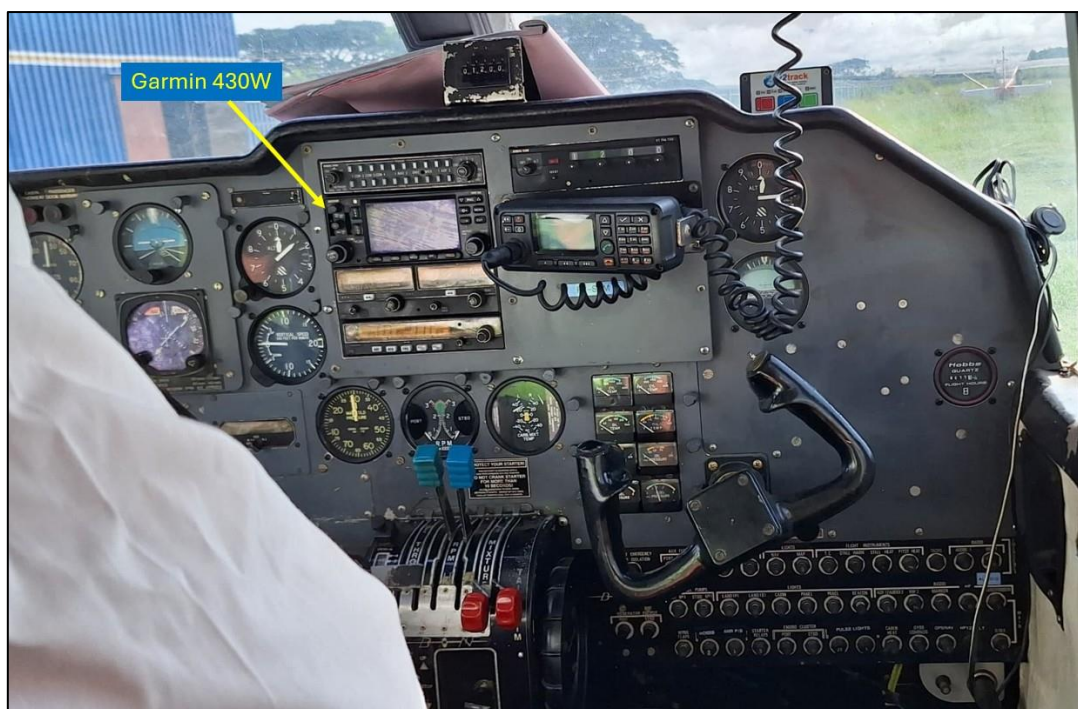
Figure 9: Instrument panel. Garmin 430W in centre console to right of flight instruments

The Garmin GNS 430W<sup>18</sup> TAWS system installed in SAM did not provide aural warnings of terrain proximity, it only provided colour warnings. Effective use of colour enhances a pilot's ability to see the aircraft's position relative to ground features. It graphically warns the pilot when proximity conflicts loom ahead, importantly terrain warnings. Aural warnings (auditory alerts) can be more effective for immediate reactions.

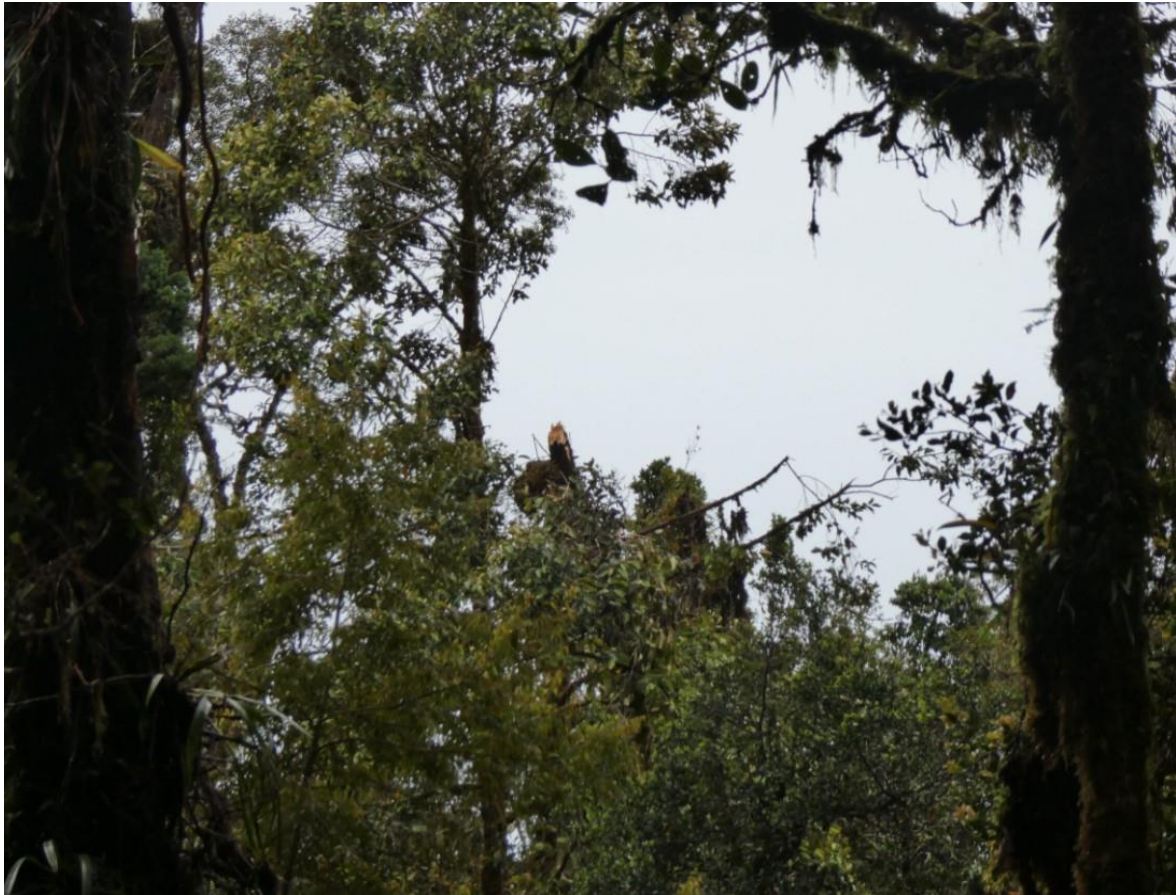
The right-wing fuel tank was ruptured during the impact with the tree and there was physical evidence of fuel loss due to the rupturing of the tank.

The impact damage indicated that the aircraft was flying at speeds that would normally be associated with engine-powered speeds. The aircraft had flown directly into the cliff face of the heavily vegetated steep mountain slope.

**Figure 12: View back along aircraft's track showing first tree impact trunk severed**

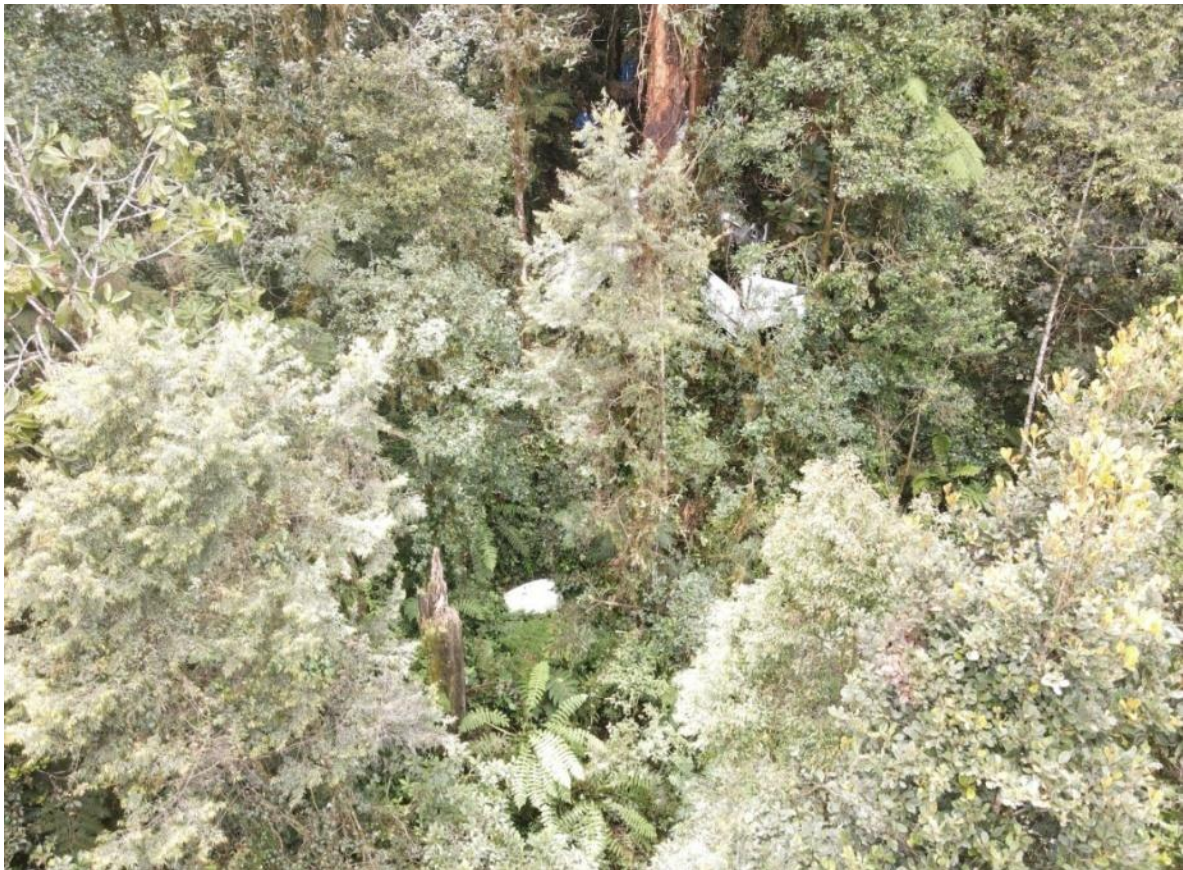
**Figure 13: Accident site showing large tree that arrested the aircraft's forward trajectory**

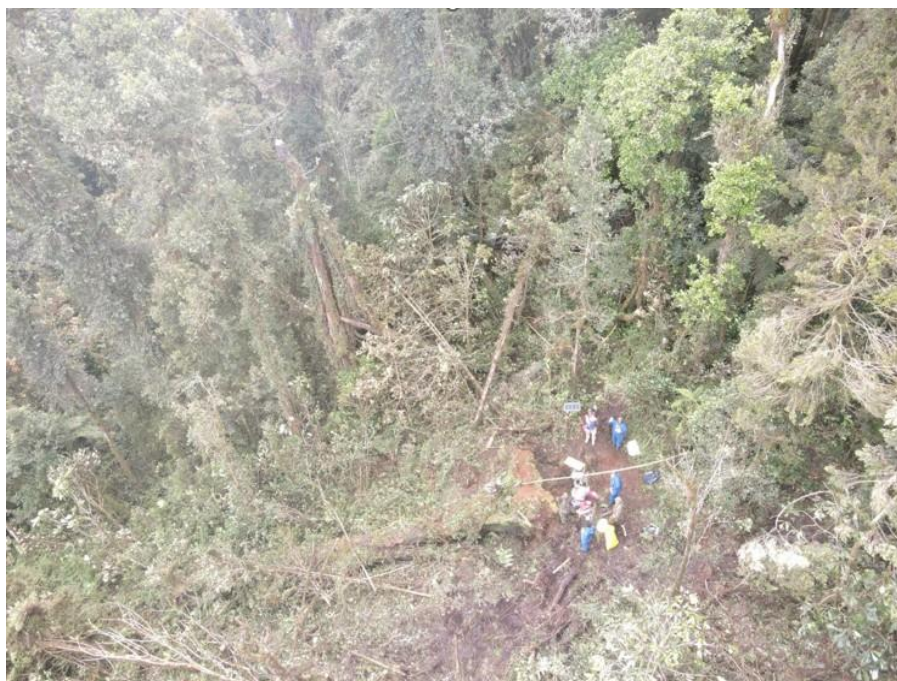
Figure 14: Drone view at staging point adjacent to accident site

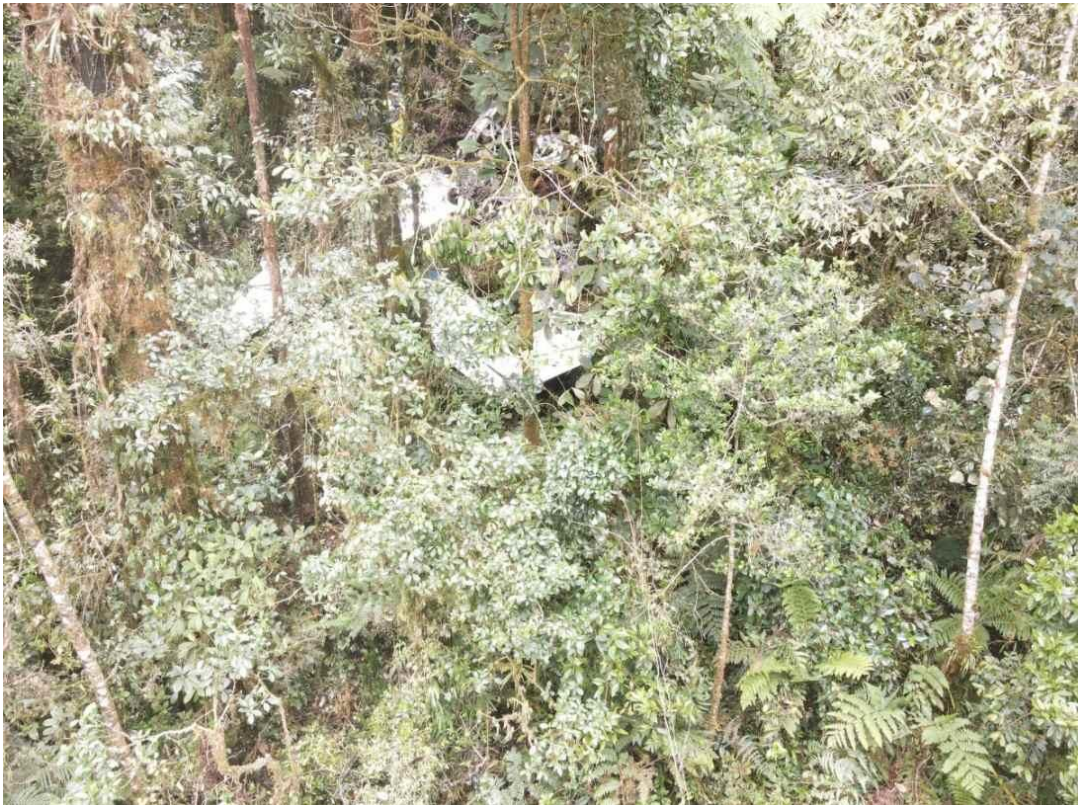
The terrain was steep averaging a slope of 55 deg, and the forest vegetation was dense.

Figure 15: Wreckage on the steep cliff covered with dense vegetation

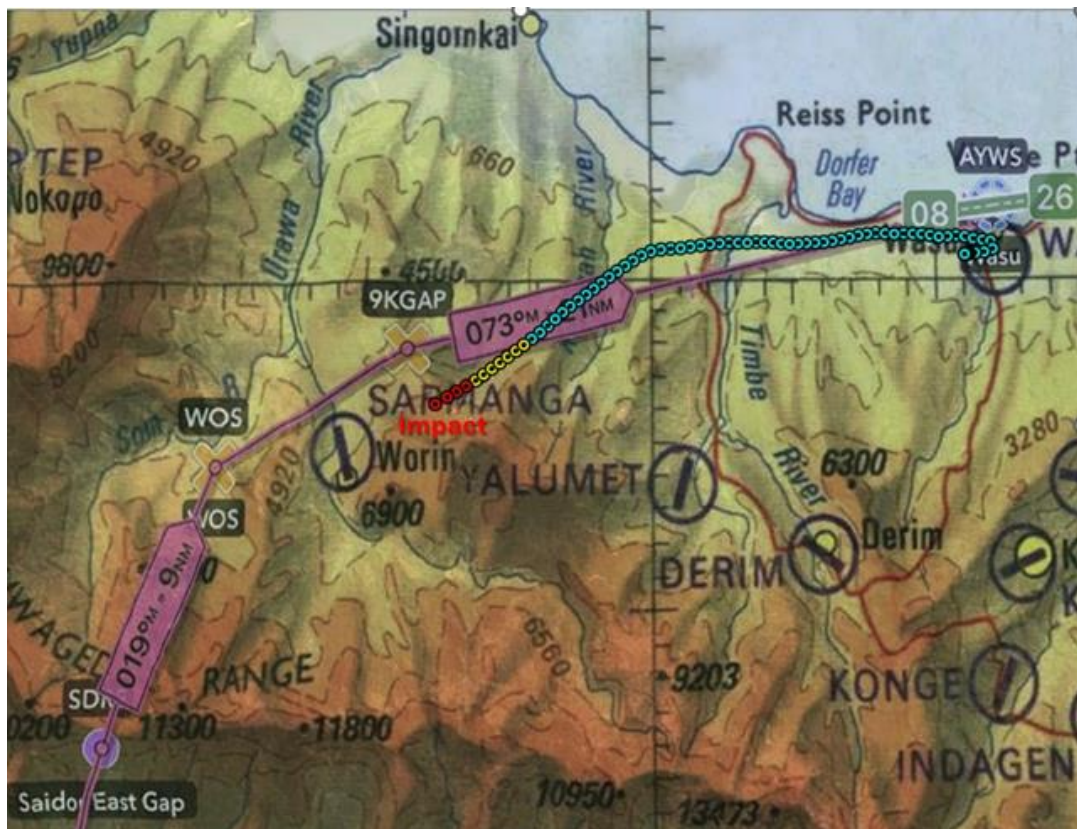
The investigation found that the initial track details on the route charts supplied to the investigators taken from the operators *Oz Runways* app differed in some instances from the documented routes in the NCA hard copy *Route Guide*. (See *Appendix 5.6* for *NCA Route Guide*).

Figure 17: NCA Route Guide Chart for Area 3 Sapganga 1 and 2 with SAM track depicted

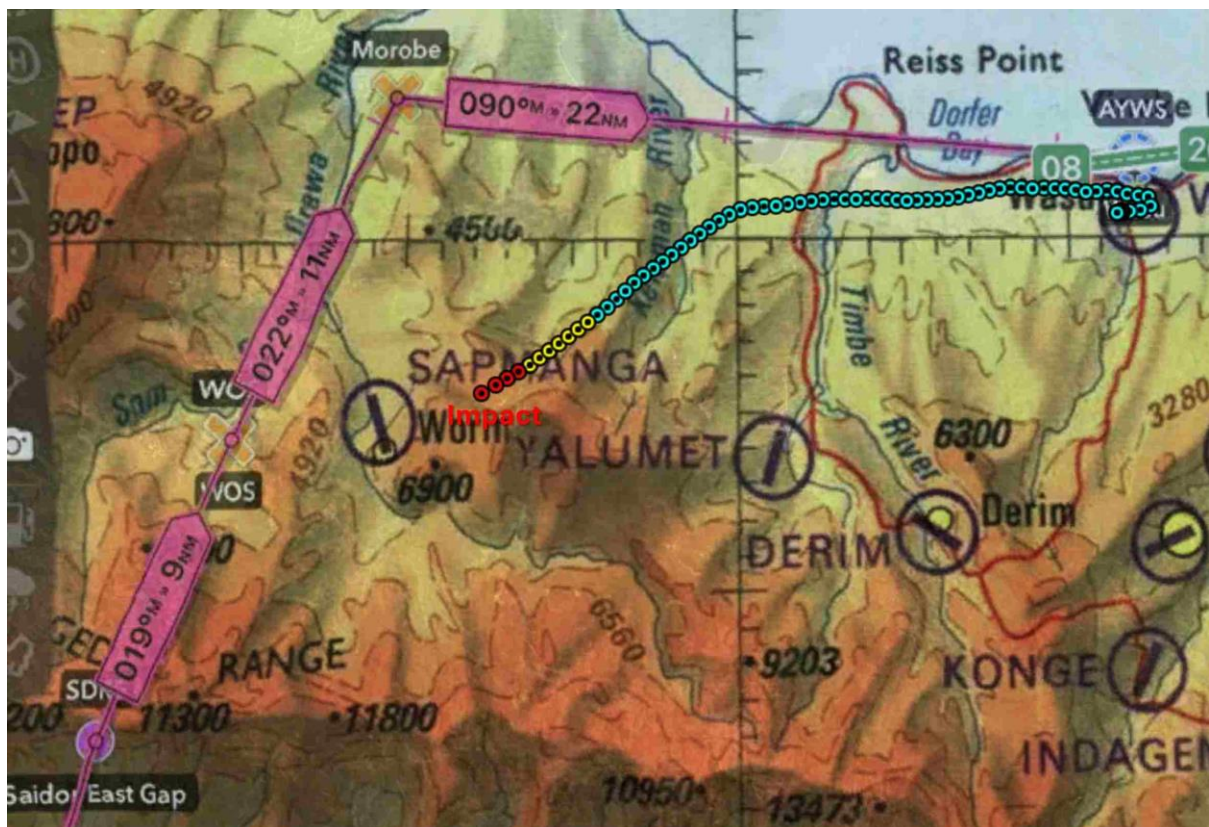
Figure 19:NCA Route Guide Chart for Area 3 Sapmanga 3 and 4 with SAM track depicted

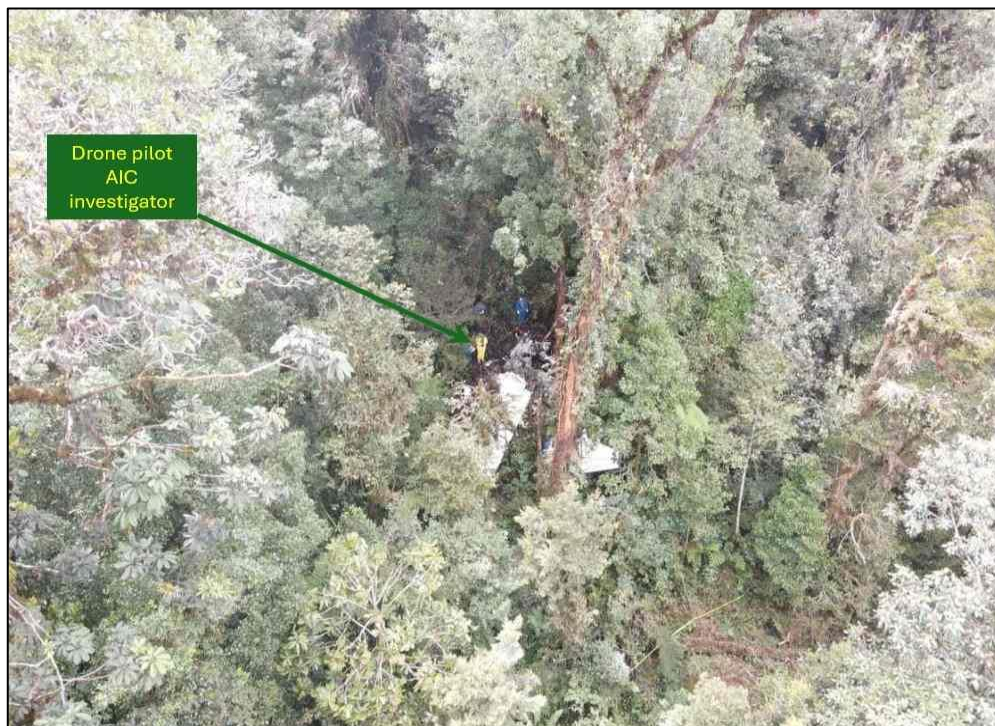
The accident site was on a steep cliff face about 30 metres below the top of a ridge. It was densely vegetated and wet. The recovery team and the AIC investigator were winched into the site from a hovering helicopter. Movement around the site during the on-site phase was difficult and dangerous. The investigator who travelled to the accident site made effective use of drone technology to capture evidence in video and photographic form.

Figure 20: Wreckage viewed from above vegetation canopy  
(AIC drone pilot investigator in yellow PPE)

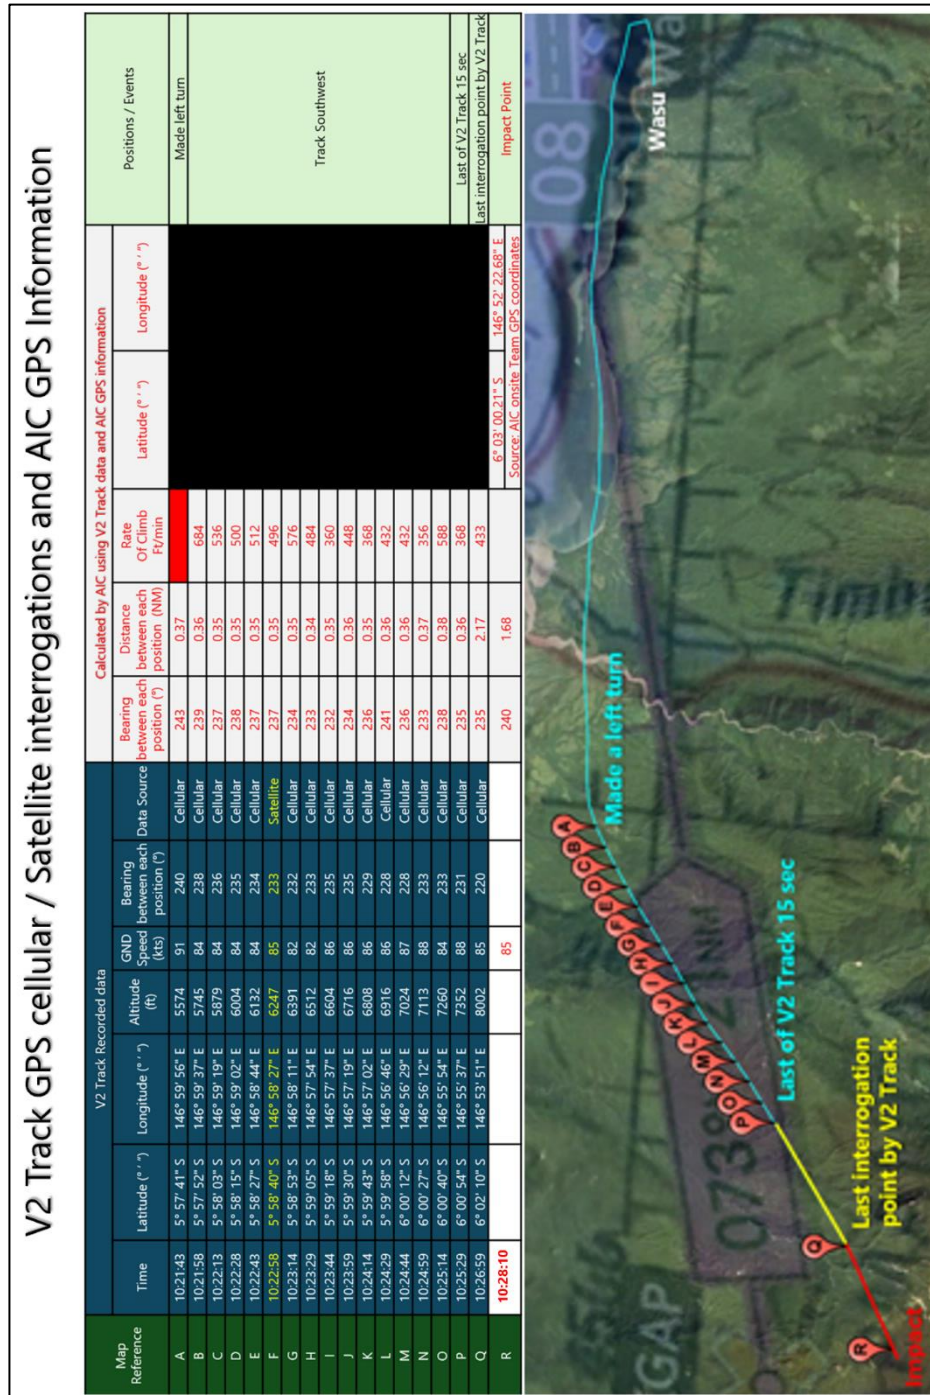
Figure 21: Track data table and P2-SAM track overlaid on terrain graphic

<sup>30</sup> The data calibrated by the AIC was from V2 Track recorded data to calculate time, bearing and distance and used the GPS coordinates of the impact point taken by the AIC on-site investigator to establish the track of the last 1.68 nm.

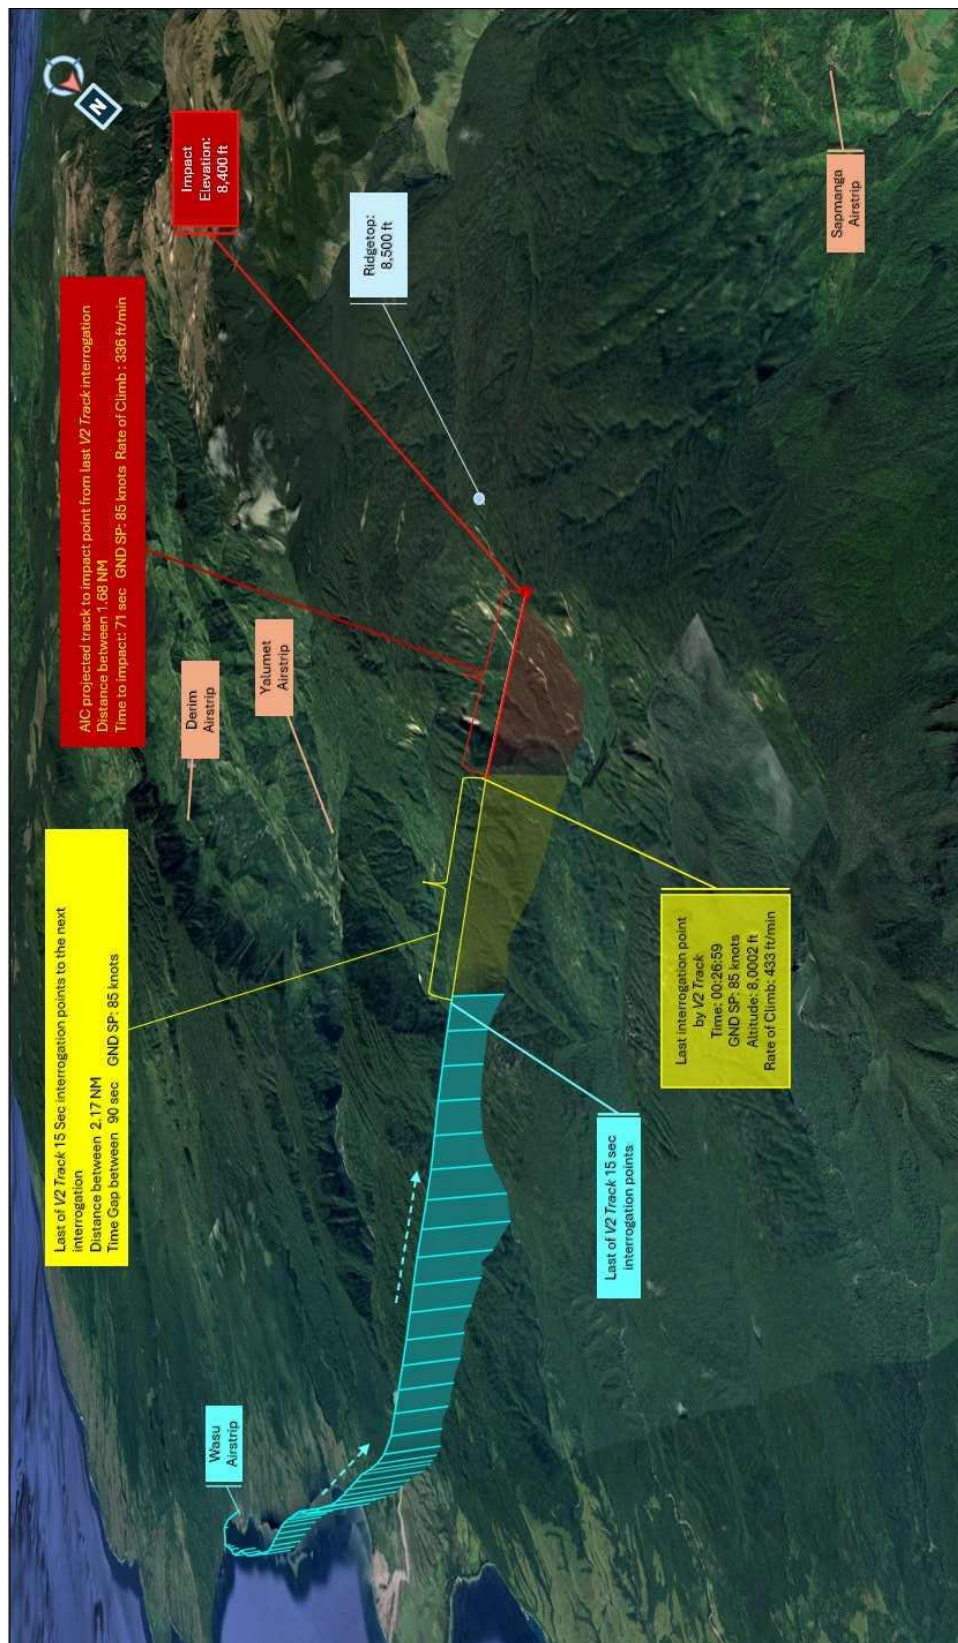
Figure 22: Aircraft track sourced from V2 Track data overlaid on terrain mapping

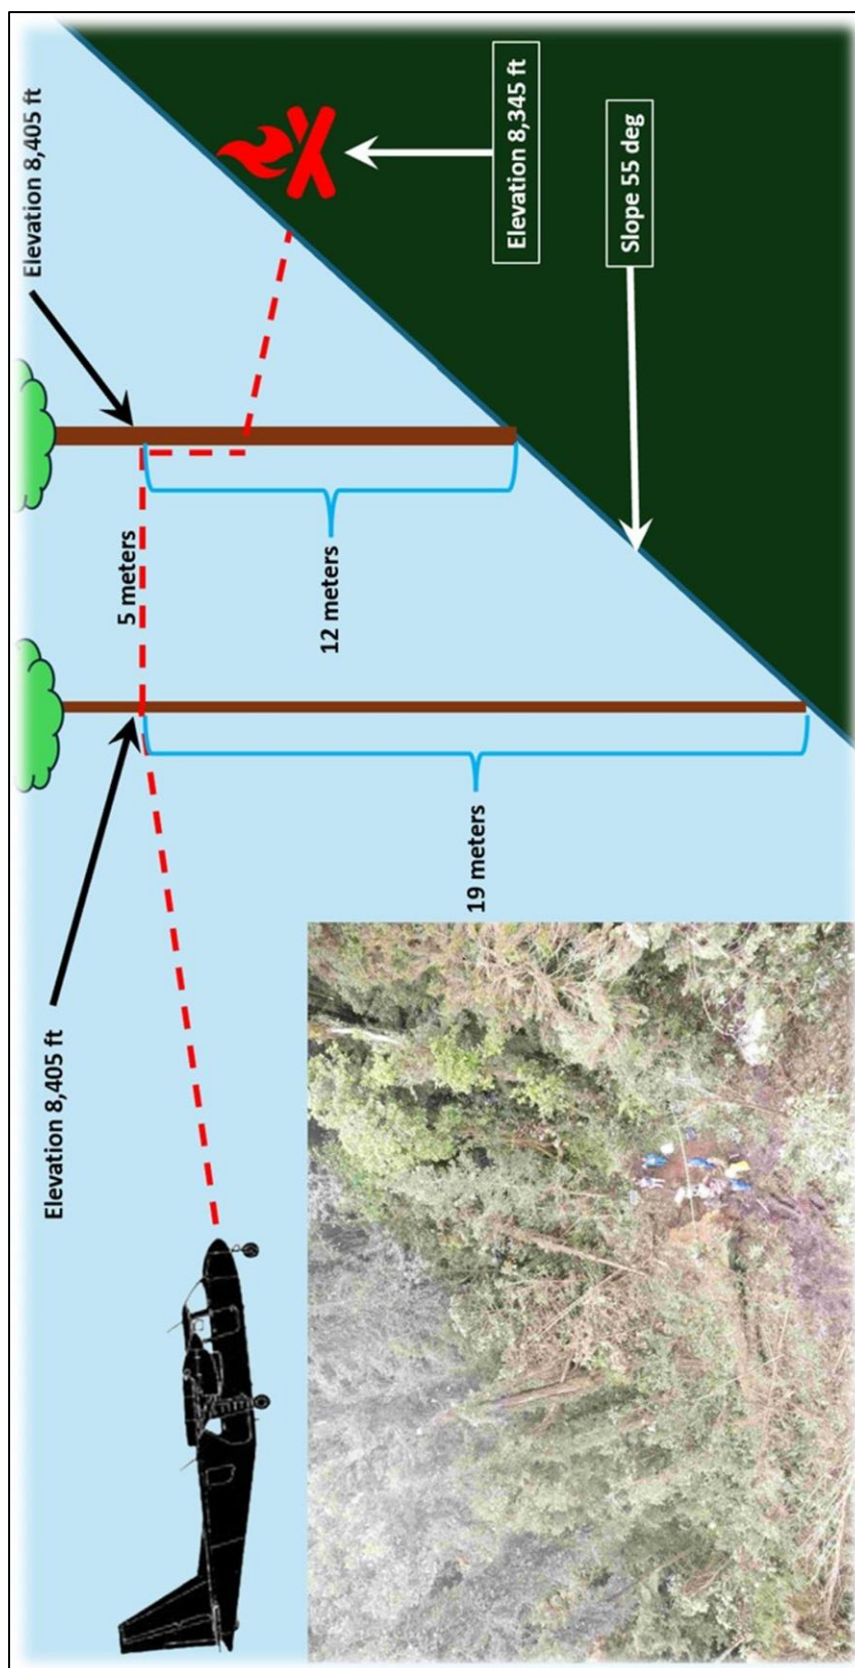
Figure 23: Graphic interpretation of accident site slope and tree impact (Created by AIC)

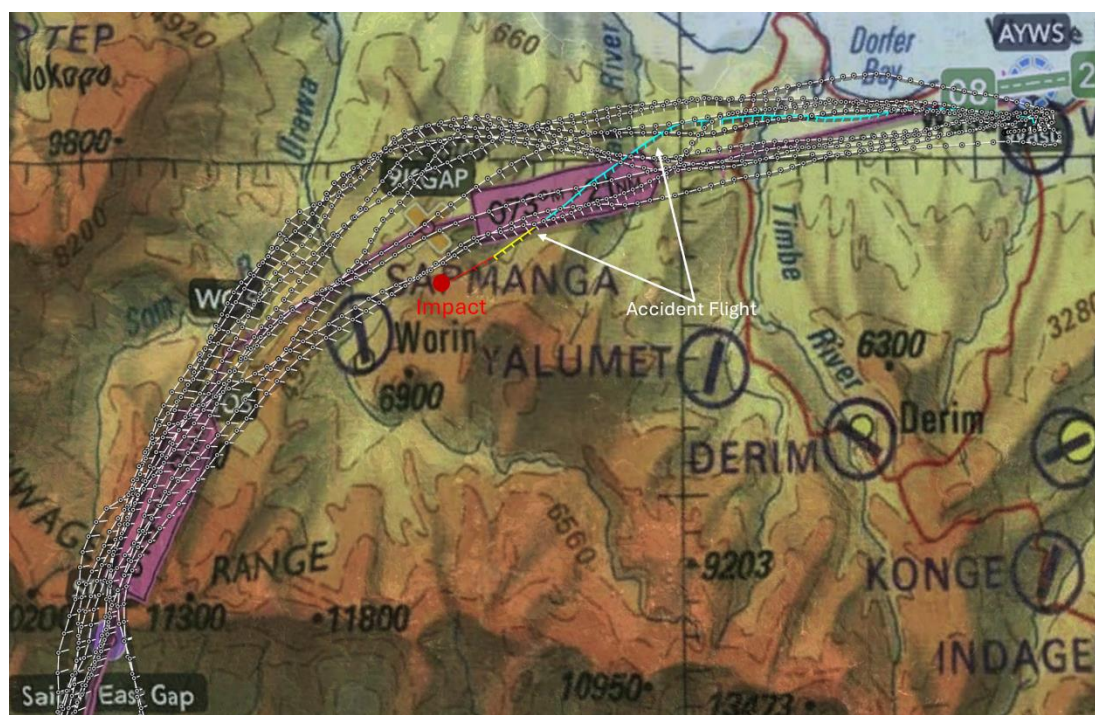
**Figure 27:NCA Route Guide Chart for Area 3 Sapmanga 1 and 2 with SAM and previous flight tracks depicted**

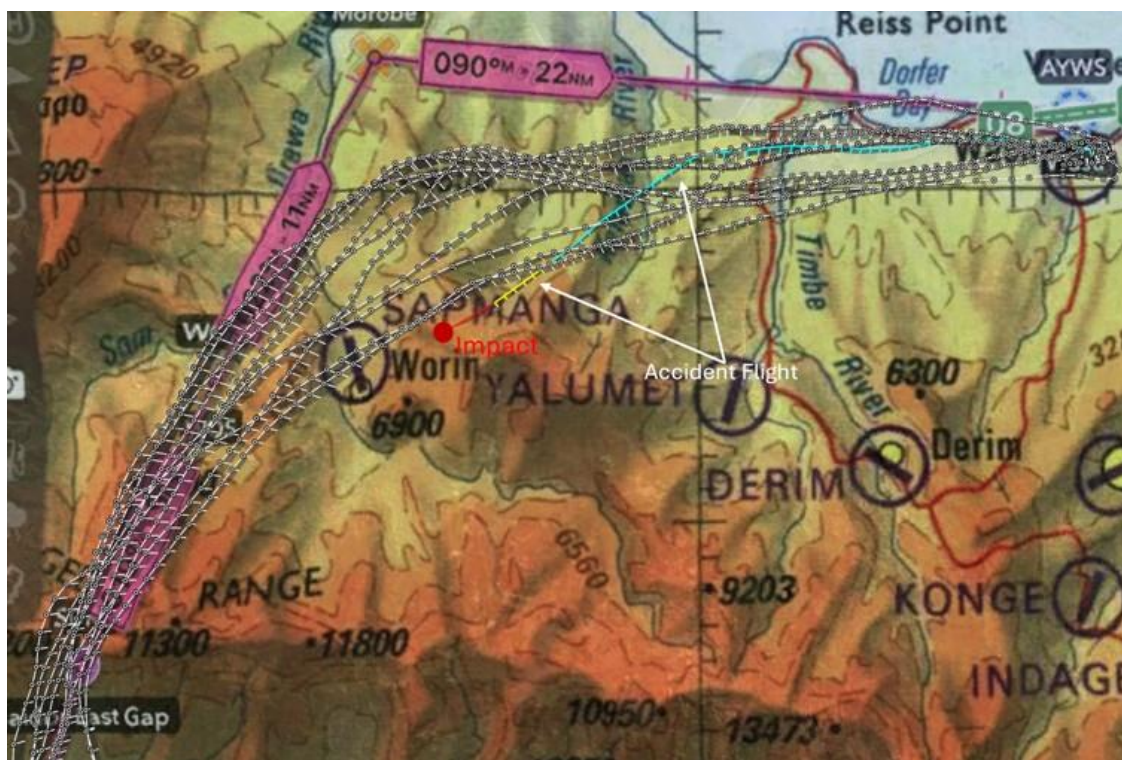
Figure 28:NCA Route Guide Chart for Area 3 Sapmanga 3 and 4 with SAM and previous flight tracks depicted
