FINAL REPORT

AIC 25-1001

OPERATOR	: Tropicair Limited
REGISTRATION	: P2-AXL
MANUFACTURER	: De Havilland Aircraft of Canada
MODEL	: DHC-6-400
CLASS/CATEGORY	: Runway Excursion
LOCATION	: Kerema Airport, Gulf Province, Papua New Guinea
OCCURRENCE DATE	: 6 February 2025

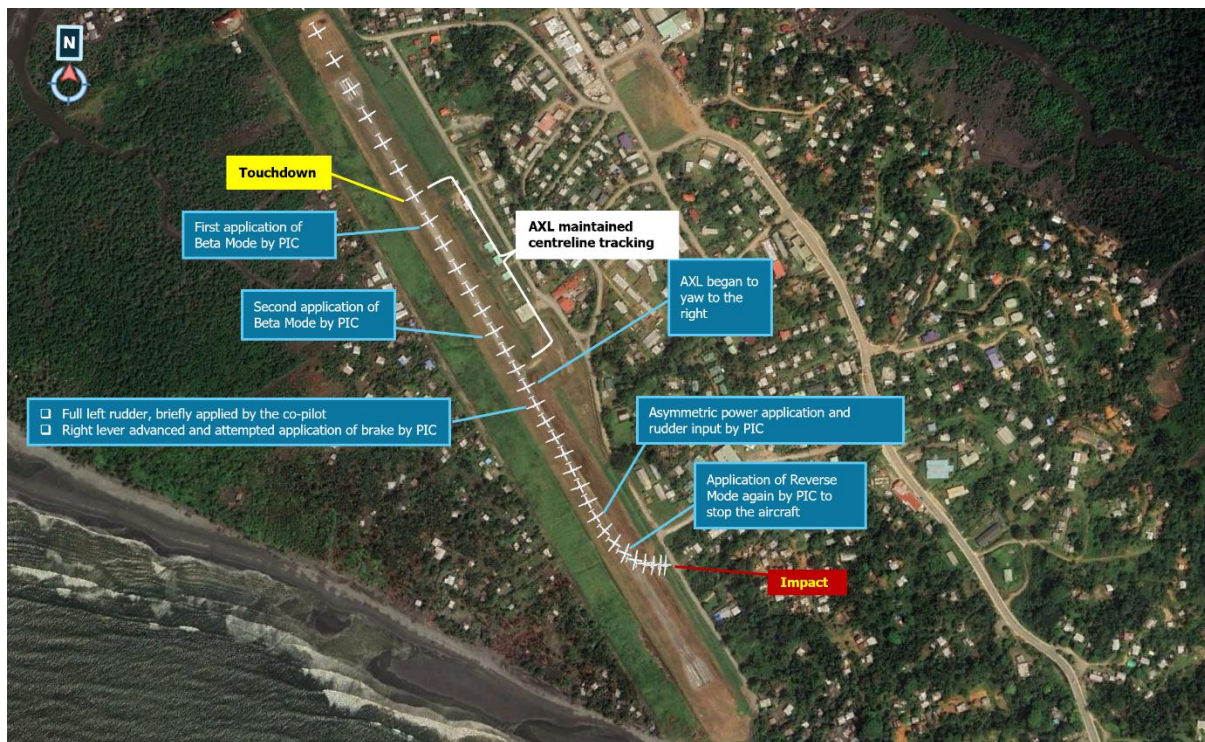
Figure 4: Illustration of P2-AXL tracking along the runway from touchdown to impact.

Recorded data showed that the PIC continued to apply asymmetric power while the aircraft continued to drift further right of the runway on the grass surface of the runway edge, before making a sharp left turn. This was in response to the induced asymmetric thrust effect, with an increase of power in the right engine that generated a left yaw moment. The aircraft then re-entered the runway and overshot the centreline before continuing further left onto the grass surface of the runway edge. The PIC applied Reverse, however, the aircraft continued to skid further left and eventually impacted the side of the drainage ditch.

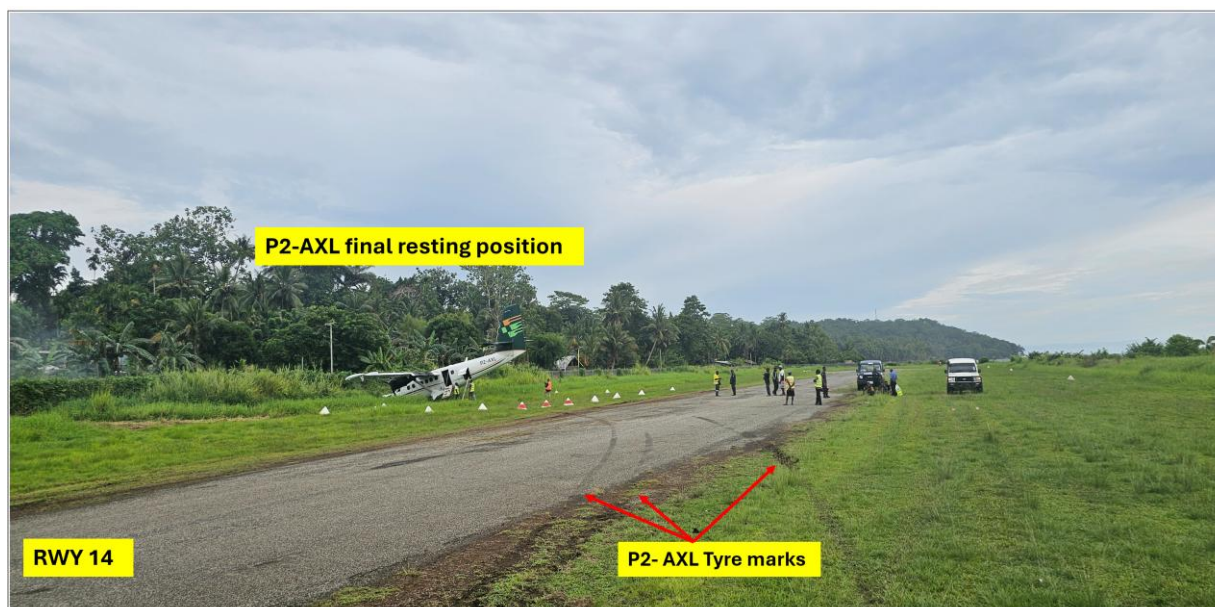
Figure 5: Tyre marks depicting P2-AXL track on the grass surface, right side of RWY 14 before turning left and re-entering RWY 14.

Tyre markings identified by the onsite investigation, showed that the right main wheel had rolled onto the grass surface of the runway edge on the right side of the runway, approximately 300 metres from the touchdown point of RWY 14.

The tyre markings also showed that the aircraft travelled approximately 170 m further forward with all three wheels on the grass surface. The tyre marks then indicated a change of direction to the left, back towards the runway. The deep imprinted tyre marks on the grass surface and then onto the sealed bitumen surface indicated that the aircraft had begun to skid.

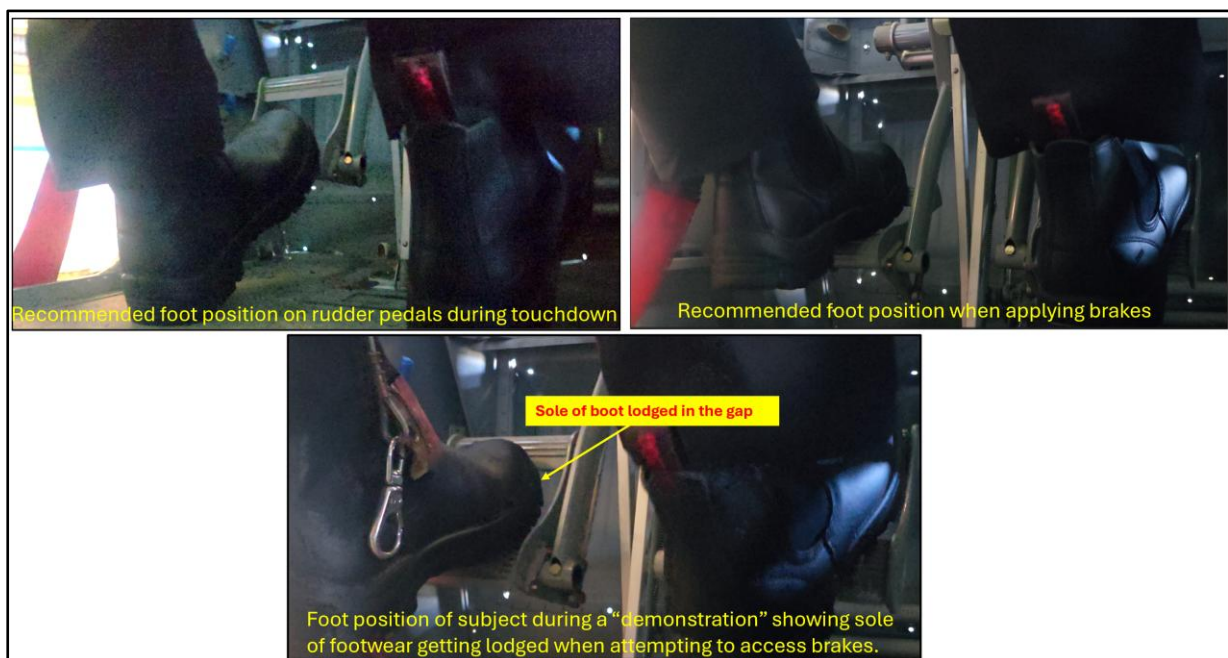
Figure 7: Demonstration of Foot/Feet position on Rudder Pedals and Brakes.

As part of the investigation, a subject was instructed to demonstrate a series of foot positions on the rudder pedal assembly, that could lead to the reported interference when attempting to access the brakes. The assessment was performed using footwear similar in size and type, as that worn by the PIC at the time of the occurrence.

In one of the demonstrations, the sole of the footwear got lodged in the gap between the rudder and brakes. Video review of the landing roll was inadequate due to the PIC's feet position on the rudder pedals not being visible. However, demonstration results support the PIC's account. Refer to Figure 7 below, showing images of the demonstrations conducted.

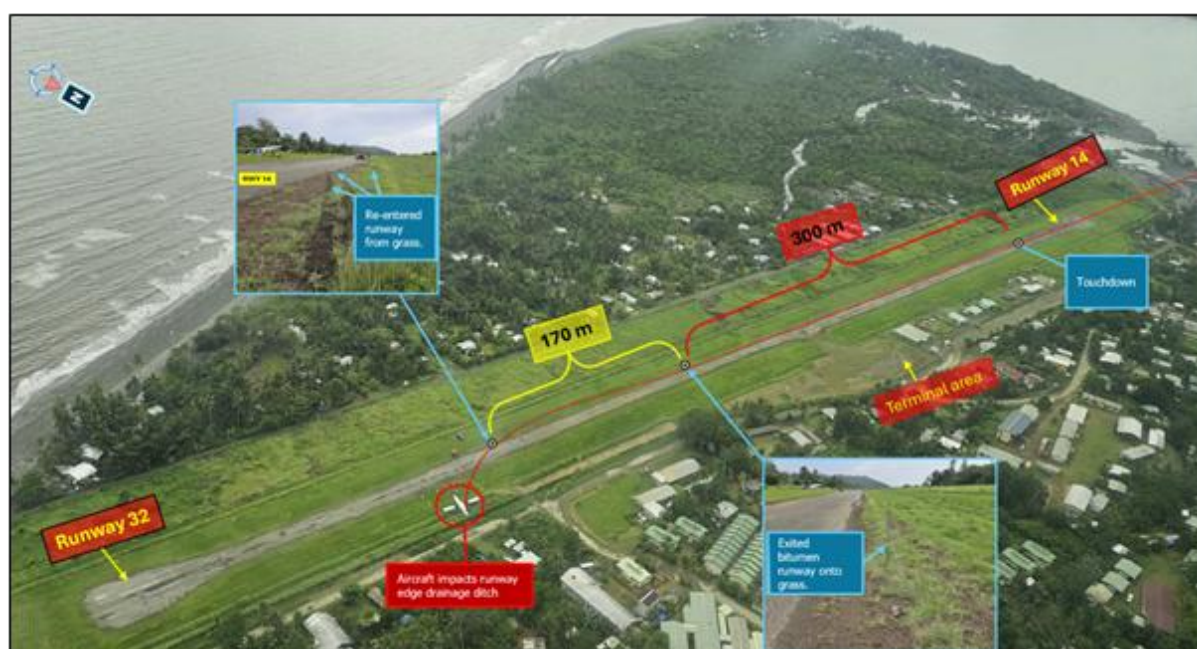
Figure 14: Ground track during the landing roll leading to the accident.

Observations also showed that the aircraft had travelled a further 170 m forward with all three wheels on the grass surface. The tyre marks then indicated a change of direction to the left, back towards the runway. The deep imprinted tyre marks on the grass surface tracking back onto the sealed bitumen surface indicated that the aircraft had begun to skid. The tyre marks showed that the aircraft continued over the runway surface and further onto the grass surface of the runway edge on the left side and into the drainage ditch.

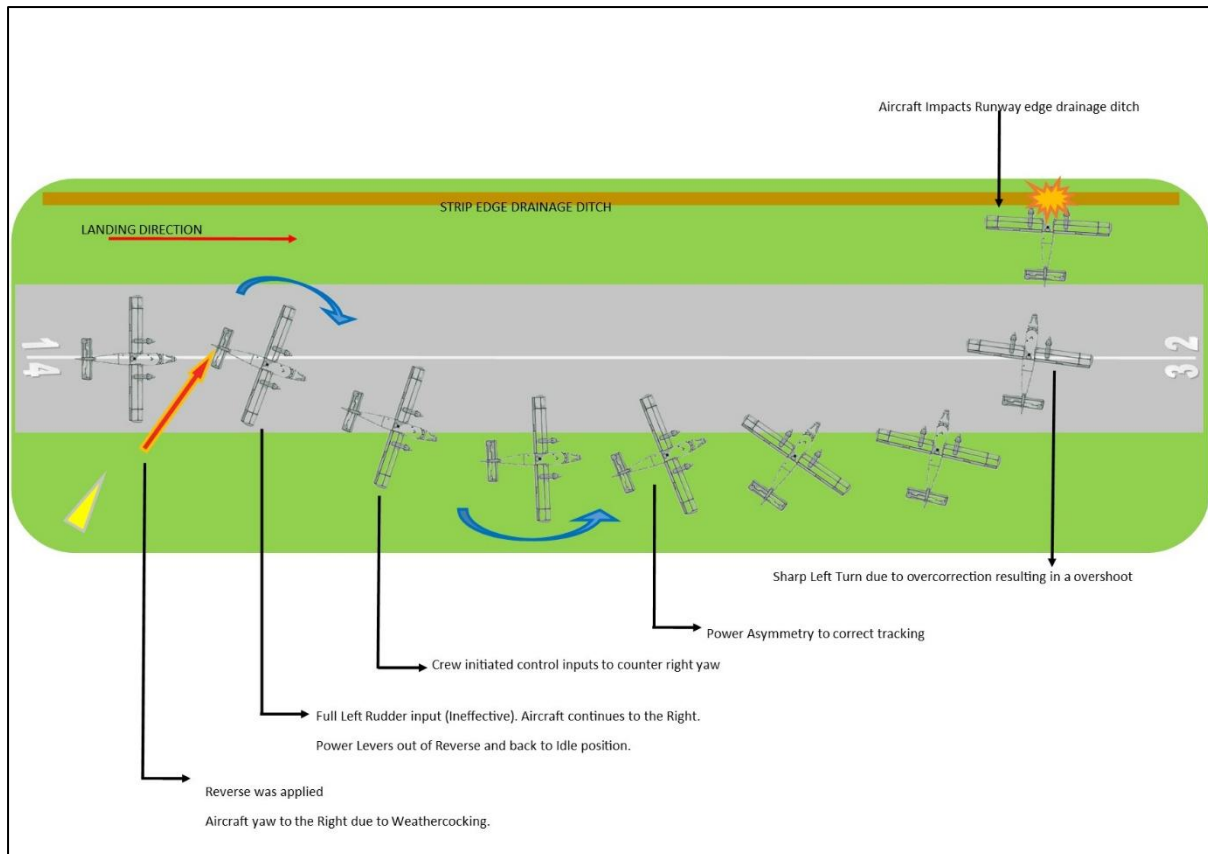
Figure 15: Illustration showing initial yaw to the right, leading to right drift and overcorrection.

Despite the crew's efforts to recover from the loss of directional control, the asymmetric power inputs caused the aircraft to accelerate past the runway edge and into the drainage ditch. Recorded data showed that the aircraft impacted the drainage ditch at a considerable speed and momentum.

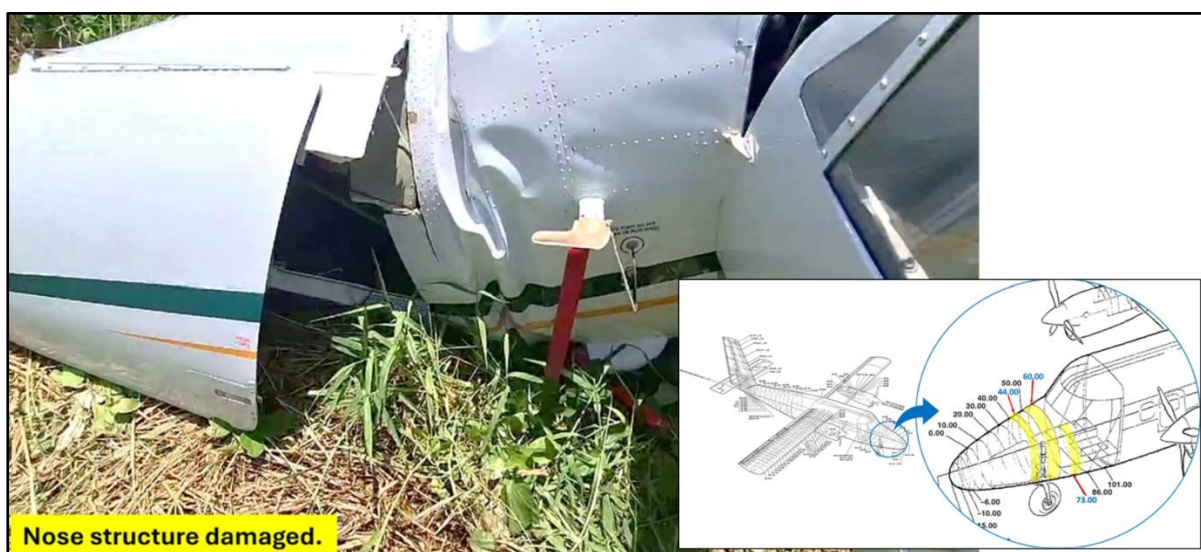
Figure 16: Structural damage to the nose section (FS 40.00-FS 60.00), showing deformation and deterioration.

The onsite damage assessment by the AIC team identified extensive damage primarily localised to the aircraft's nose section (Refer to Figure 15) This area contains internal mounting shelves and equipment enclosures. The extent of the damage suggests a potential compromise to both the airframe structure and the integrity of multiple onboard systems located within the nose cone area.

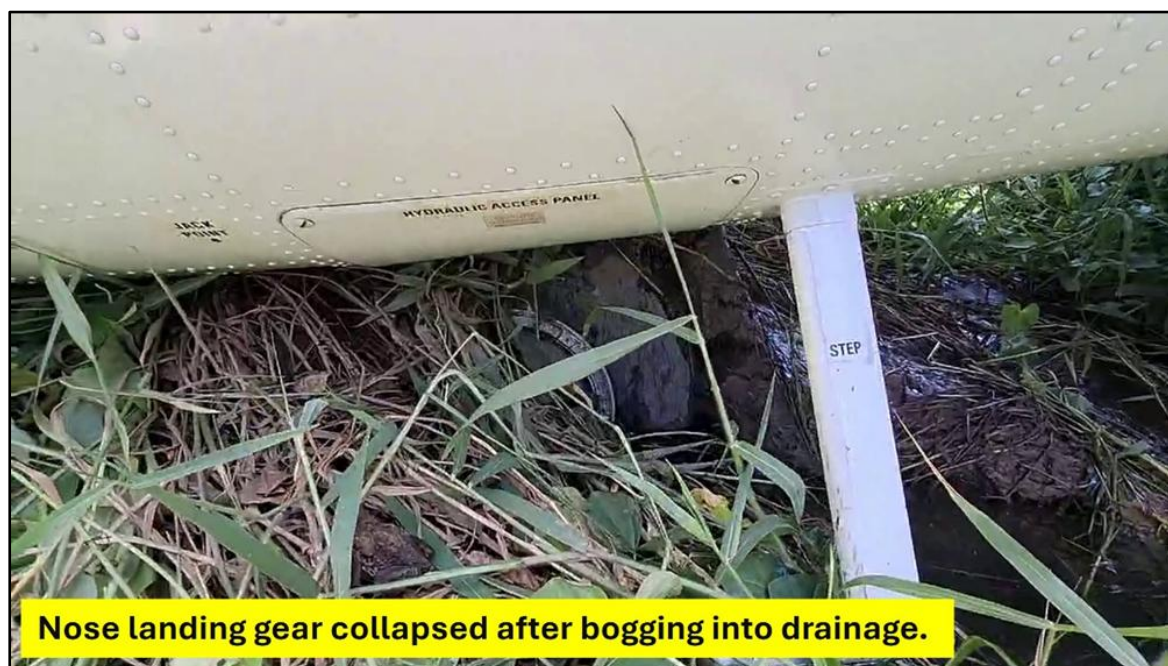
Figure 17: Nose landing gear bogged in the drainage ditch.

The Nose Landing Gear had collapsed as a result of the runway excursion. Due to the collapse, the Nose Landing Gear was removed to prevent further damage to the airframe structure.

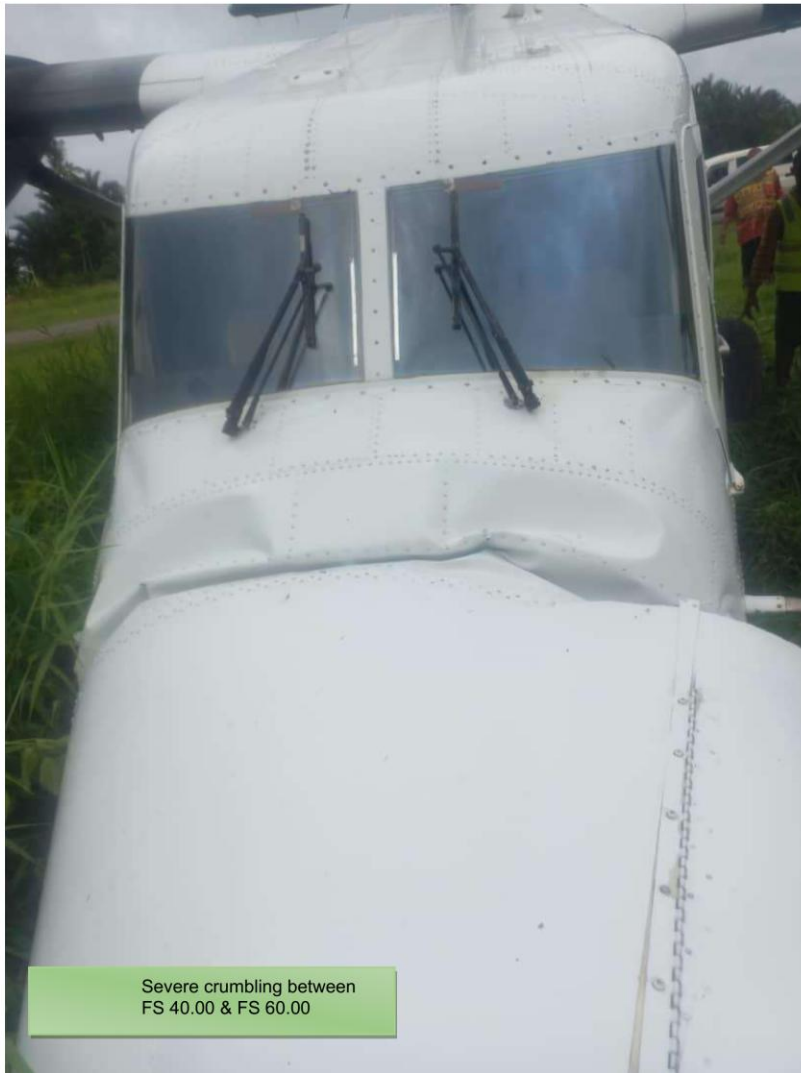
Severe crumpling between
FS 40.00 & FS 60.00

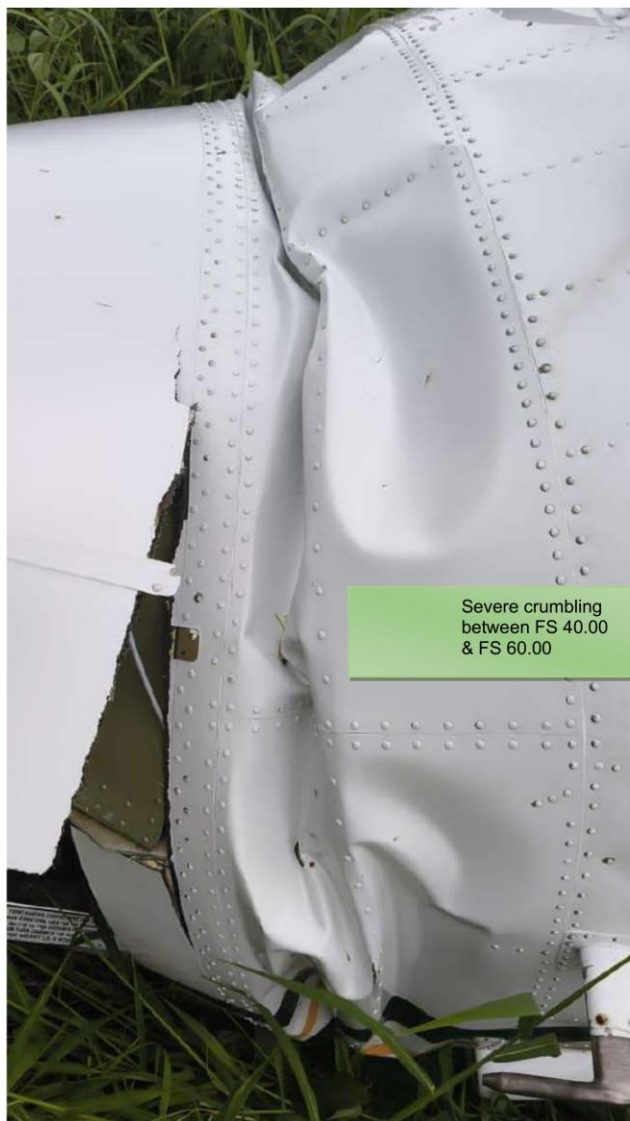
Severe crumpling
between FS 40.00
& FS 60.00

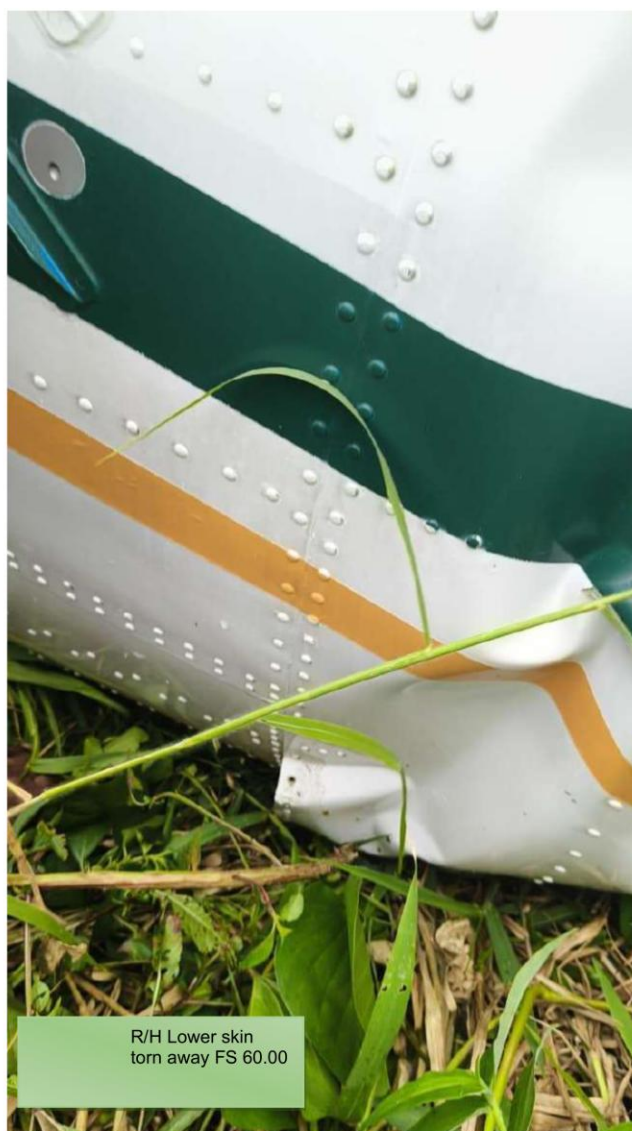
R/H Lower skin
torn away FS 60.00

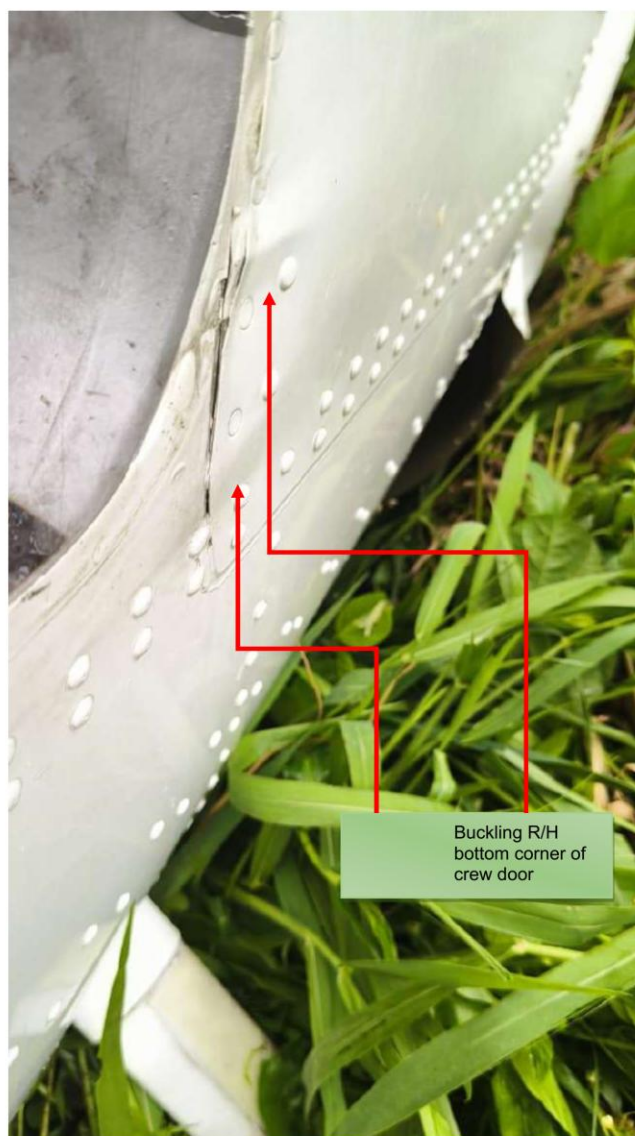
Buckling R/H
bottom corner of
crew door
