PRELIMINARY REPORT

AIC 25-1003

OPERATOR	: Tropicair Limited
REGISTRATION	: P2-AMH
MANUFACTURER	: Cessna Aircraft Company
MODEL	: Cessna 208B Grand Caravan
OCCURRENCE DESCRIPTION /CLASS/CATEGORY	: Abnormal Runway Contact – Hard Landing
LOCATION	: Balimo Airstrip, Western Province
OCCURRENCE DATE	: 13 July 2025

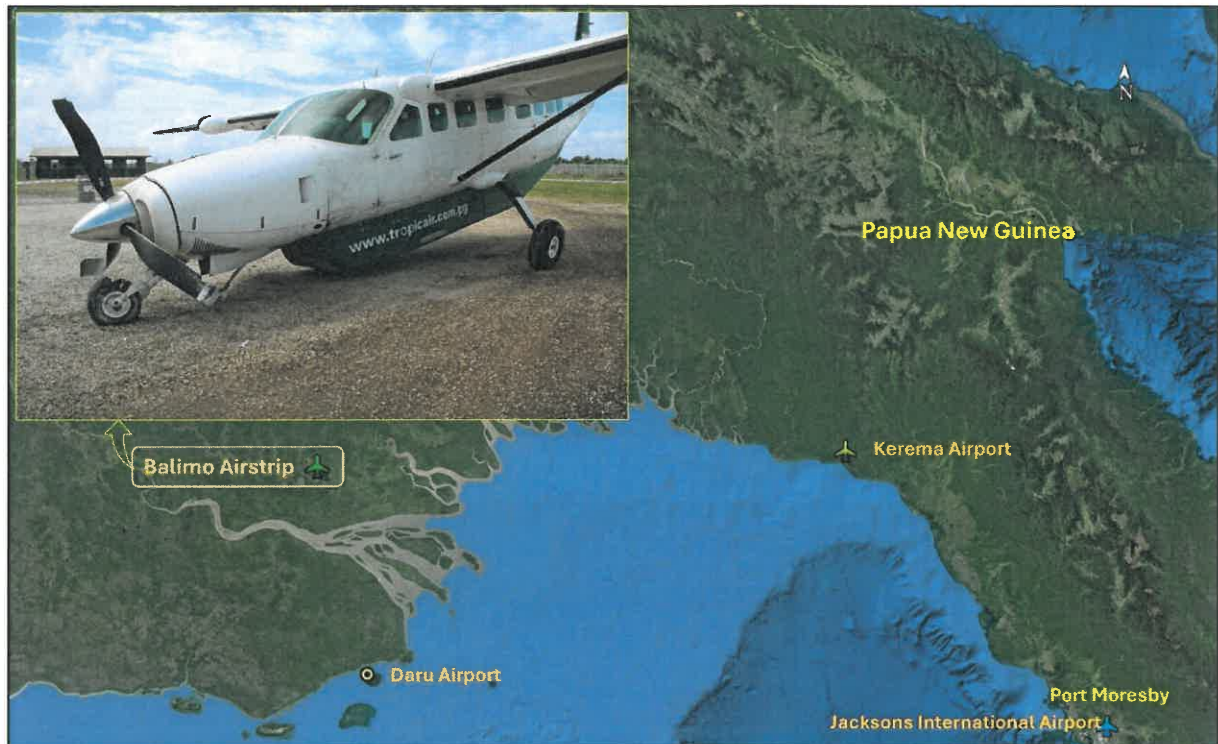
On 13 July 2025, at 14:18 local (04:15 UTC¹), a Cessna 208B Grand Caravan aircraft, registered P2-AMH, owned and operated by Tropicair Limited, sustained substantial damage due to a landing gear assembly collapse following heavy landing at Balimo Airstrip.

Figure 1: P2-AMH accident site, Balimo Airstrip, Western Province.

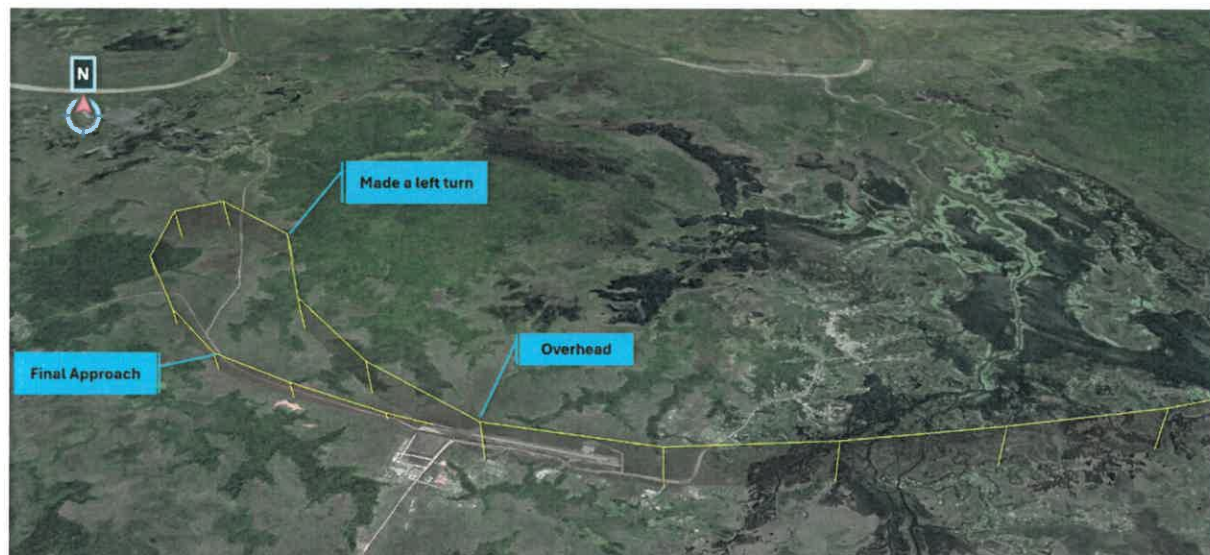
Figure 3: P2-AMH at the circuit area.

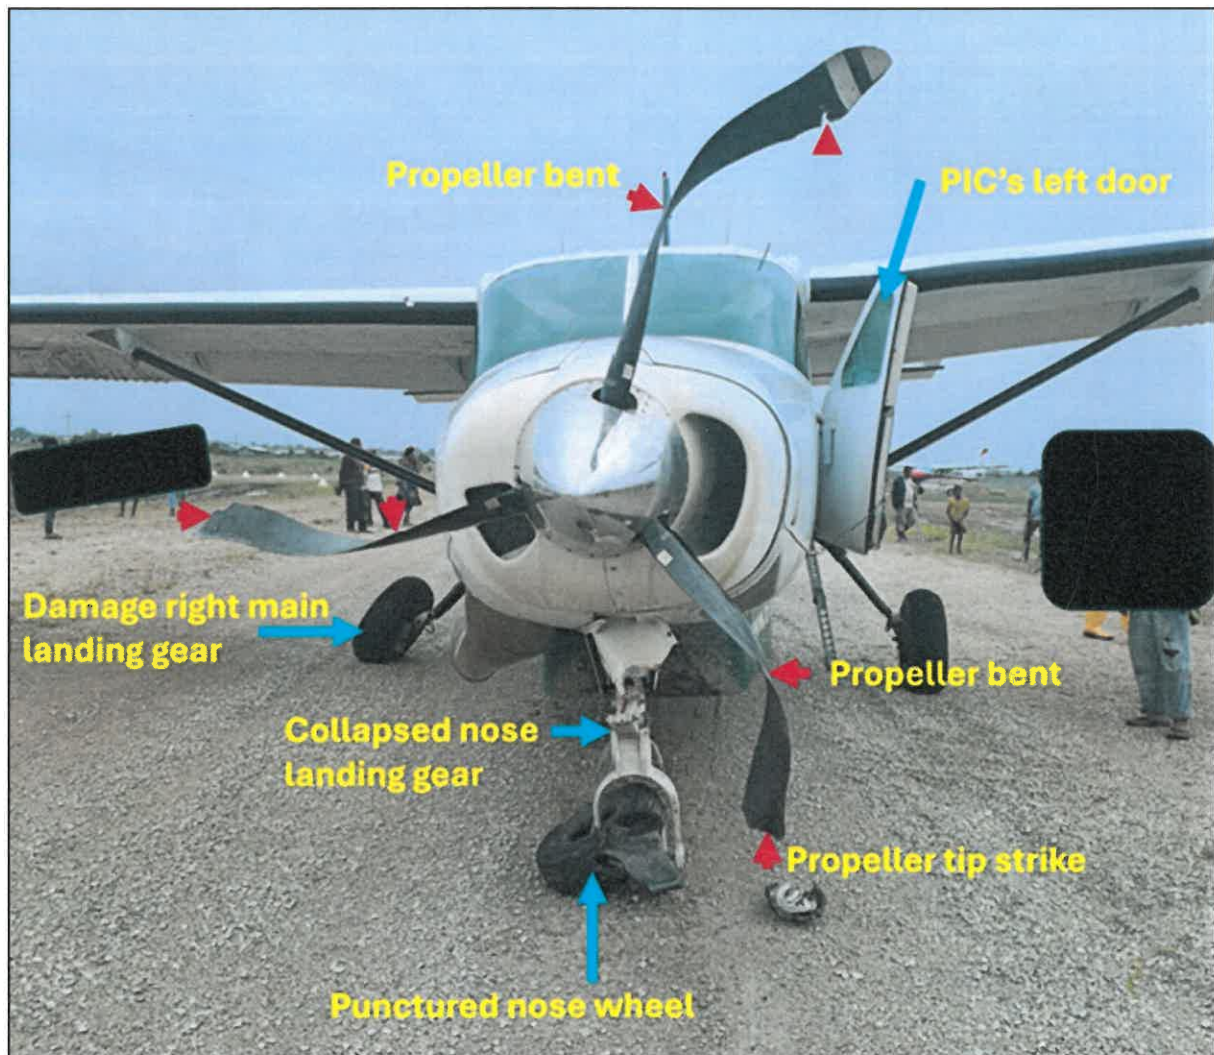
Evidence shows a tail strike also occurred during the aircraft's second contact with the ground. The aircraft nose subsequently contacted the ground heavily and the nose landing gear collapsed. As the nose dropped, the propellers struck the ground. The aircraft nose dragged across the surface and decelerated before eventually coming to rest.

The aircraft sustained significant damage to the nose landing gear, right main landing gear assemblies, the propeller assembly, and exhibited evidence of a tail strike.

Figure 4: Damage sustained by the aircraft

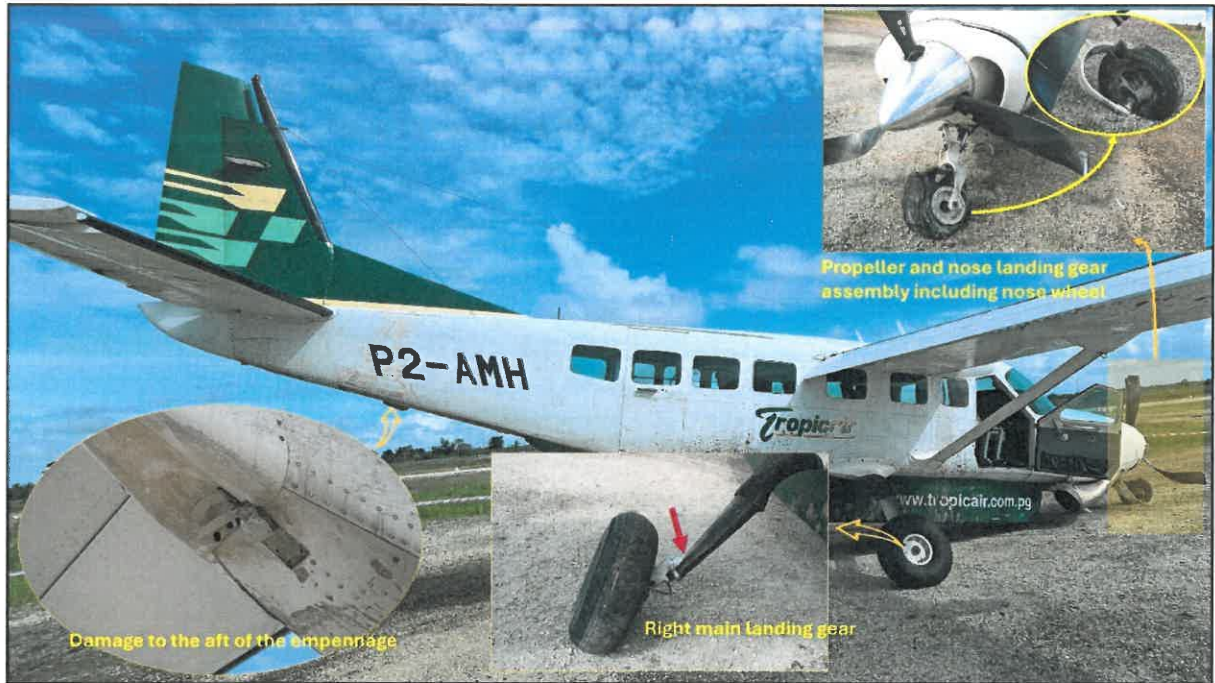
- Nose wheel and nose landing gear assembly: The nose wheel was found deflated, and the nose landing gear assembly collapsed.
- Propeller assembly: All three propeller blades showed signs of ground impact, with tips broken off and blades bent.
- Right main landing gear: Found bent.
- Aft section of the empennage: Strike mark observed.

Figure 5: Observation of the damage to the aircraft
