PRELIMINARY REPORT

AIC 26-1003

OPERATOR	:	Helicopter Support Limited (Solomon Islands)
REGISTRATION	:	H4-HSA
MANUFACTURER	:	Bell Textron
MODEL	:	Bell 222U
CLASS/CATEGORY	:	Engine Failure – Ditching
LOCATION	:	Munda, Western Province (Solomon Islands)
OCCURRENCE DATE	:	17 April 2026

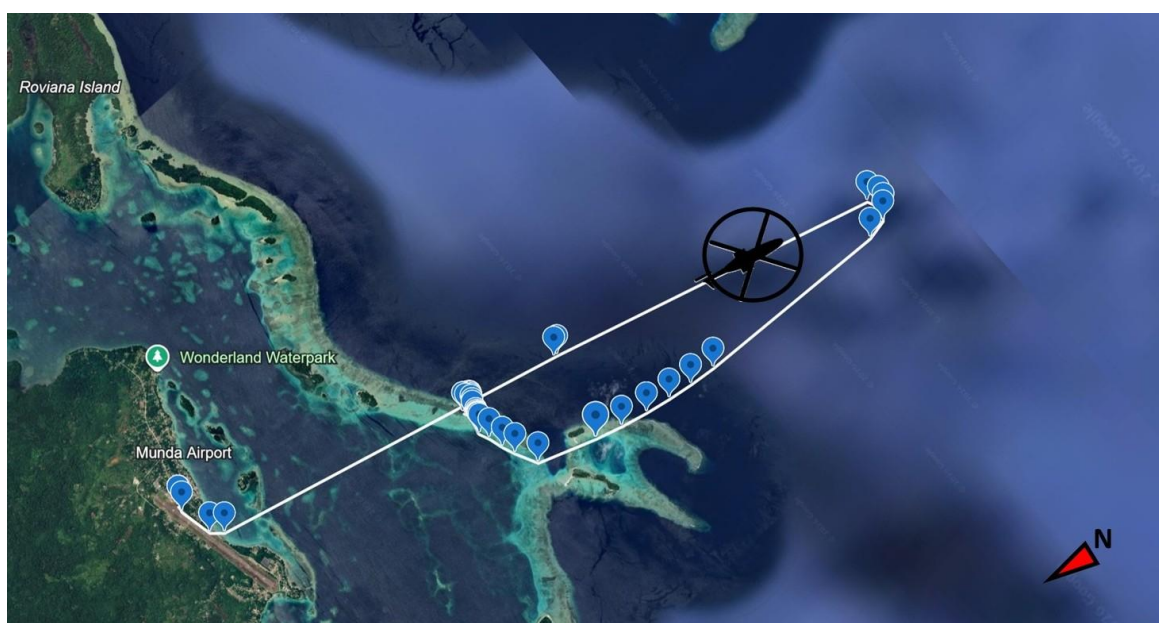
Figure 1: Overview of Flight Track from Munda Airport to the ditching site.

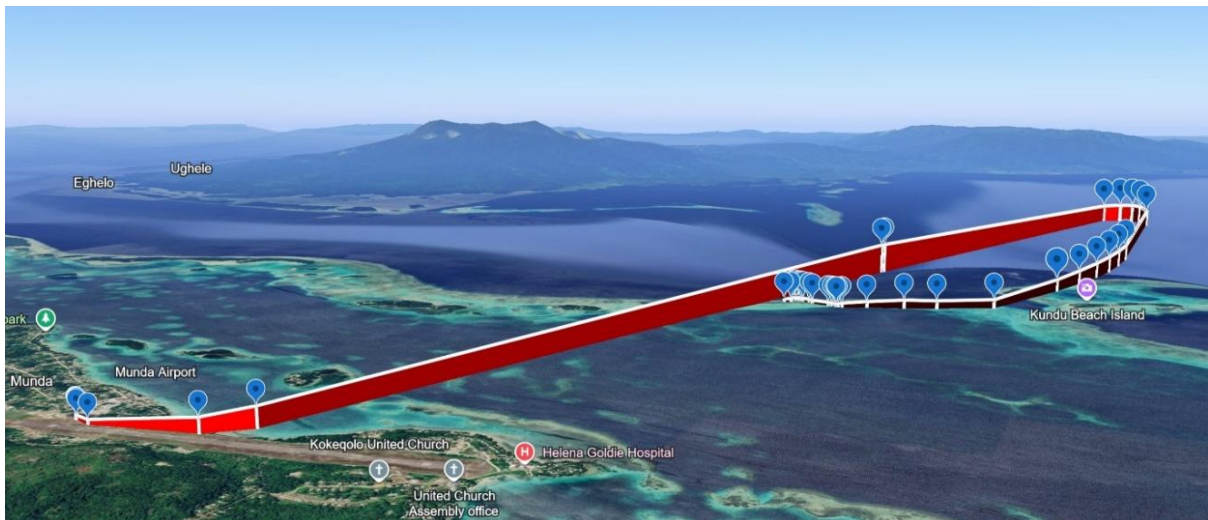
Figure 2: H4-HSA Departure from Munda Airport and track outbound.

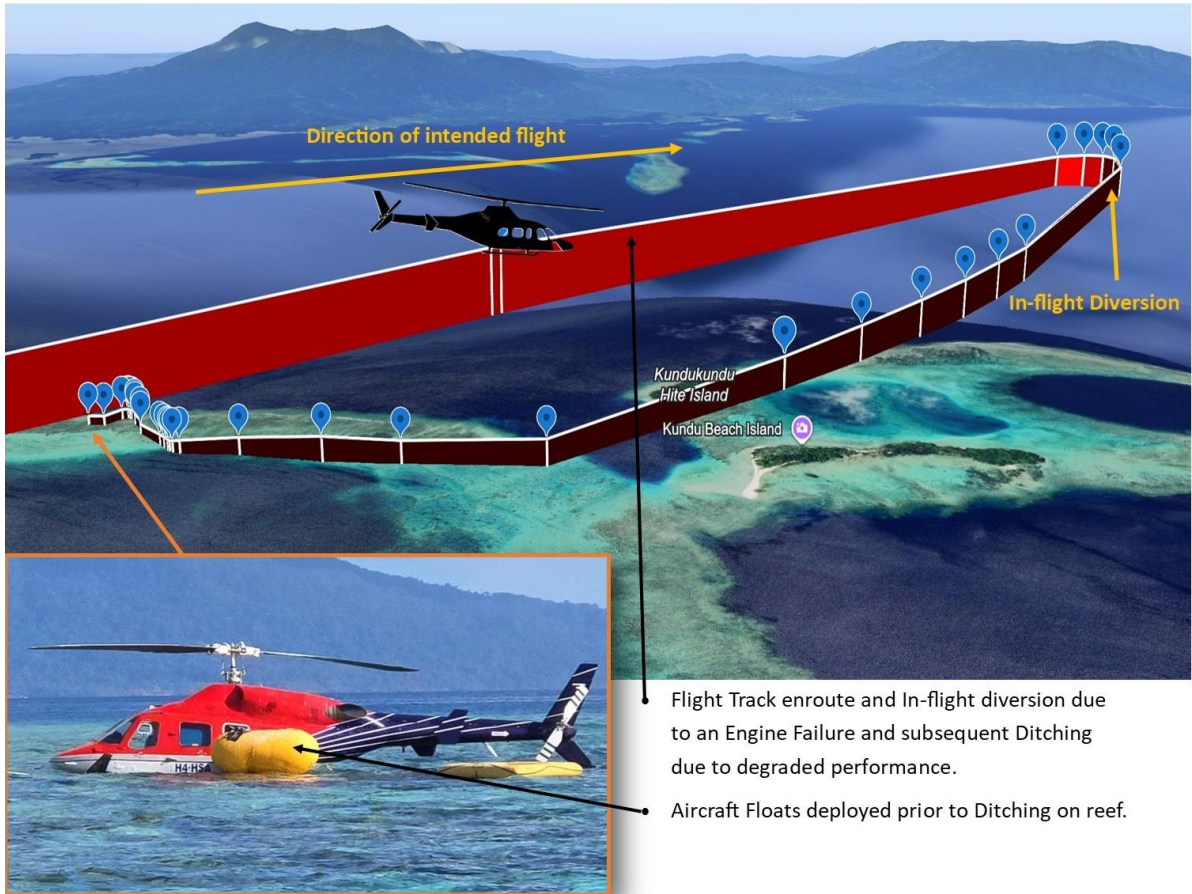
According to the pilot, shortly after evacuating, they were rescued by locals in dinghies from the nearby islands. The aircraft was partially submerged in water. Apart from the float covers detaching from the aircraft, and airframe exposure to saltwater, there was no further impact related damage to the aircraft.

Figure 3: Final Resting position of H4-HSA following the in-flight diversion and track back towards Munda.

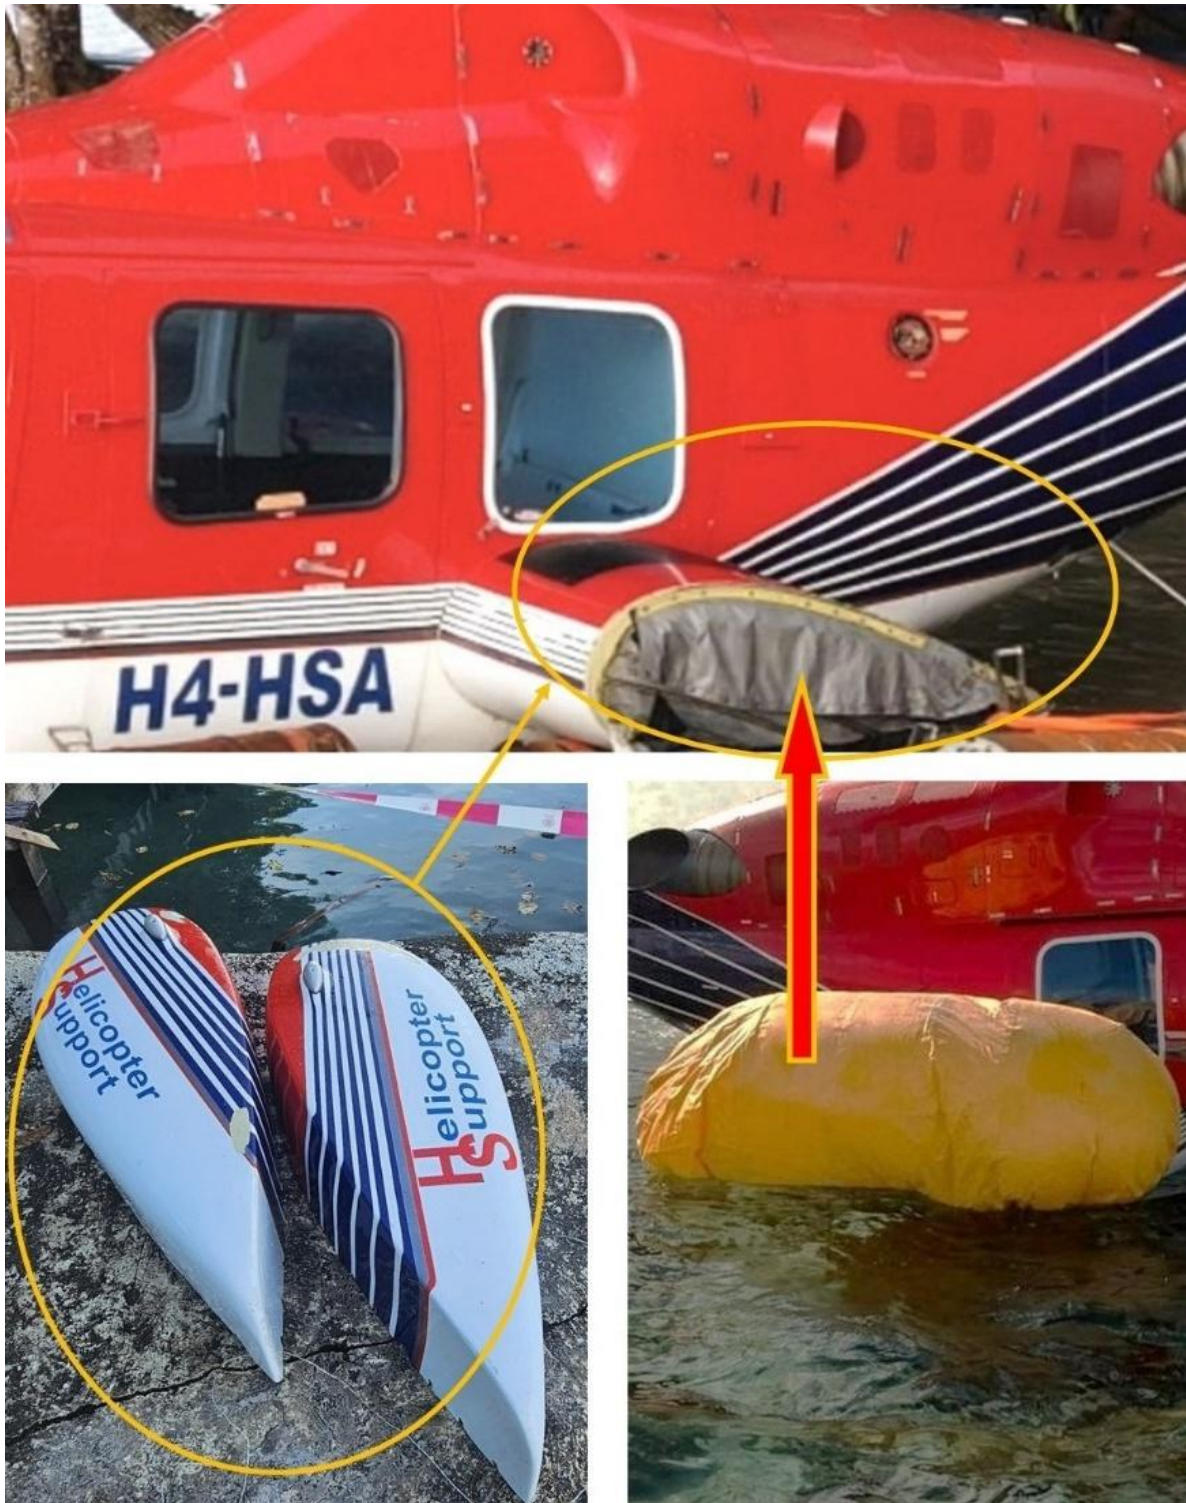
Figure 4: Deployment of Floats and their location (H4-HSA).
