## FINAL REPORT

AIC 25-2001

| REGISTRATION | : | VH-NAB |
| CLASS/CATEGORY | : | Mainwheel failure — Loss of Directional Control |

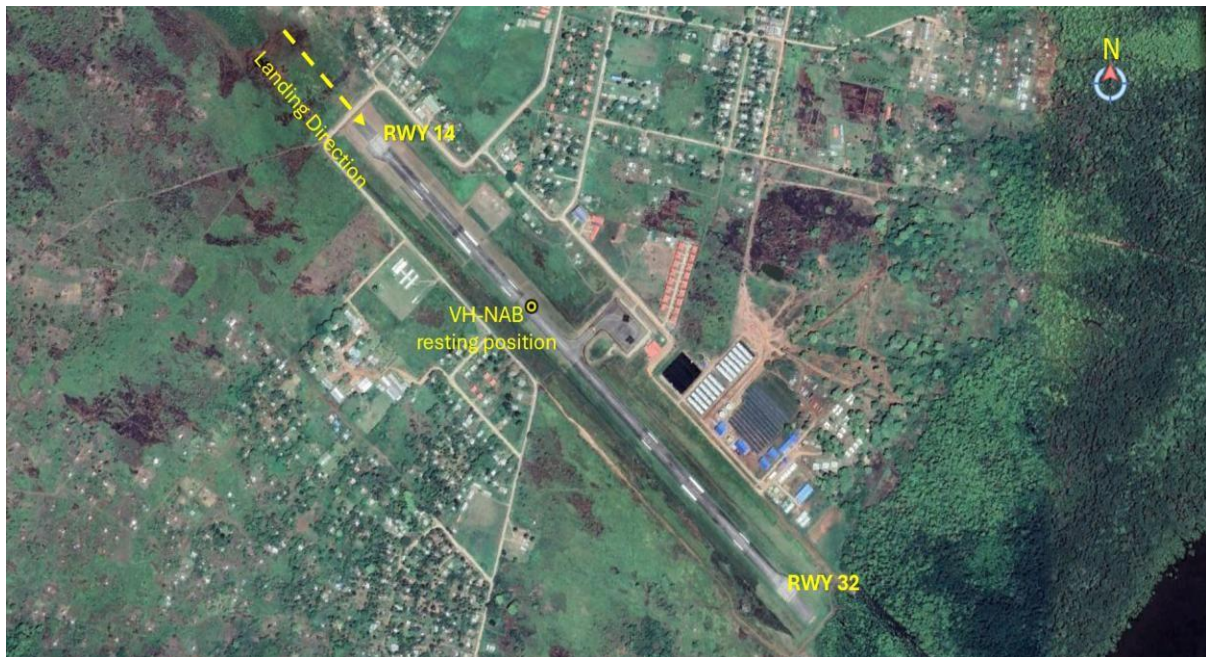
Figure 2: Depiction of VH-NAB resting position at the occurrence site, Daru Airport.

The right landing gear axle and leg dug into the asphalt runway surface and made a scrape and divet that lifted a small piece of asphalt, requiring minor repair to the asphalt.

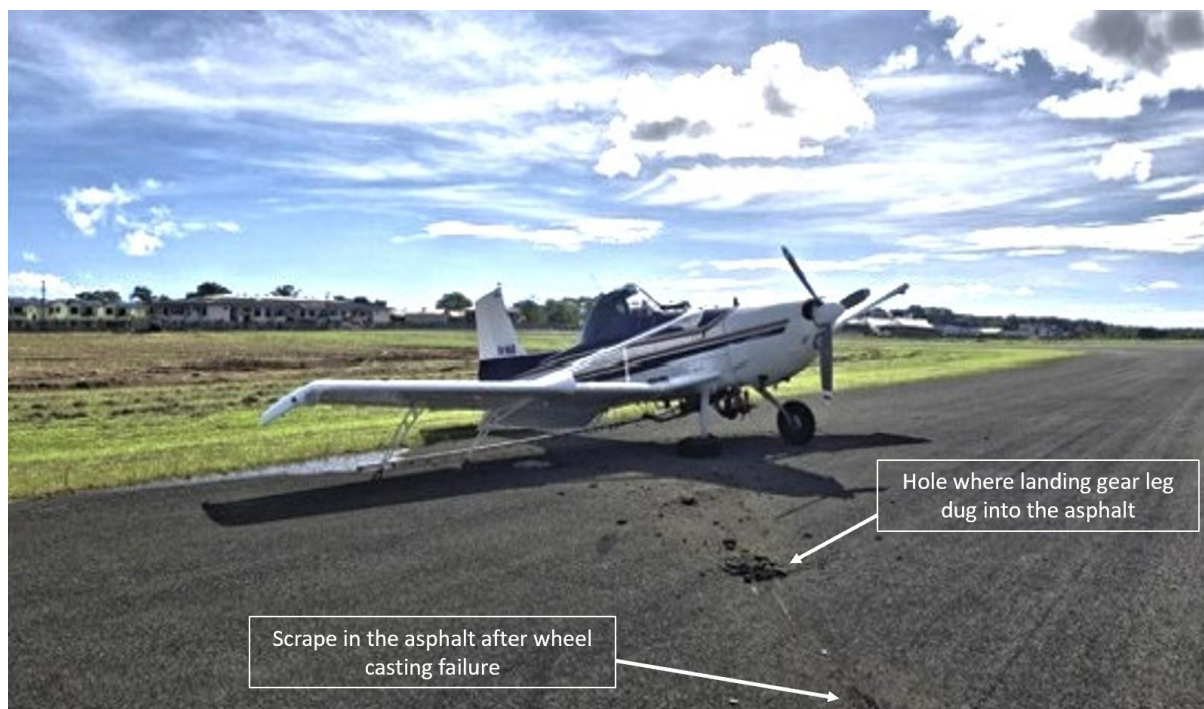
Figure 3: VH-NAB at its resting position after the occurrence at Daru Airport.

The aircraft sustained significant damage to the right main landing gear wheel assembly, axle and brakes. The landing gear leg and associated airframe and airframe attachment points were not damaged.

He then heard what he described as a loud “bang” noise and the aircraft veered toward the left of the runway. The right mainwheel had fractured and in the area of the bearings had fragmented. The axle and bottom of the leg dug into the asphalt and the aircraft pivoted around and came to rest near the edge of the runway with the nose of the aircraft pointing across the runway.

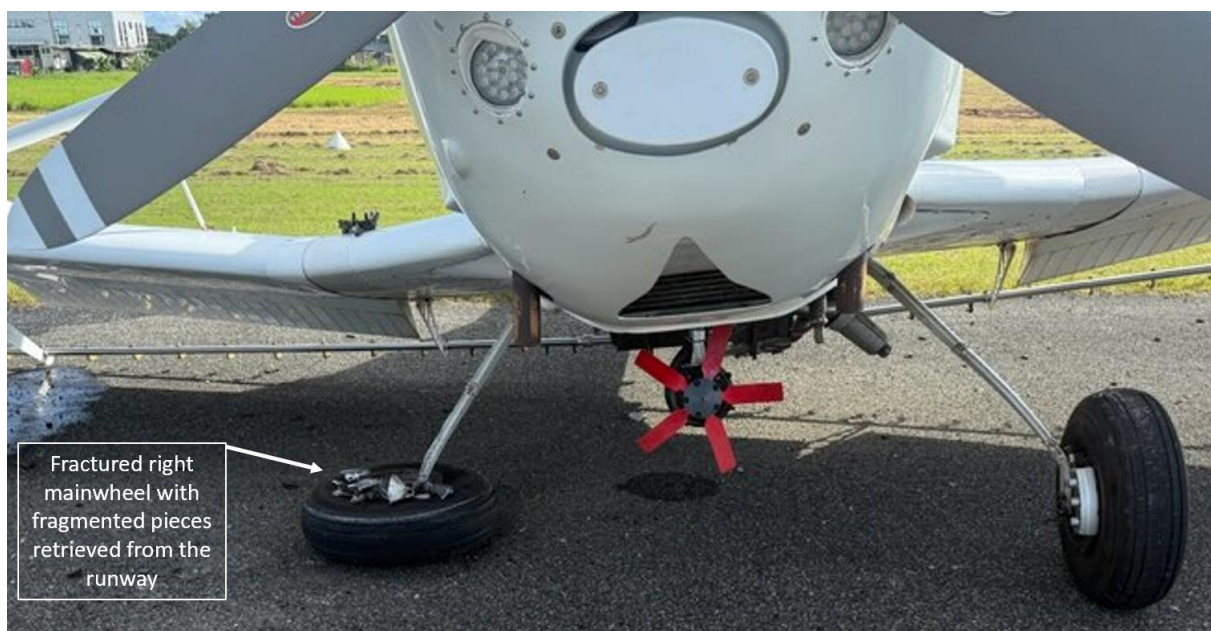
Figure 4: Damage sustained by VH-NAB

He found that the required spacer between the wheel halves on the right wheel assembly (see *Appendix 5.1*) was missing, and the wheel bearings were dry of grease. With no wheel-half spacer, when the wheel nut was tightened to its limit there was insufficient pre-load on the wheel bearings.

The right wheel assembly halves, bearings and the brake assembly also failed due to the out of balance overload and were substantially damaged. An inspection of the left wheel revealed that it did not have a wheel spacer.

The investigation found that because the wheel halves had been assembled without the required spacers, the wheel halves had not been able to be adequately tightened and there was therefore no wheel-bearing pre-loading. That allowed the joined halves to loosen after a small number of takeoffs and landings. The vibration and subsequent wobble on the right axle accentuated to the point of bearing failure and immediate wheel casting failure. The right brake assembly also failed when the wheel fractured.

The main landing gear wheel halves had been incorrectly assembled and the spacers required to ensure correct wheel bearing pre-loading had not been installed when the tyres were last changed. The axle bearings in the right wheel assembly had not been greased before fitment to the landing gear axles.

New wheel assemblies were installed (left and right main wheels) which included a wheel-half spacer. The right brake assembly and associated hoses and hardware were replaced.

The engineer replaced all the landing gear hardware, including the axle bolts and as a safety precaution he replaced the right main gear leg attach bolts.

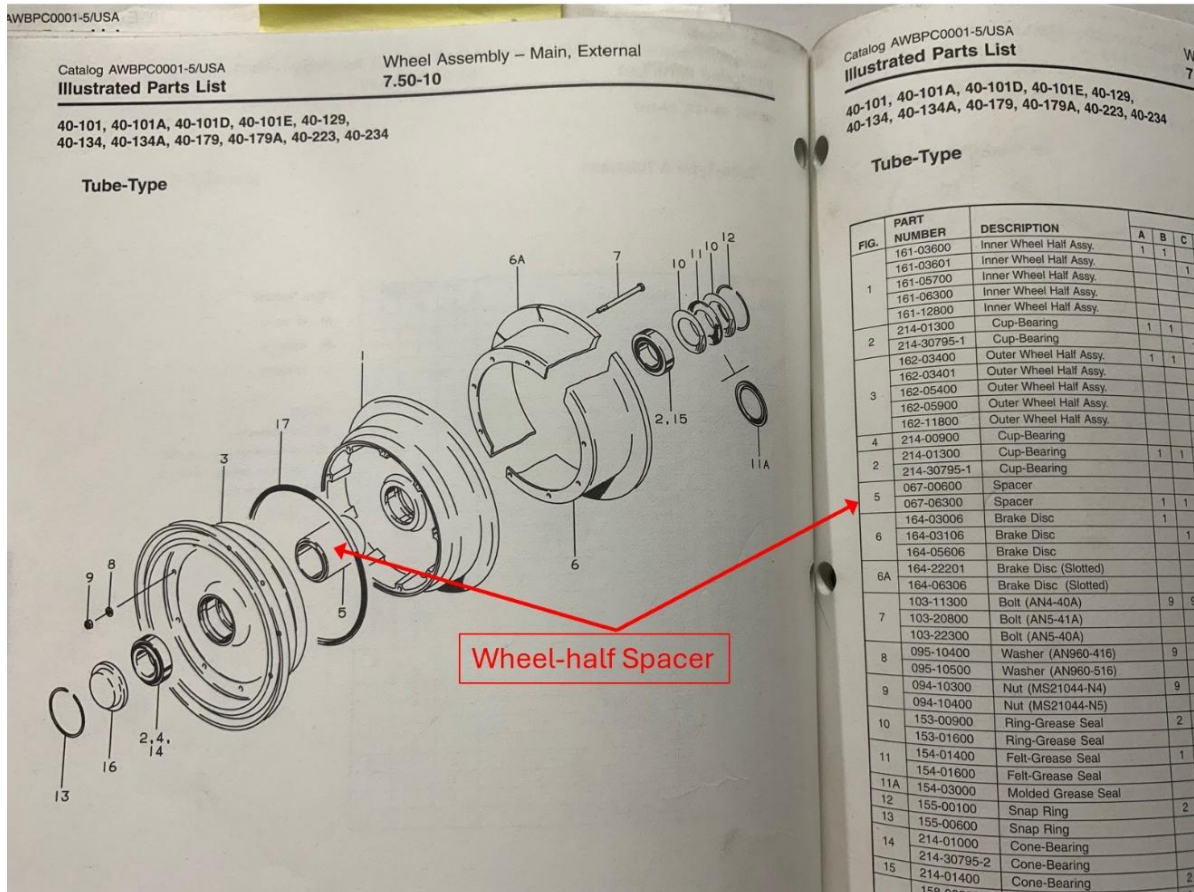
### 5.1 Cleveland C163001-0601 main wheel assembly

Cleveland C163001-0601 main wheel assembly showing spacer required for pre-loading the wheel bearings.
