**PAPUA NEW GUINEA
ACCIDENT INVESTIGATION COMMISSION
FINAL REPORT**

P2-MFK

Gippsland Aeronautics GA8–TC 320

Hard landing - Downdraft undershoot

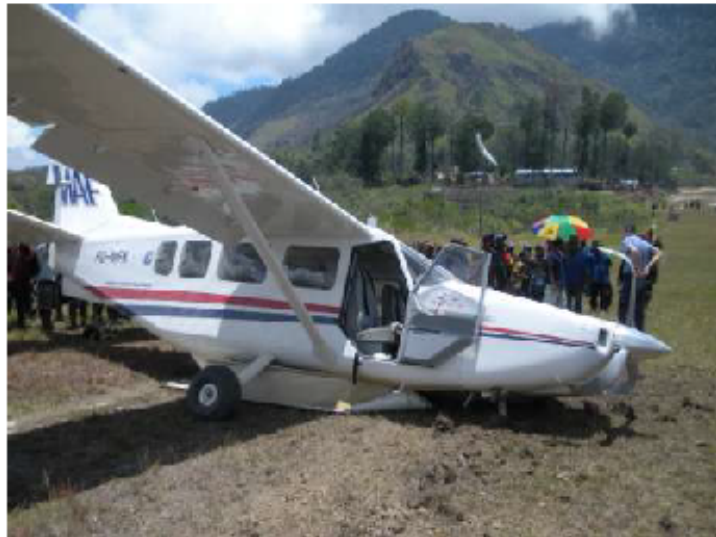
P2-MFK

GA8-TC 320 S/N 130

The aircraft was significantly damaged by the vertical landing forces and subsequent slide to a stop. One passenger received a cut on his left eyebrow as a result of the occurrence. Some passenger baggage items (mainly foodstuffs) in the pod were damaged or destroyed.
