FINAL REPORT

**PAPUA NEW GUINEA
ACCIDENT INVESTIGATION COMMISSION
AIRCRAFT ACCIDENT REPORT**

P2-MCJ

Double propeller overspeed

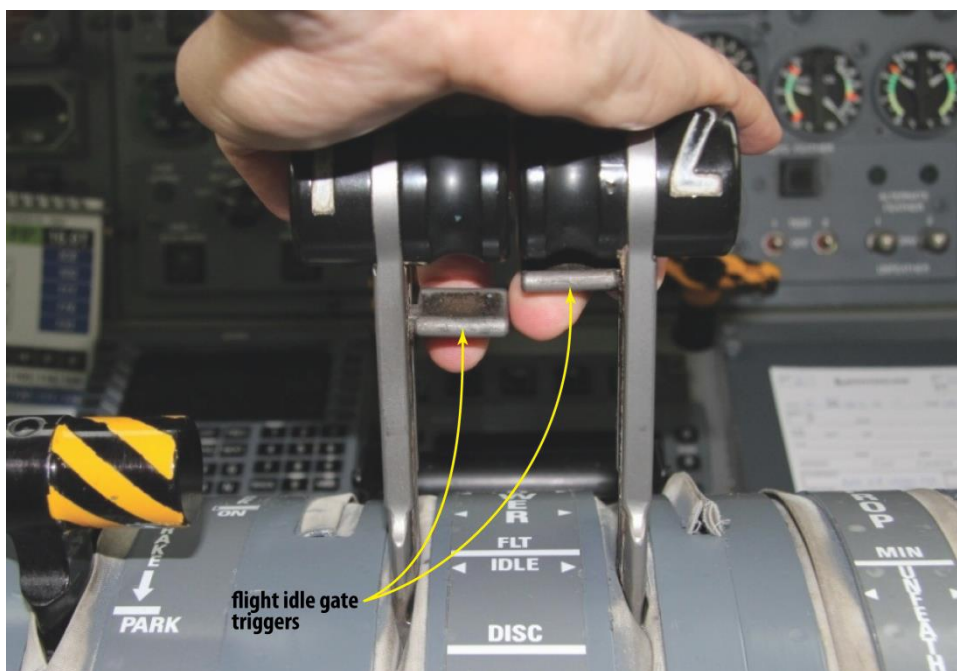
Figure 10: Power levers showing flight idle gate triggers, with right trigger lifted

Testing conducted by the Australian Transport Safety Bureau (ATSB) on an exemplar aircraft confirmed that only one of the triggers needs to be lifted about 6 mm to enable both power levers to bypass the flight idle gate into the ground beta range.

Further testing was conducted from both the Pilot-in-Command's and First Officer's sides, with the seat on each side adjusted to the normal flight position. With the hand placed with the palm on top of the power levers, there was a distinct tendency for the middle two fingers to touch the flight idle gate triggers when moving the power levers rearward. Figure 10 shows the power levers with one of the triggers lifted to the height required to bypass the gate.

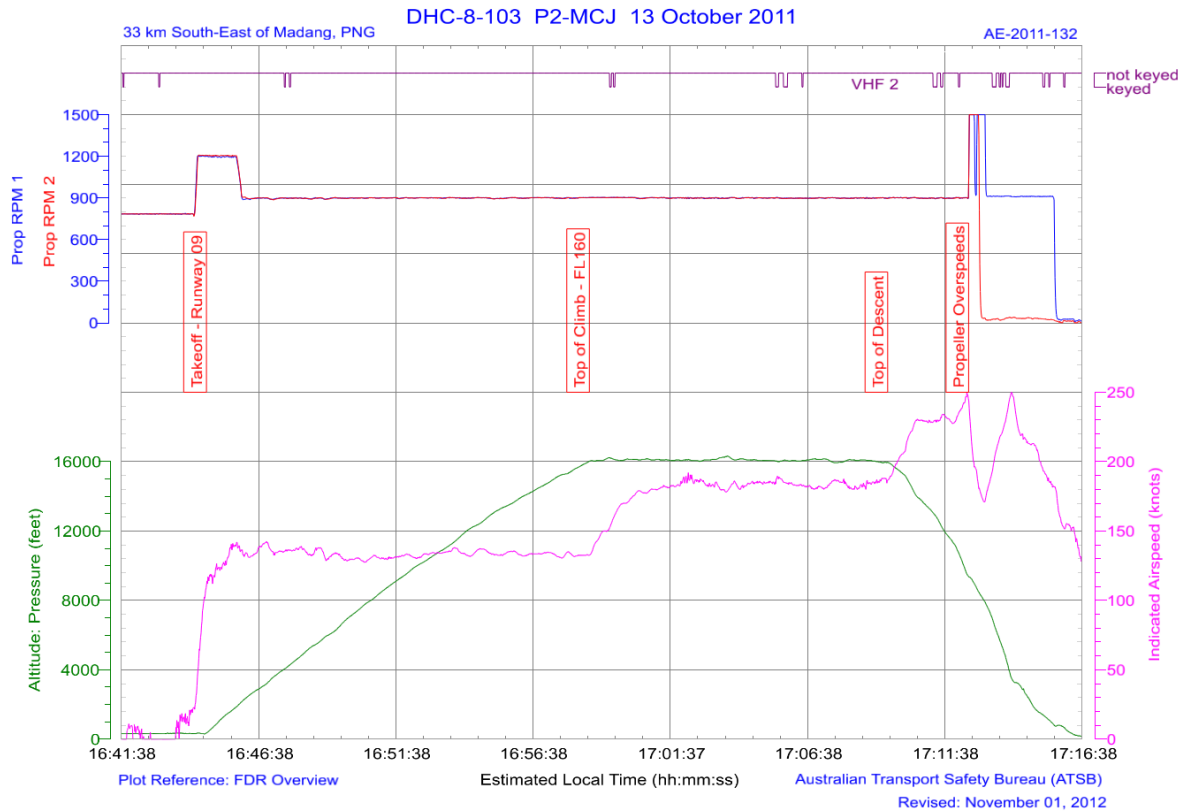
Figure 12: Overview of FDR data

Neither the FDR data nor the CVR audio was time-stamped with UTC⁸ or local time. No time-stamped ATC recordings were available to correlate with the FDR microphone keying parameter. An approximate correlation with local time was obtained through the ATC time check calls that were recorded on the CVR. Five such calls were made; in four cases the time given was in units of a minute and for one call the time was given as 56 ½. As a consequence, the tolerance of the estimated local time is ± 30 seconds. Figure 12 gives an overview of FDR data from the flight correlated with local time.

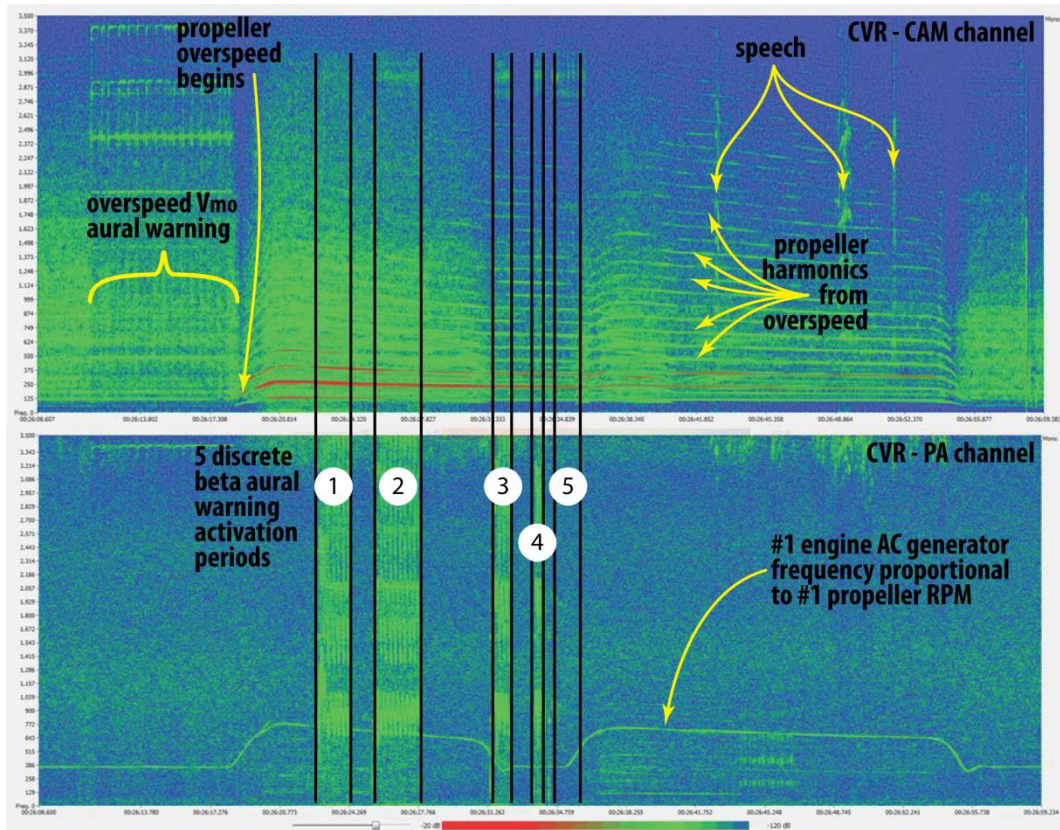
Figure 13: CVR plot showing beta warning horn activation

The CVR recording revealed that the beta warning horn sounded intermittently after the propellers started to overspeed. A plot of the CVR recording illustrates the points at which the beta warning horn sounded (Figure 13). The warning horn was barely discernible above the very loud noise made by the propeller blades and may not have been audible to the flight crew during the propeller overspeed event.

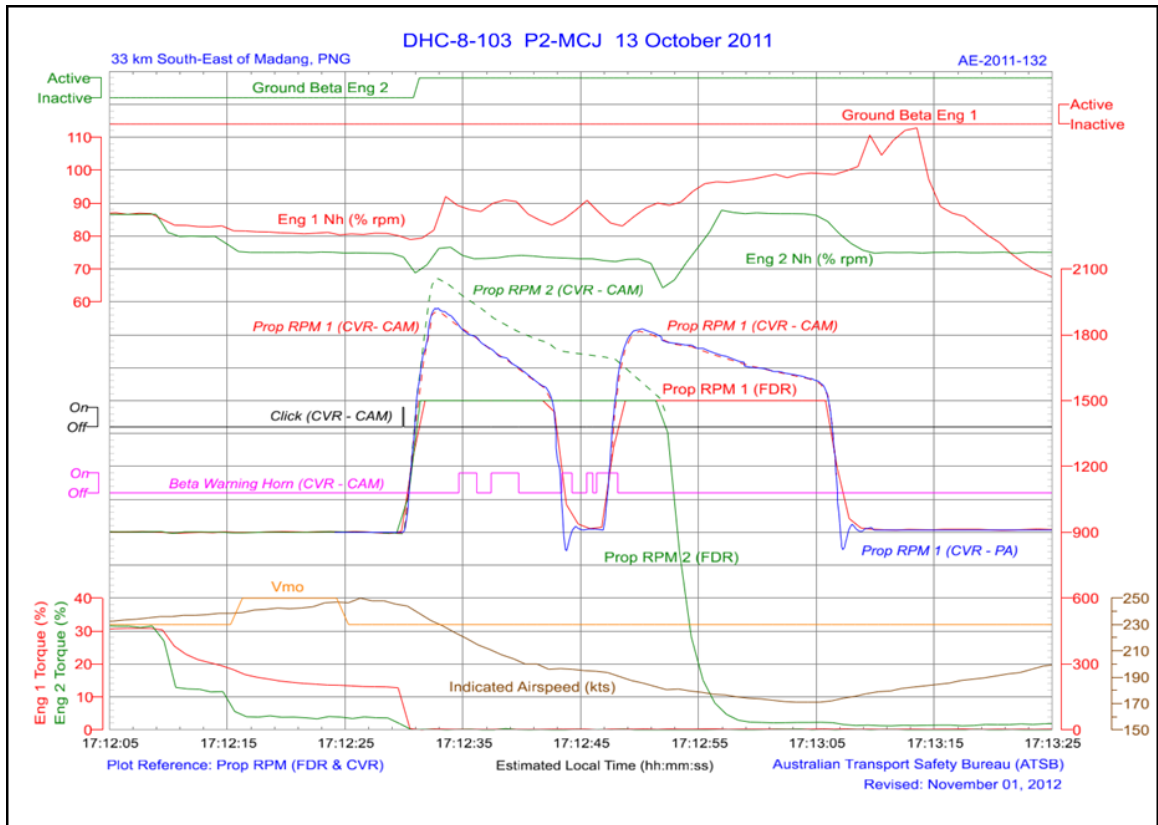
Figure 14: FDR readout of the occurrence with CVR overlay for propeller speed¹¹

The plot in Figure 13 is a 60-second extract of FDR data that starts about 10 seconds before the propeller overspeeds began. The FDR had a 1,500 RPM upper recording limit for propeller speed so the FDR data was combined with information from the CVR; propeller speed above 1,500 RPM, beta warning horn operation, and an audible click were overlaid on the plot.

The high-speed compressor and turbine speeds (N_H) of both engines dipped slightly at the initiation of the propeller overspeed. This was caused by the activation of the pneumatic section of the overspeed governors which reduced fuel flow to the engines when propeller speed (N_P) was greater than 1,309 RPM. It confirmed that the overspeed governor pneumatic sections had operated as designed.

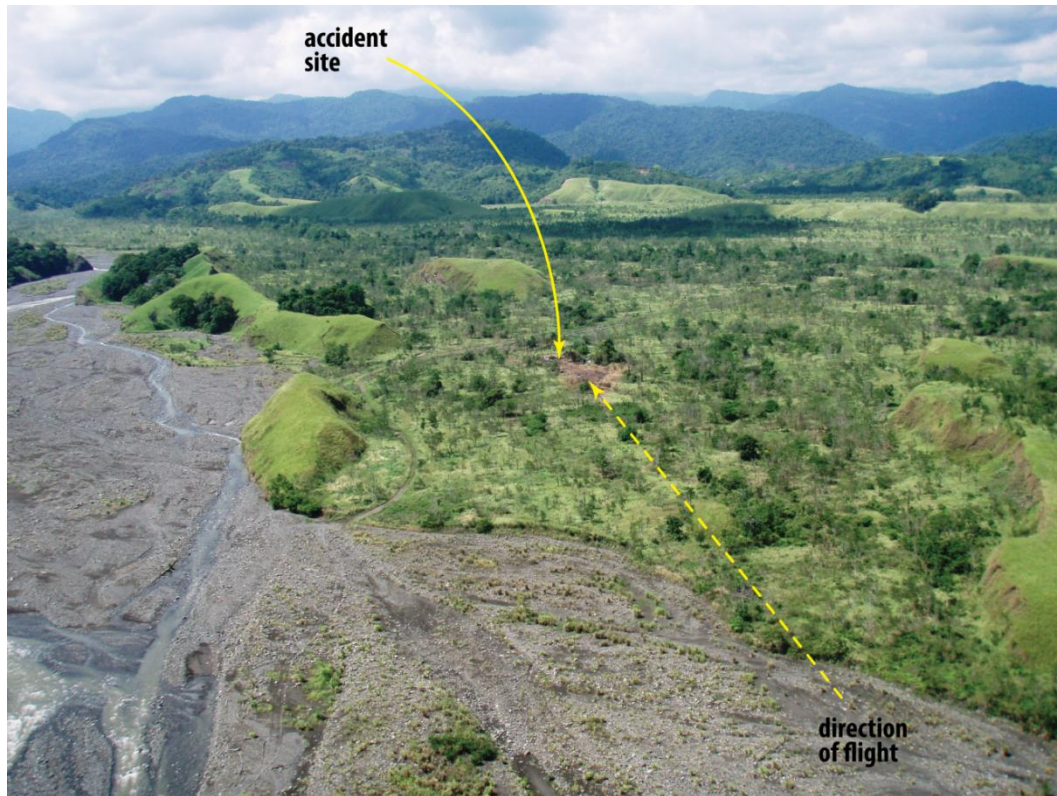
Figure 15: Overview of the area surrounding the accident site

The accident site was 35 km south south east of Madang. The aircraft impacted sparsely wooded flat and rocky terrain, adjacent to and parallel to the Guabe River. The photograph in Figure 15 was taken looking in the approximate direction of flight, with the accident site highlighted in the middle of the image.

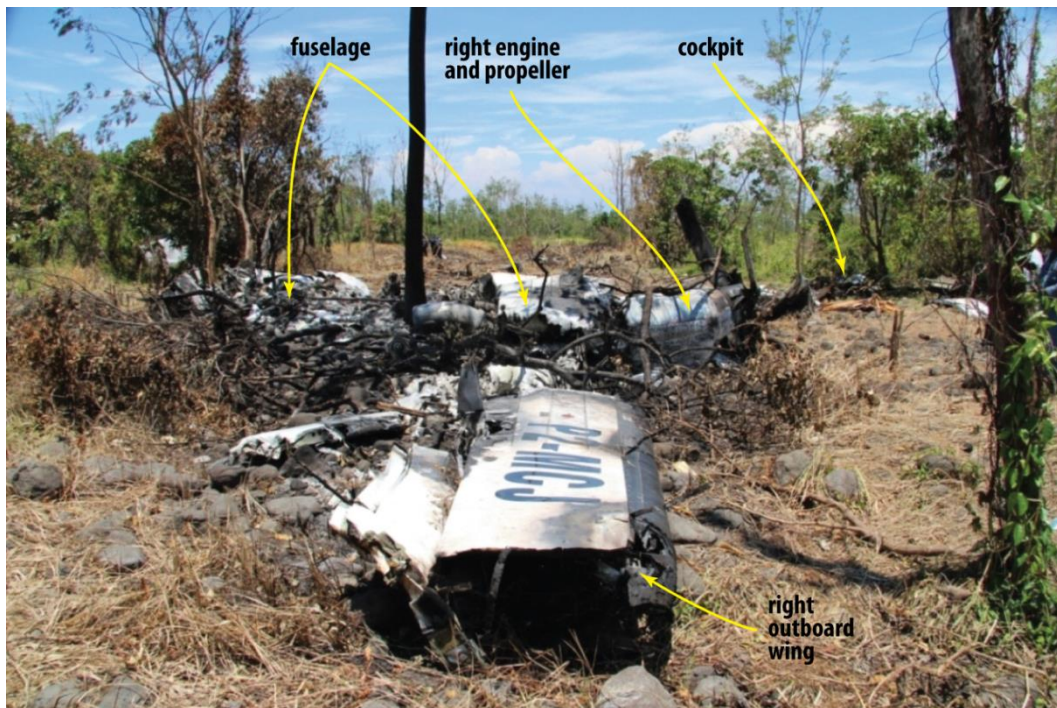
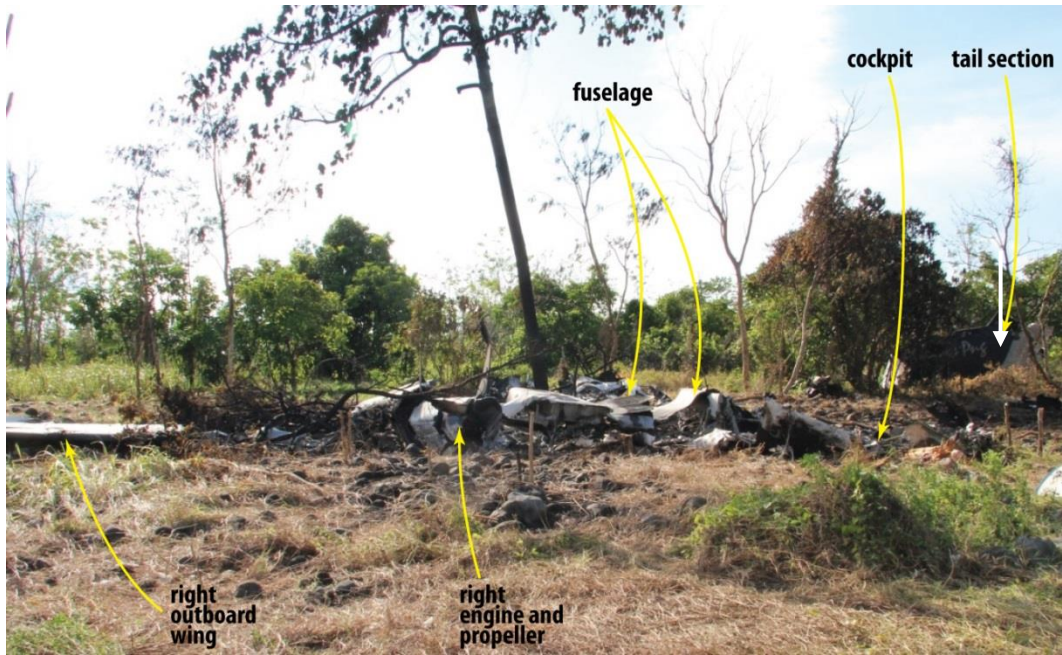
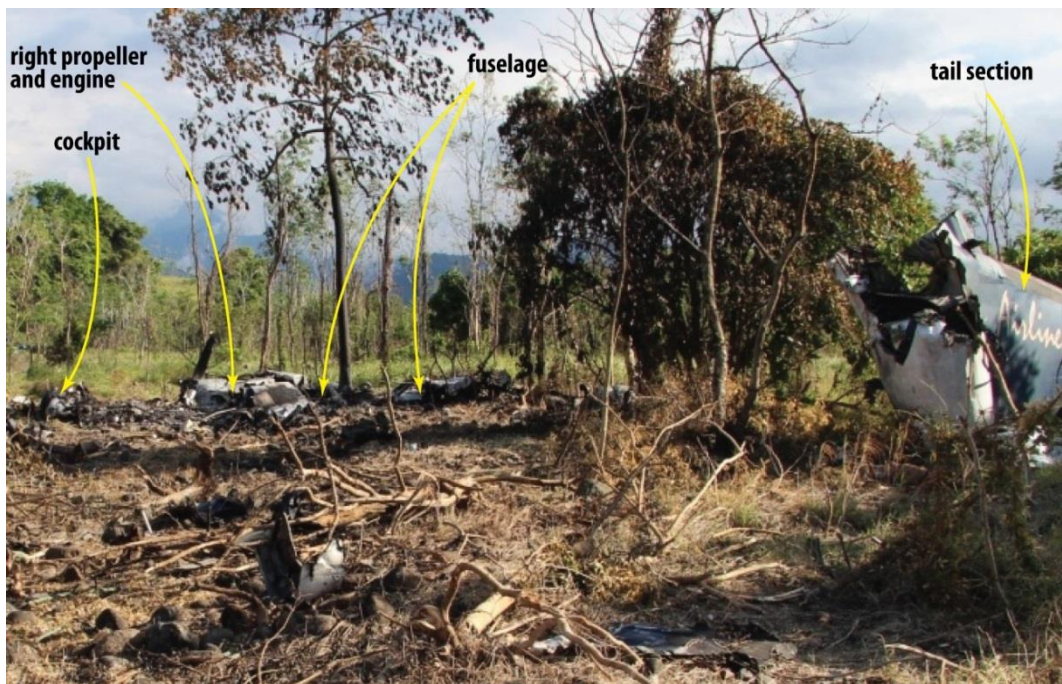
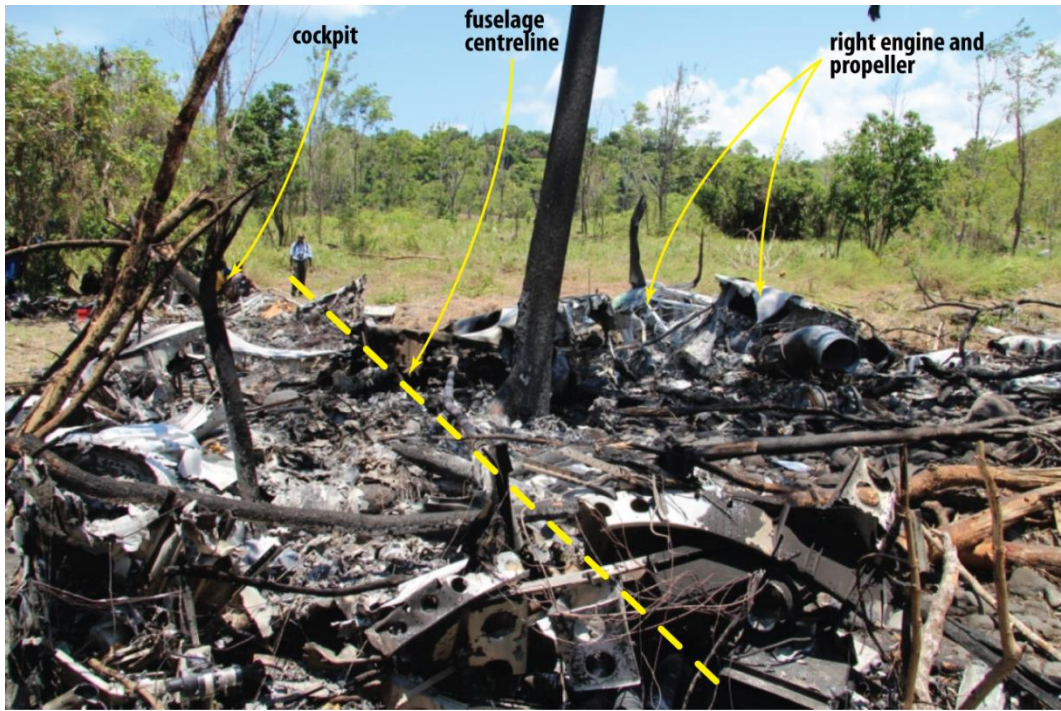
On-site examination of the wreckage revealed the aircraft had been configured with the flaps and landing gear fully retracted. The left engine had separated from the left wing and had broken into two sections (Figure 4). The left propeller hub was still

The right engine was still attached to the right wing. It was severely damaged by fire. The reduction gearbox outer case had completely disintegrated and the right propeller blades were in the fully feathered position (Figures 18 and 33).

Figures 17, 18, 19, and 20 show the wreckage from the sides, front, and rear of the aircraft.

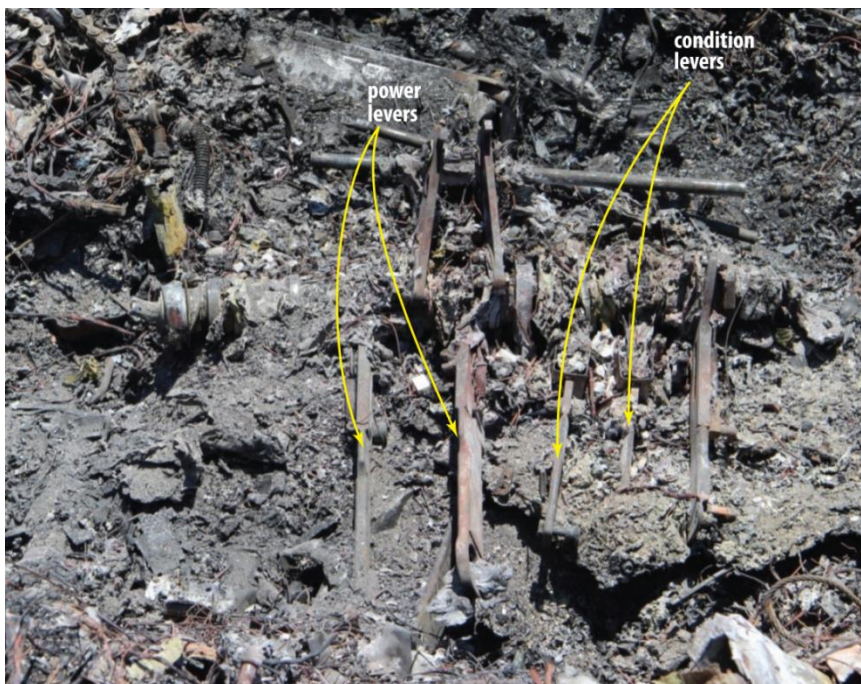
Figure 27: Power lever quadrant components as found on-site

The power lever quadrant and its remaining components were identified in the burnt remains of the cockpit section. Power lever and condition lever settings could not be ascertained due to the significant disruption of the cockpit.

The power lever quadrant components (Figure 27) were removed from the accident site so that a detailed examination could be conducted. For further details of that examination refer to *Tests and research*.

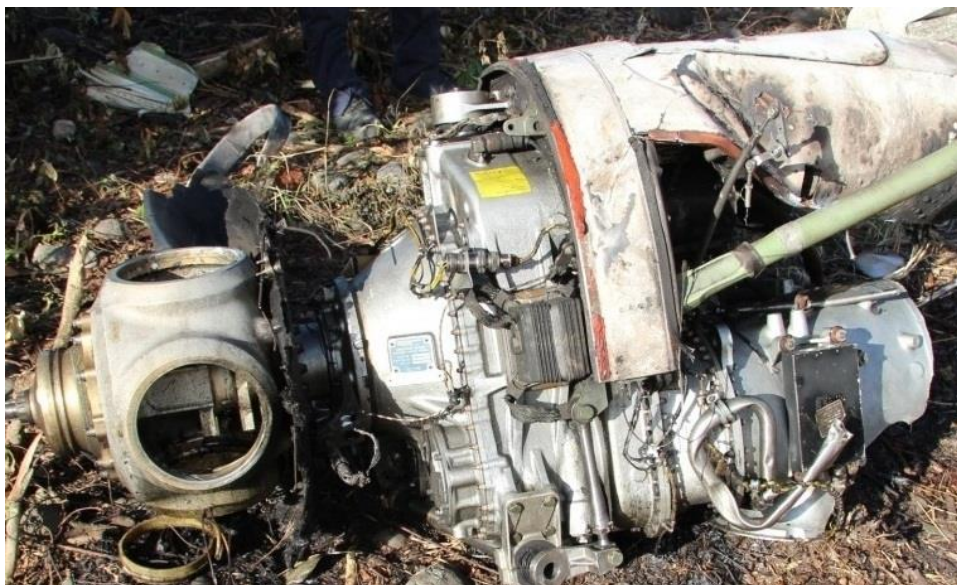
Figure 28: Left engine reduction gear box section

The left engine had separated from the left wing and had broken into two sections, the reduction gear box section and the turbo-machinery section. Both engine sections came to rest outside the fire zone of the main aircraft wreckage. The reduction gear box was still attached to part of the nacelle and its engine mount points.

The reduction gear box section contained the propeller hub, one propeller blade, the propeller transfer tube, the propeller control unit (PCU) assembly, and the overspeed governor and pump. The hydro-mechanical unit (HMU) controls to the PCU were present in the reduction gearbox section, still attached to the PCU. No pre-impact anomalies were identified within the reduction gear box section or its components during the onsite inspection (Figure 28).

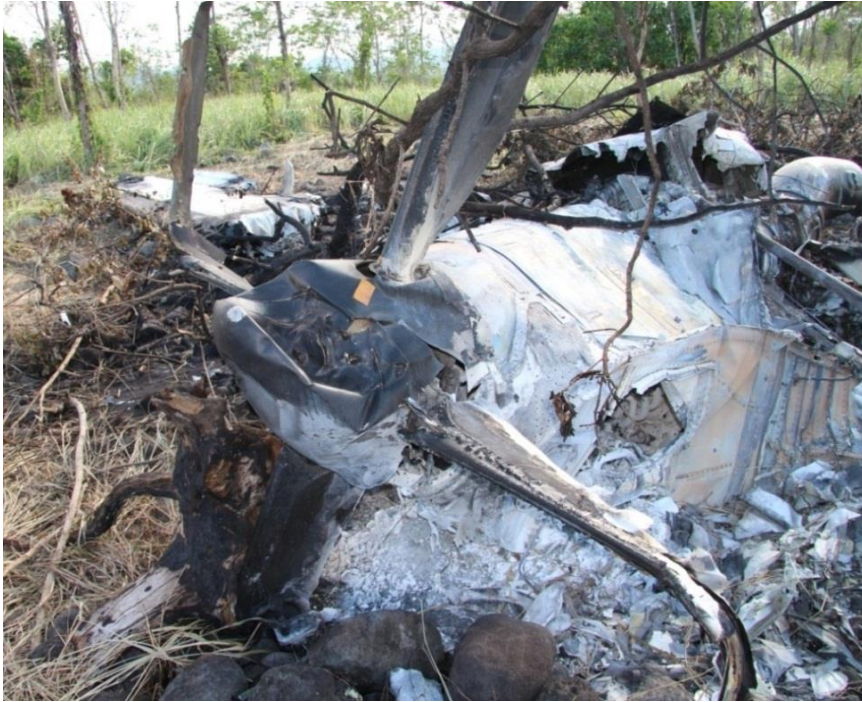
Figure 33: Right engine and propeller assembly

The right engine was still attached to the right wing. It had sustained considerable thermal damage in the post-impact fire (Figure 33).

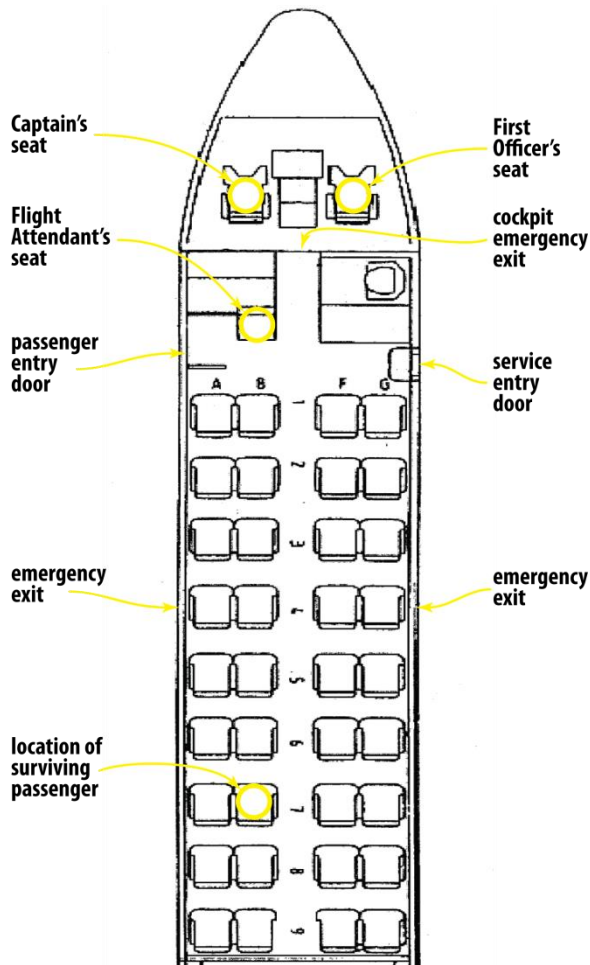
Figure 38: Aircraft configuration and survivors' seating positions

The aircraft was configured with 36 passenger seats. Exits were located at the passenger entry door just forward of row 1 on the left, a service entry door just forward of row 1 on the right, two emergency exits (left and right) at row 4, and an exit was provided in the roof of the cockpit for use by the pilots in the event of an emergency. Of the 32 people on board, the Pilot-in-Command, First Officer, Flight Attendant, and one passenger located in row 7B were the only survivors (Figure 38).

The significant post-impact fire damage to the aircraft precluded a detailed examination of the fuselage for liveable volume. However, the burnt outline of the aircraft that remained after the fire indicated that the fuselage had been more-or-less intact before the fire. That meant the fuselage may have provided adequate liveable volume for the occupants and this is consistent with the survival of the passenger in row 7.

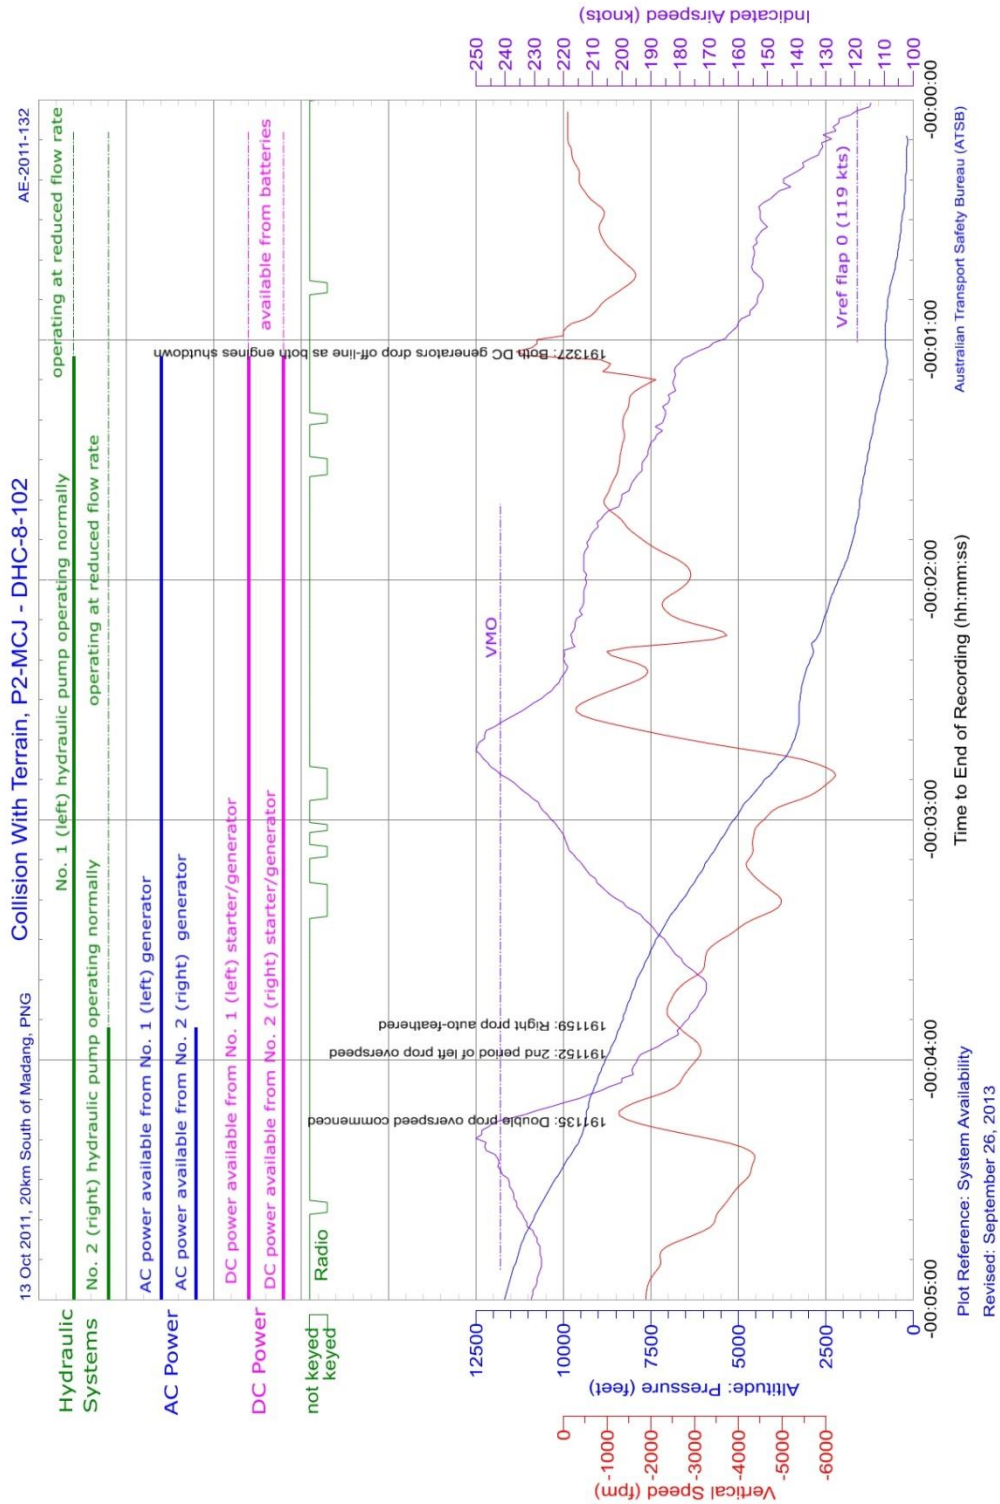
Figure 49: Rate of descent and availability of systems following the overspeed event¹⁴

The operator's DHC-8 standard operating procedures (SOPs) (see Appendix 5.3) stated that the aircraft should be descended at 2,000 ft per minute on a 2x descent profile. In the 30 seconds before the V_{MO} overspeed warning sounded, MCJ's rate of descent was increasing from approximately 2,200 to approximately 4,200 ft per minute (Figure 49).

The aircraft descended with the left propeller windmilling. The rate of descent increased erratically from about 1,500 ft per minute passing 10,090 ft when the overspeeds occurred, to over 6,000 ft per minute as the aircraft passed through 4,880 ft AMSL (Figure 49). The rate of descent subsequently decreased until impact. The Pilot-in-Command stated that prior to the propeller overspeeds he had been attempting to descend below a layer of cloud in order to remain visual, and he thought that he had persisted with this mental objective after the overspeeds occurred. He said that he had had 'control problems' after the overspeeds occurred. This would in part have been because of the windmilling left propeller. In addition, although the aircraft was certified for operation with the yaw damper inoperative, and is fully controllable with the rudder control unmodified by input from the yaw damper, the lack of the yaw damper would have made the rudder more sensitive to control inputs, leading to a tendency to over-control the rudder.

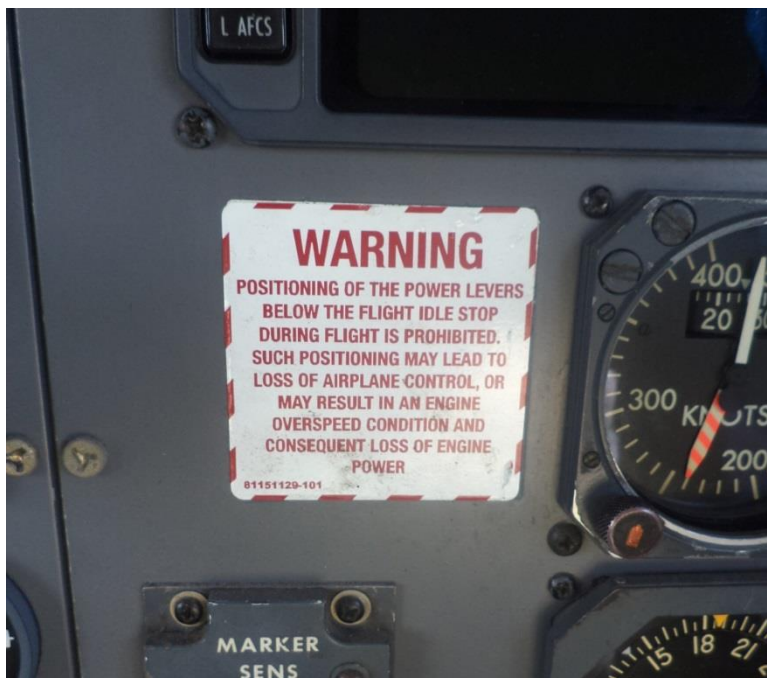
Cockpit placard installed in the operator’s DHC-8 aircraft

“Warning | positioning the power levers below the flight idle stop during flight is prohibited. Such positioning may lead to loss of airplane control, or may result in an engine overspeed condition and consequent loss of engine power.”

On 24 October 2011 the operator ordered Service Bulletin (SB) kits (SB8-76-24) for all its DHC-8 aircraft. However, the requirement by CASA PNG for the beta lockout mechanism to be fitted within 120 days of 5 November 2011 could not be met due to supply constraints from the sole supplier of the N_P indicators needed for the modification. All operators of DHC-8 aircraft in PNG were forced to apply to CASA PNG for an extension to the AD compliance date. This was granted, with a requirement for the operators to inform CASA PNG of the SB kit delivery dates and the installation schedule. The operator of MCJ had installed the SB-8-76-24 kit on all its DHC-8 aircraft by 7 November 2012.
