FINAL REPORT

AIC 15-2029

Bell Helicopters B407

In-flight External Load Jettison

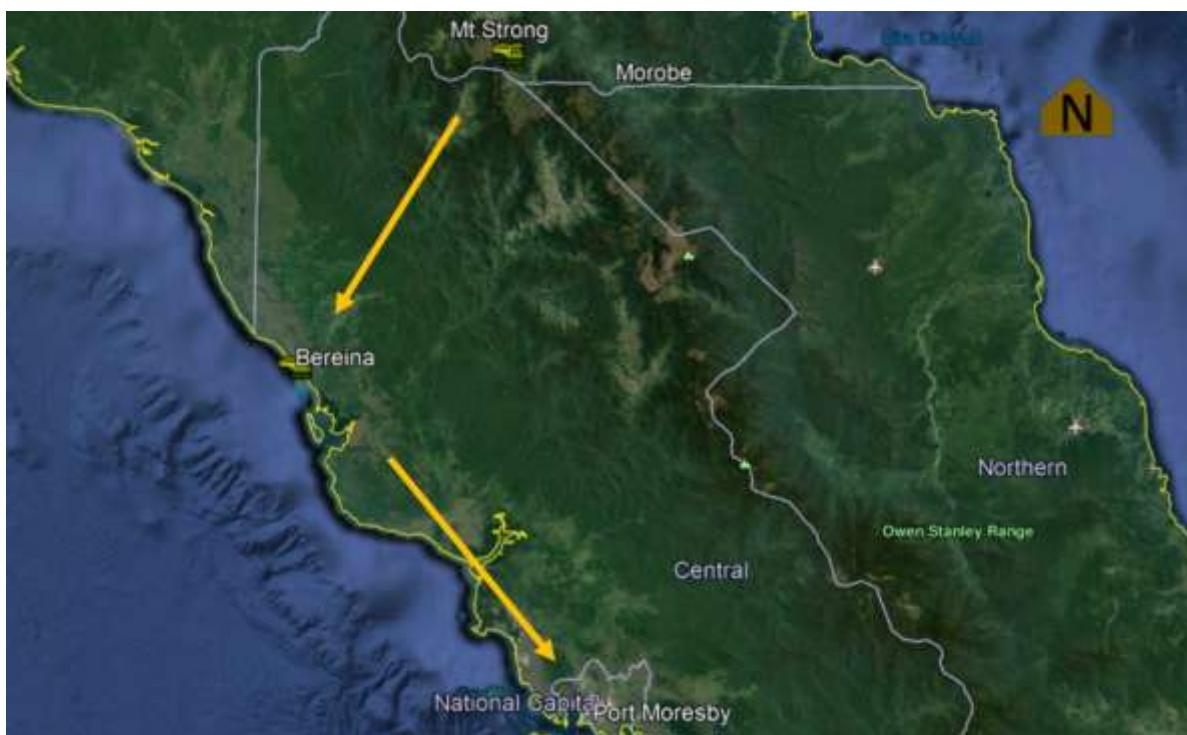
Figure 1: P2-HSL flight after occurrence

The pilot stated that he landed the helicopter safely at Mt. Strong and performed a visual external check of the helicopter with the engine running and rotors turning. After securing the external load equipment, the pilot flew the helicopter to Bereina and refuelled it with the engine running and rotors turning. The pilot picked up one of the loadmasters and positioned the helicopter from Bereina to the operator's maintenance facility at Jacksons Airport, Port Moresby (See figure 1). Following engine shut down, the Ng exceedance was confirmed by engineering personnel. The engine was removed and sent to a Rolls-Royce approved overhaul facility for inspection and repair as appropriate.

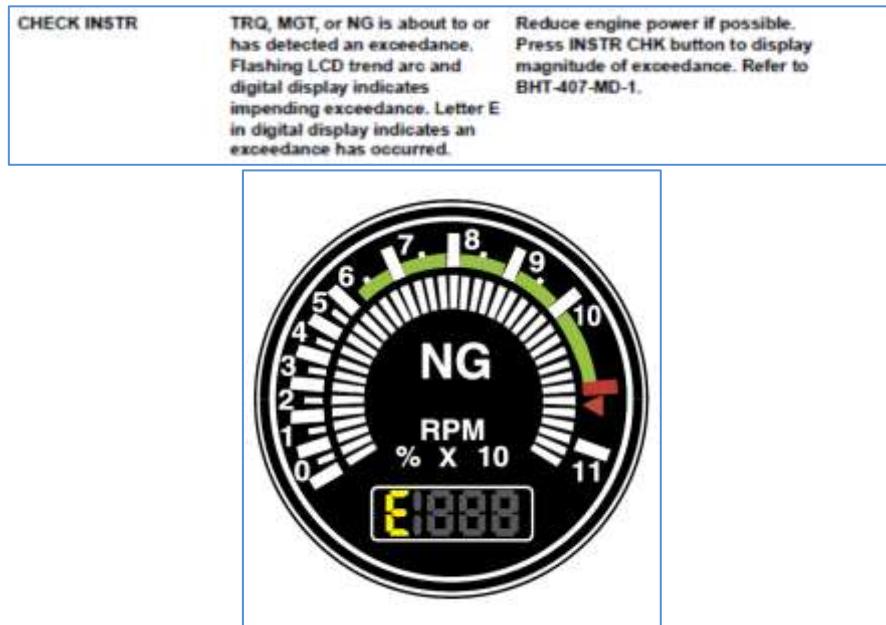
Figure 2: Extracts from flight manual in relation to Ng exceedance

An ‘E’ light on the cockpit instrument (See figure 2) indicates that the helicopter’s Ng sensor has detected an exceedance of its parameter requiring the pilot to reduce engine power and press the *INSTR CHK* button. Pressing that button displays the magnitude of the exceedance.
