## INTERIM FACTUAL REPORT

AIC 19 -1002

Air Tractor AT-502B

Impact with tree

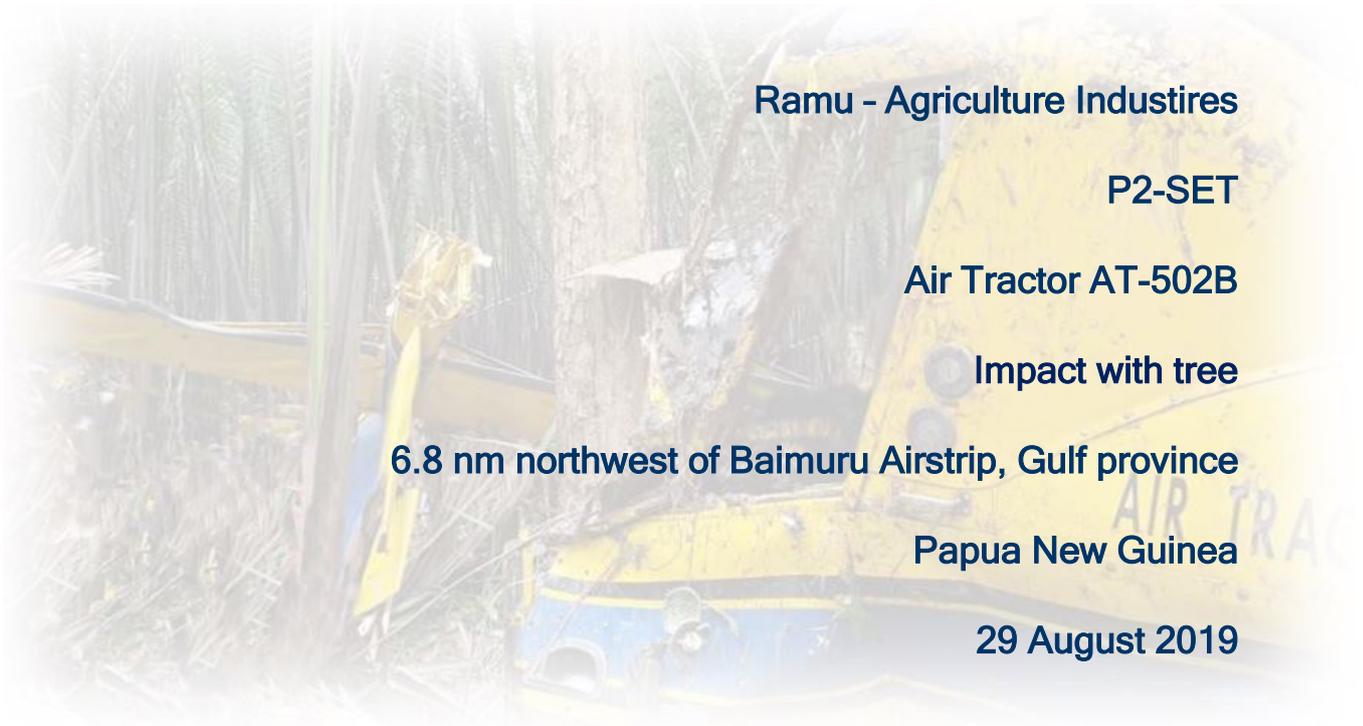
The investigation team found that the outboard section of the aircraft’s right wing was torn off as the wing clipped palm trees. The aircraft continued for another 1.3 nm before it impacted a thick tree trunk about 13 metres above ground level. The forward fuselage and engine section separated from the airframe at the bulkhead between the cockpit and the hopper. The forward fuselage including the hopper, main landing gear, engine and propeller continued another 290 metres along the direction of the flight path before becoming deeply embedded in mud. (See figure 1).
