FINAL REPORT

AIC 19 - 1002

Air Tractor 502B

Controlled Flight into terrain

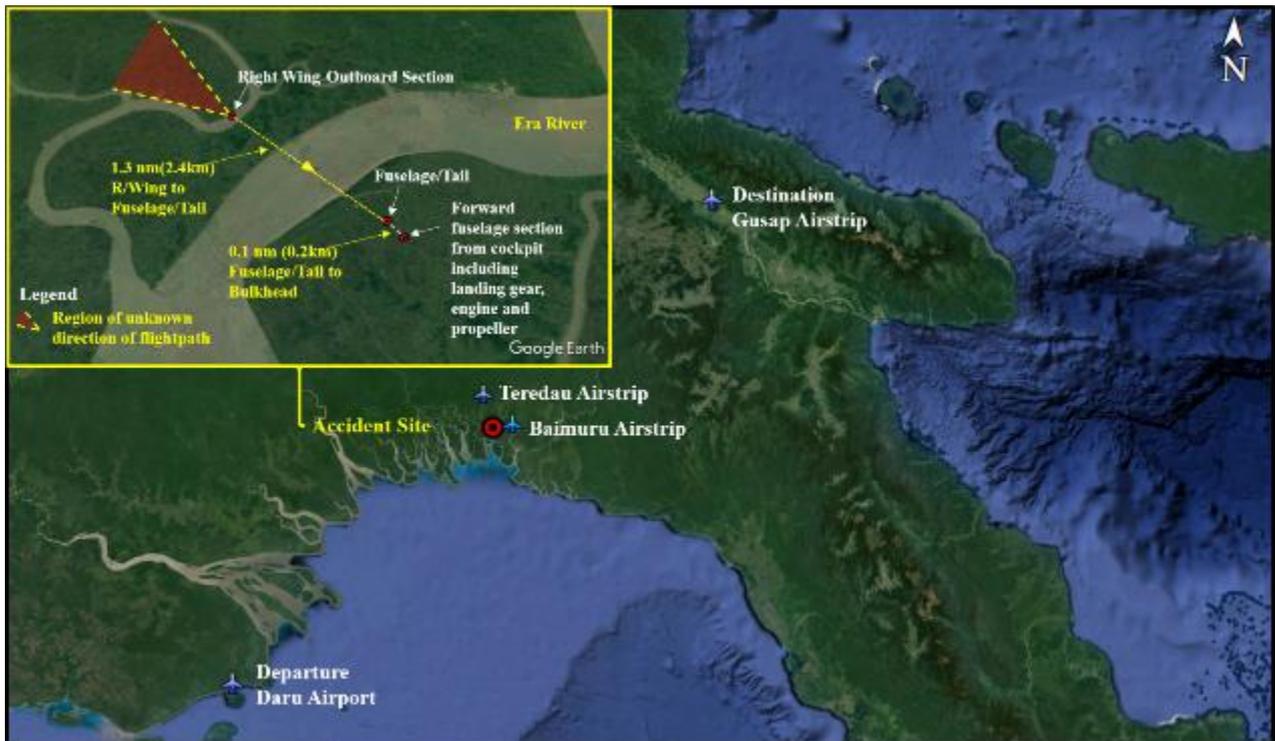
Figure 2: Depiction of accident location in relation to Baimuru Airstrip

The investigation team found that the aircraft initially clipped a protruding palm tree, separating the outboard section of the right wing. The aircraft continued for another 1.3 nm before it impacted a tall thick tree 43 feet AGL. The forward fuselage and engine section separated from the airframe at the bulkhead between the cockpit and the hopper. The forward fuselage including the hopper, main landing gear, engine and propeller continued another 290 metres along the direction of the flight path before becoming deeply embedded in mud.

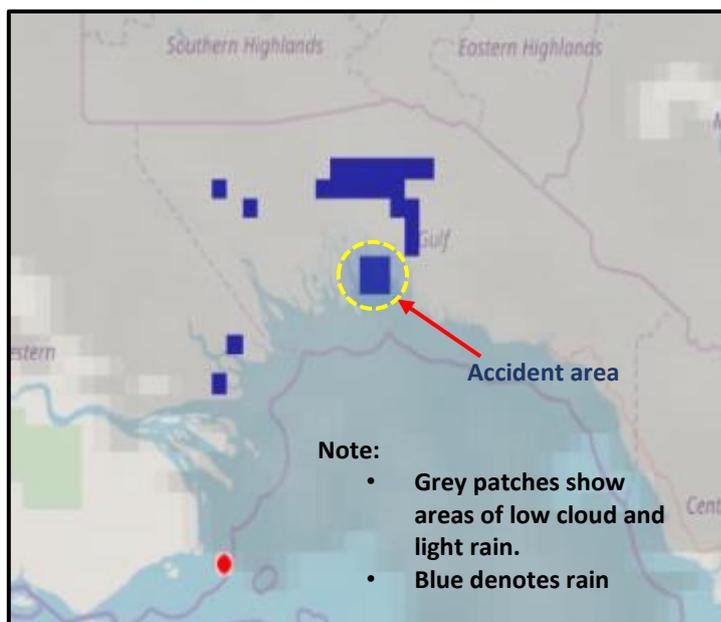
Figure 5: Weather in the area of accident on the day of the accident (Source: NWS)

According to the NWS, the dark blue shadings shown in Figure 5 indicate rainfall of at least 0.1-0.5 mm/hr. On 30 August, investigators arrived at the accident site and reported observing showers and drizzle with overcast clouds lasting for several hours. The visibility was very poor.

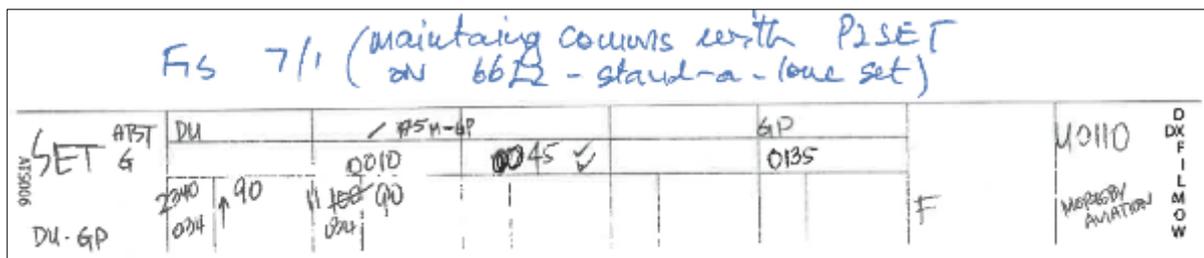
Figure 9: PNG ASL Flight Strip for Sector 1&7 with actual recorded information showing the progress of flight on P2-SET

According to the FIS flight progress strip (see Figure 9), at 09:40, while on climb to 9,000 ft, out of Daru, the pilot made his departure call from within the sector 2 airspace. Although the Moresby FIS sector 2 operator was responsible for P2-SET at that time, the call was picked up by the FIS operator who was responsible for the combined sectors 1&7. The FIS sector 1&7 operator coordinated all departure flight details to the responsible sector, the FIS sector 2 operator.

All air ground communications that FIS were operating on were recorded on four stand-alone radio sets. These HF radio antennas are located outside the Port Moresby control tower building. However, the investigation found that the communications were intermittent and filled with static interference.

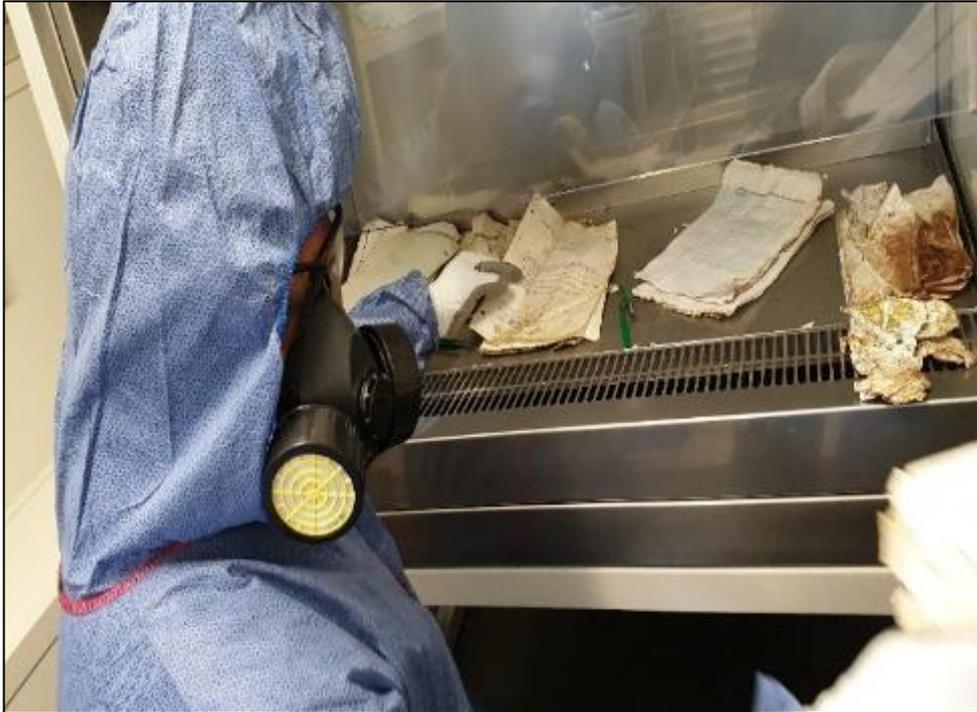
Figure 21: Lab technician placing the evidence in the Biohazard safety cabinet for processing

Evidence gathered at the accident site were contaminated (see Figure 21). They were transported to the PNG AIC Engineering Workshop and processed in the Biohazard Safety Cabinet.

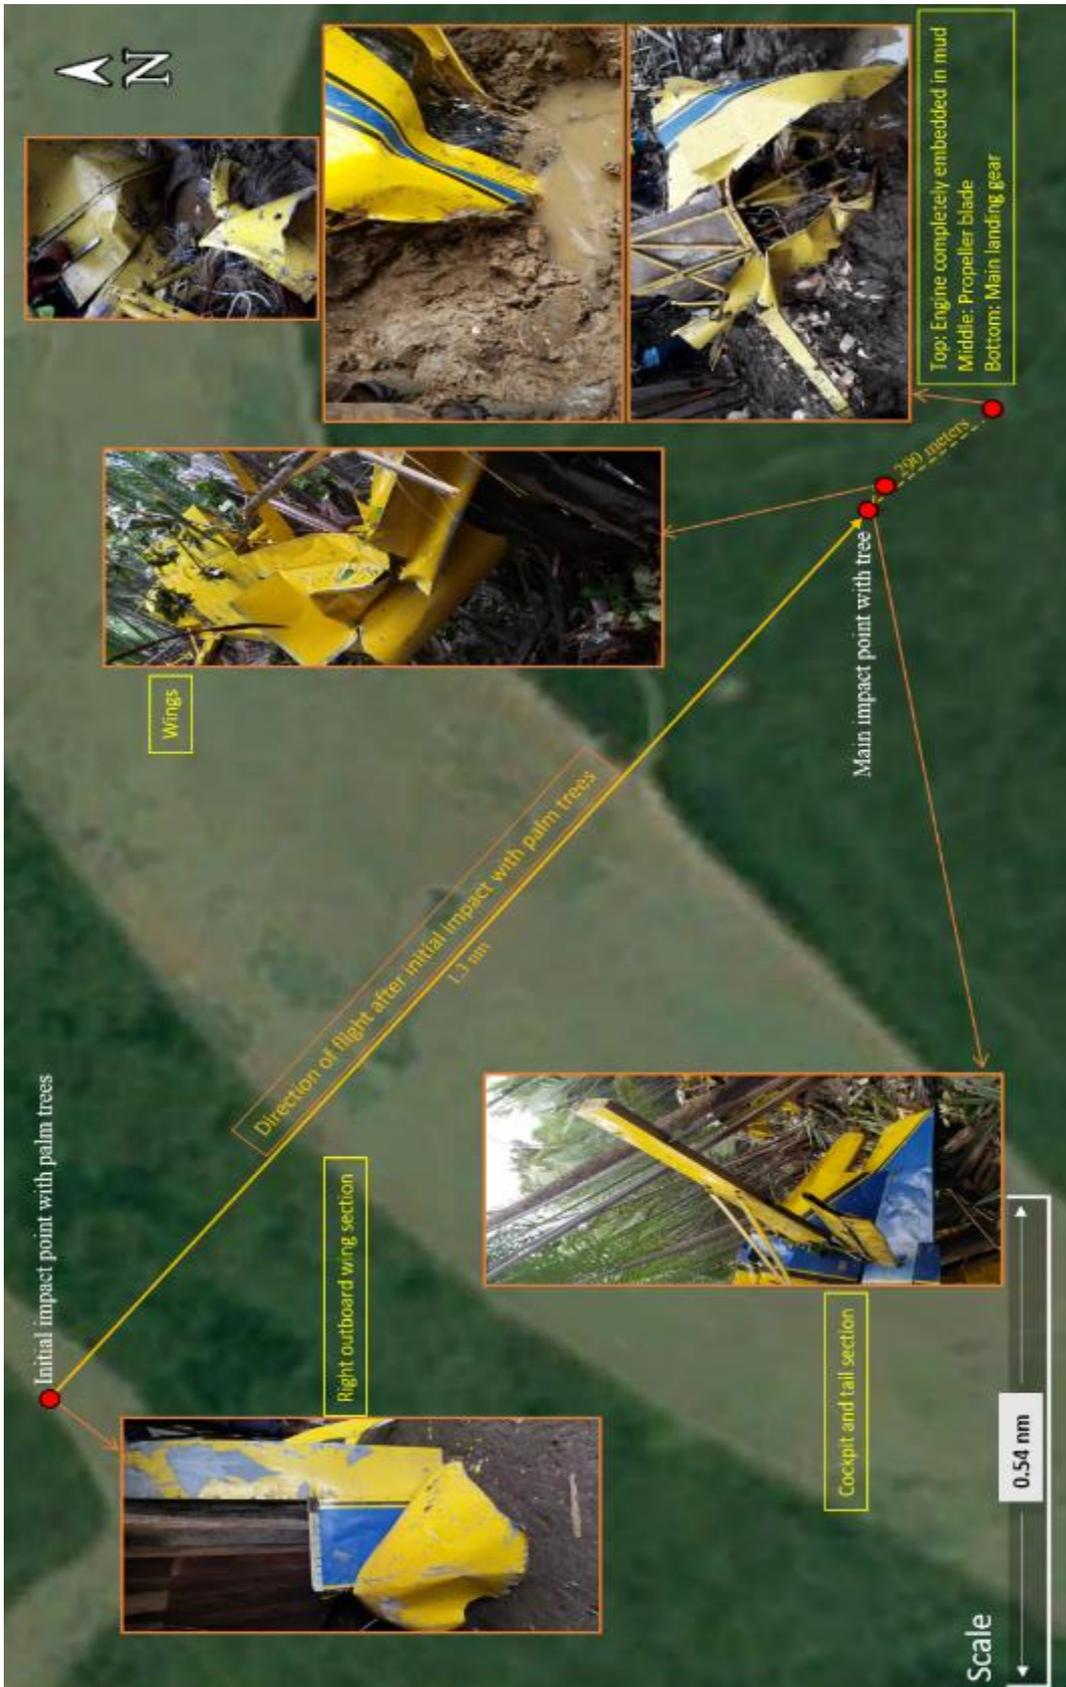
5.1 Appendix B: Wreckage diagram

The general spread of wreckage indicated that the aircraft had been tracking to the south-east prior to final impact. Aircraft components were found within a 1.3 nm radius from the main impact point (see Section 1.1 and Figure 5).
