FINAL REPORT

AIC 19 - 1001

Bell 427

Helicopter impact with water

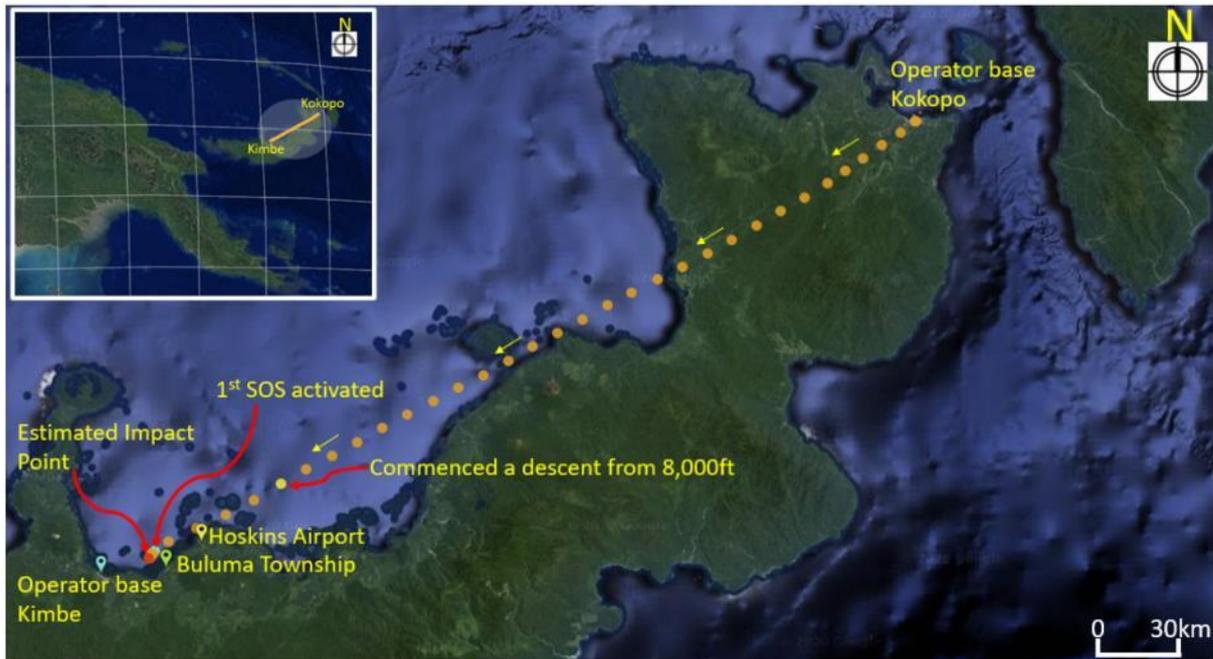
Figure 1: Depiction of P2-HSG flight path and accident location in relation to Buluma township

The tide was low at that time. The helicopter tracked on water before it arrived at a reef 3.1 nm North West of Buluma Township (*see Figure 1*). In accordance with the salvage report, the reef was less than a meter deep. As the pilot tried to lift the helicopter onto the reef, it spun out of control and impacted the reef then came to rest on its left side. The time of impact was confirmed to be at 11:25.

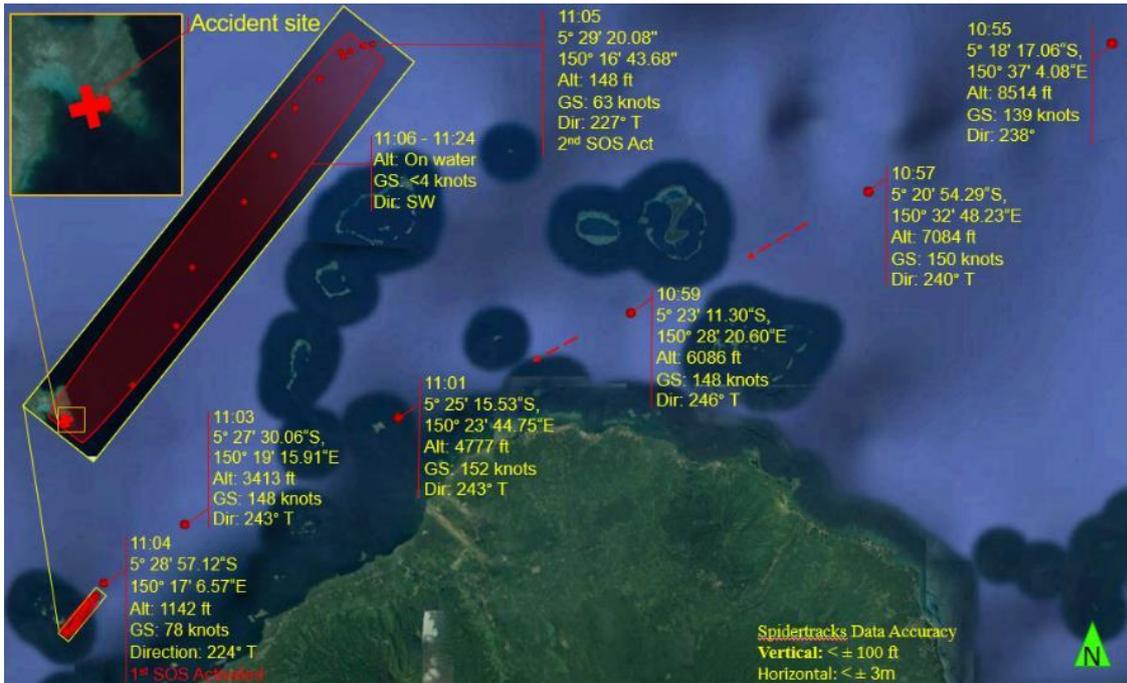
According to the Spidertracks recorded data, at 11:05, the helicopter was at 148 ft and had a groundspeed of 63 kts. The next point registered a minute later showed that the aircraft was at 40 ft. All data points recorded from 11:06 onwards, over about 20 minutes until the accident, read altitudes ranging between 37 – 46 ft, while the groundspeed remained under 5 kts (*see Figure 2*). The investigation determined that the altitude recordings were in error and that the helicopter was already in the water by 11:06 (*see Figure 3*).

Figure 2: P2-HSG recorded data points for the descent and emergency SOURCE: SPIDERTRACKS

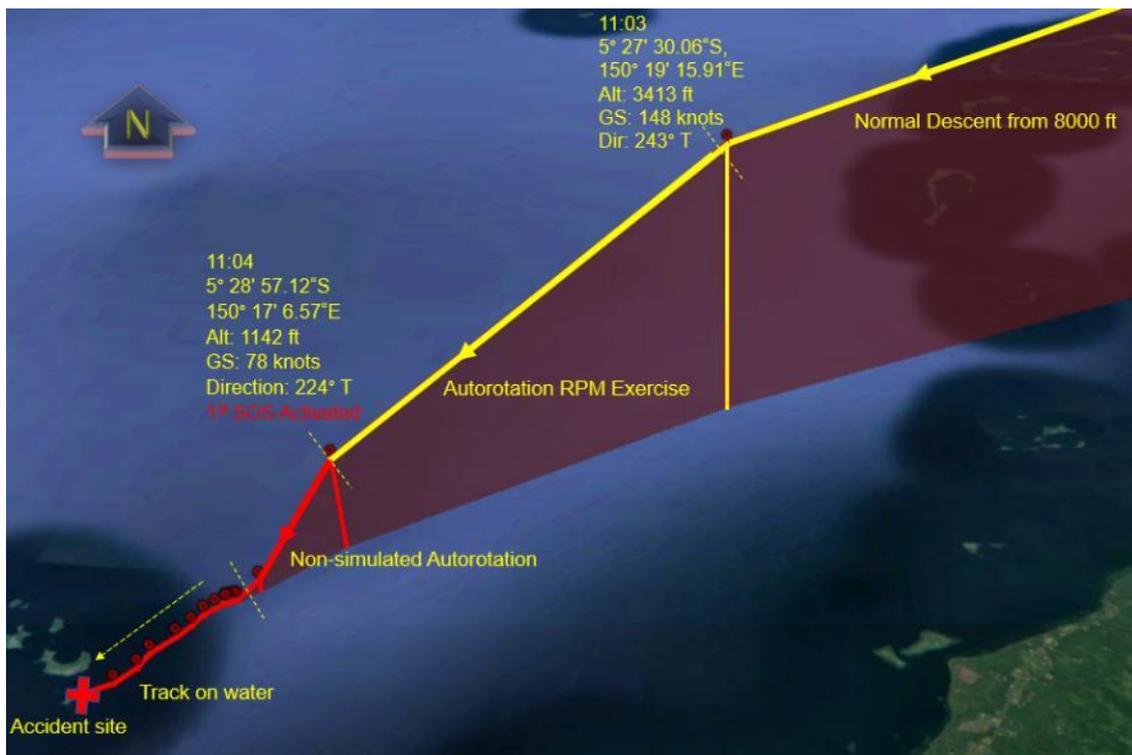
Figure 3: Depiction of the descent and emergency using P2-HSG recorded data SOURCE: SPIDERTRACKS

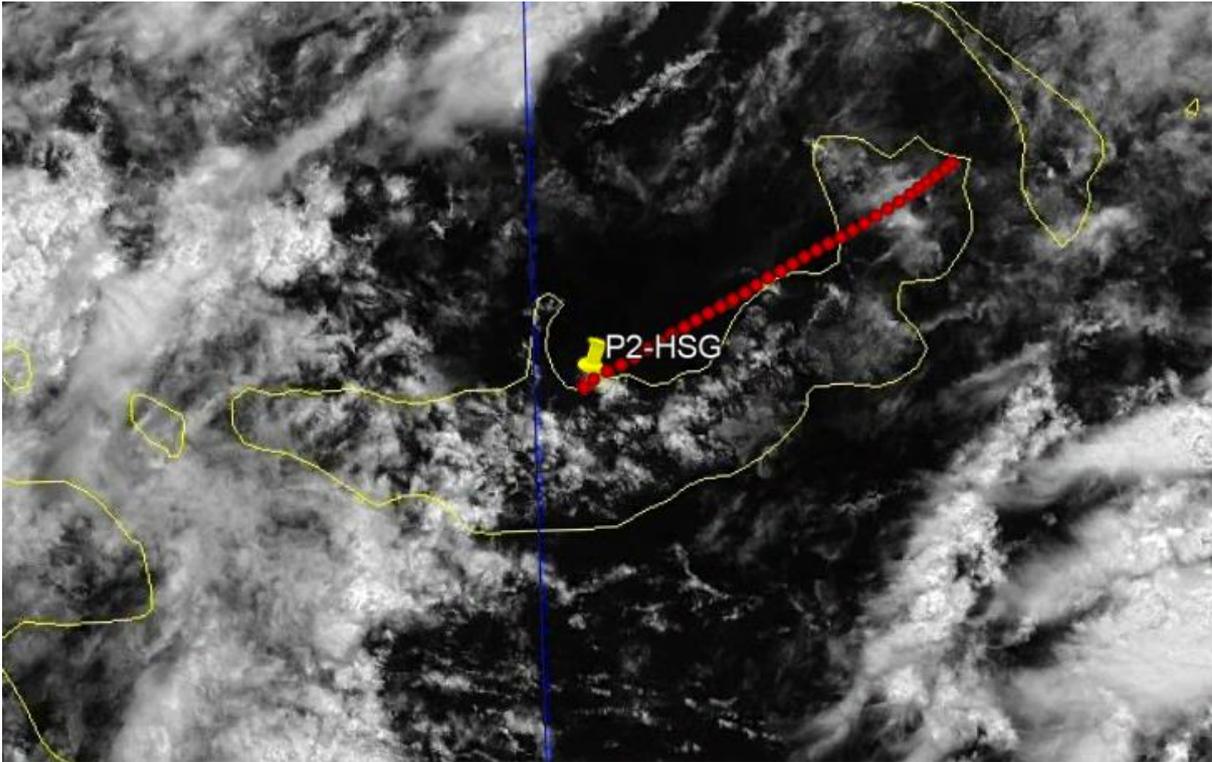
The satellite image provided by PNG National Weather Service indicated that there were scattered clouds towards the South East (SE), left of the helicopter's track. From the prominence of the clouds in the satellite image, it is identified that there was good visibility off the coast of mid New Britain's northern side along the helicopter's flight path. There was reduced visibility inland New Britain as there is evident topography weather of cloud build up along the mountain ranges.

Figure 4: Satellite image of weather around New Britain area at 11:20 on 11 August 2019 SOURCE: JAXA
GLOBAL WEATHER WATCH

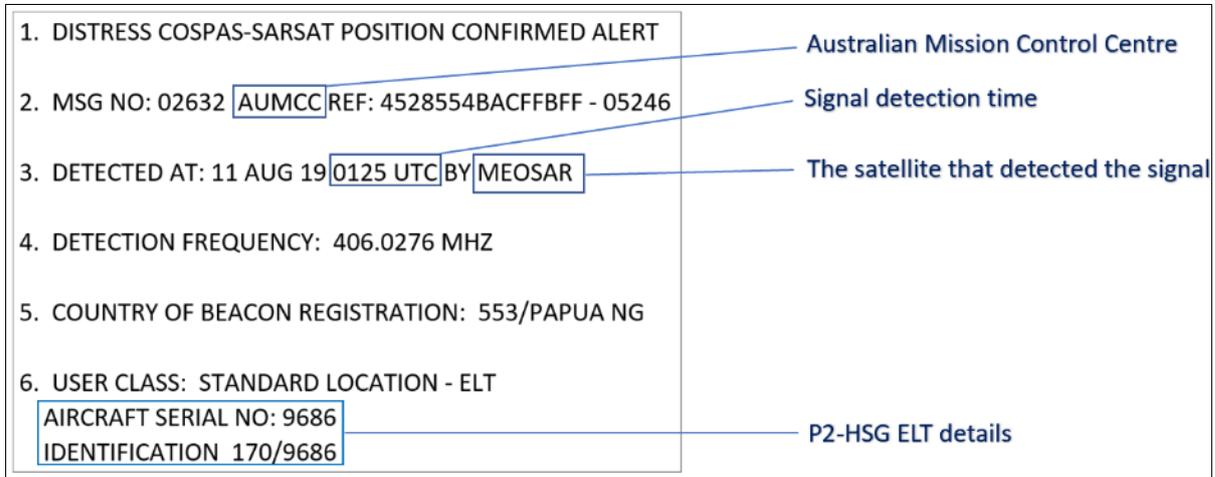
The PNG ASL Chronology of Search and Rescue (SAR) events (*refer to Appendix D, 5.4.2*), indicated that the ELT Distress COSPAS-SARSAT message was received at ATS at 11:26. The message no: 02632, transmitted through the Australian Mission Control Centre (AUMCC) via Aeronautical Fixed Telecommunication Network (AFTN), indicated that P2-HSG’s ELT beacon signal was detected at 11:25 (01:25 UTC), on frequency 406.0276 MHz.

Figure 12: Extract of P2-HSG ELT activation COSPAS-SARSAT message

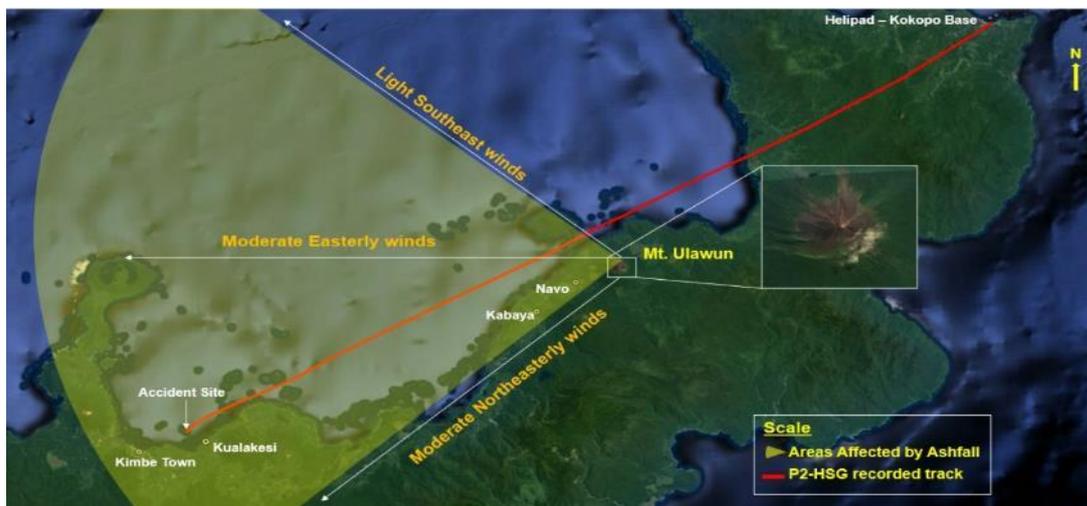
On 26 June 2019, Mt. Ulawun, a volcano located about 77 nm North West of Kimbe, erupted emitting plumes up to about 15,000 ft. This disrupted operations in the North Western region of West New Britain. The volcano erupted again on 3 August 2019. Significant amounts of ash were carried by Easterly and South Easterly winds during that time. The ash began to settle and within a week, general aviation operations were resumed.

Figure 17: Depiction of areas affected by Mt. Ulawun's eruptions subject to wind movement

The investigators borescope¹⁵ inspection of both engines revealed no sign of ash contamination. However, the accident site was under water. The helicopter remained under water for more than 24 hours. As a result, the investigation could not determine whether there had been any ash ingestion.
