Preliminary Report

AIC 24-1001

North Coast Aviation

Runway excursion

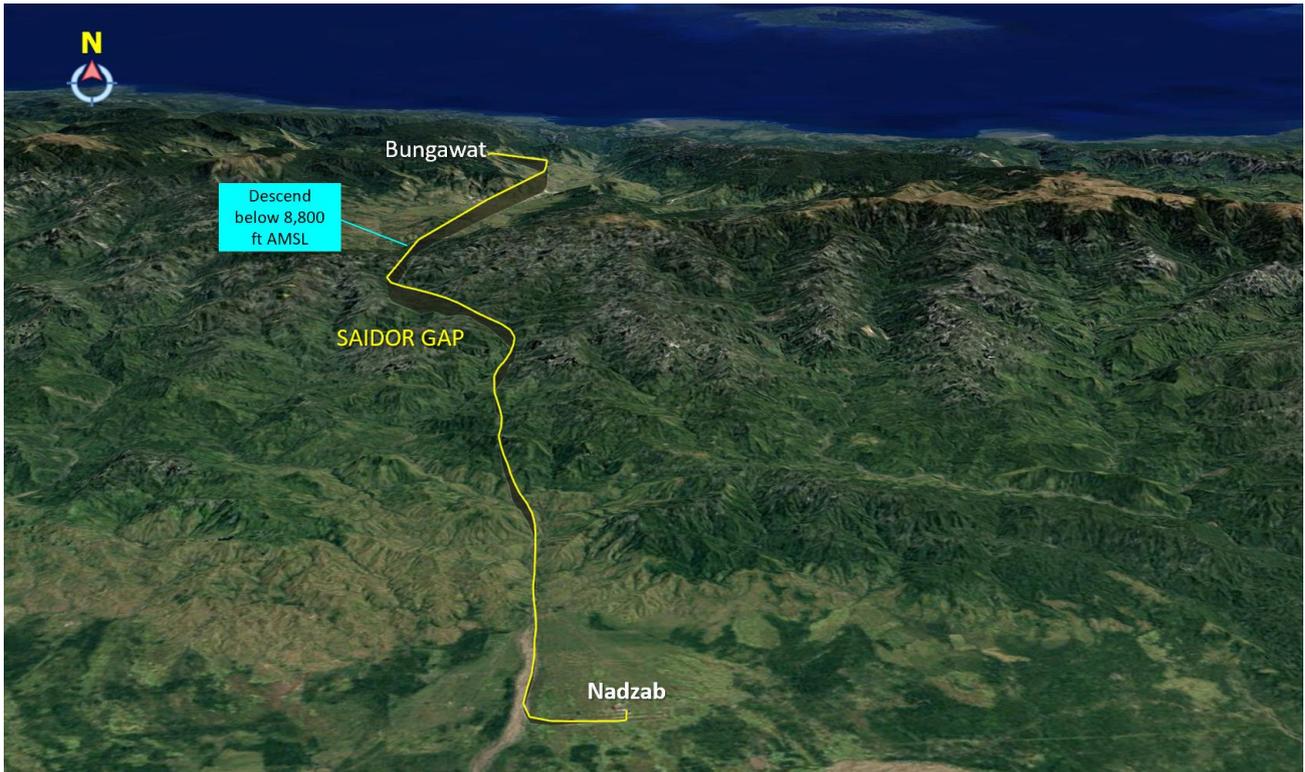
Figure 2: P2-NCA flight path from Nadzab to Bungawat Airstrip.

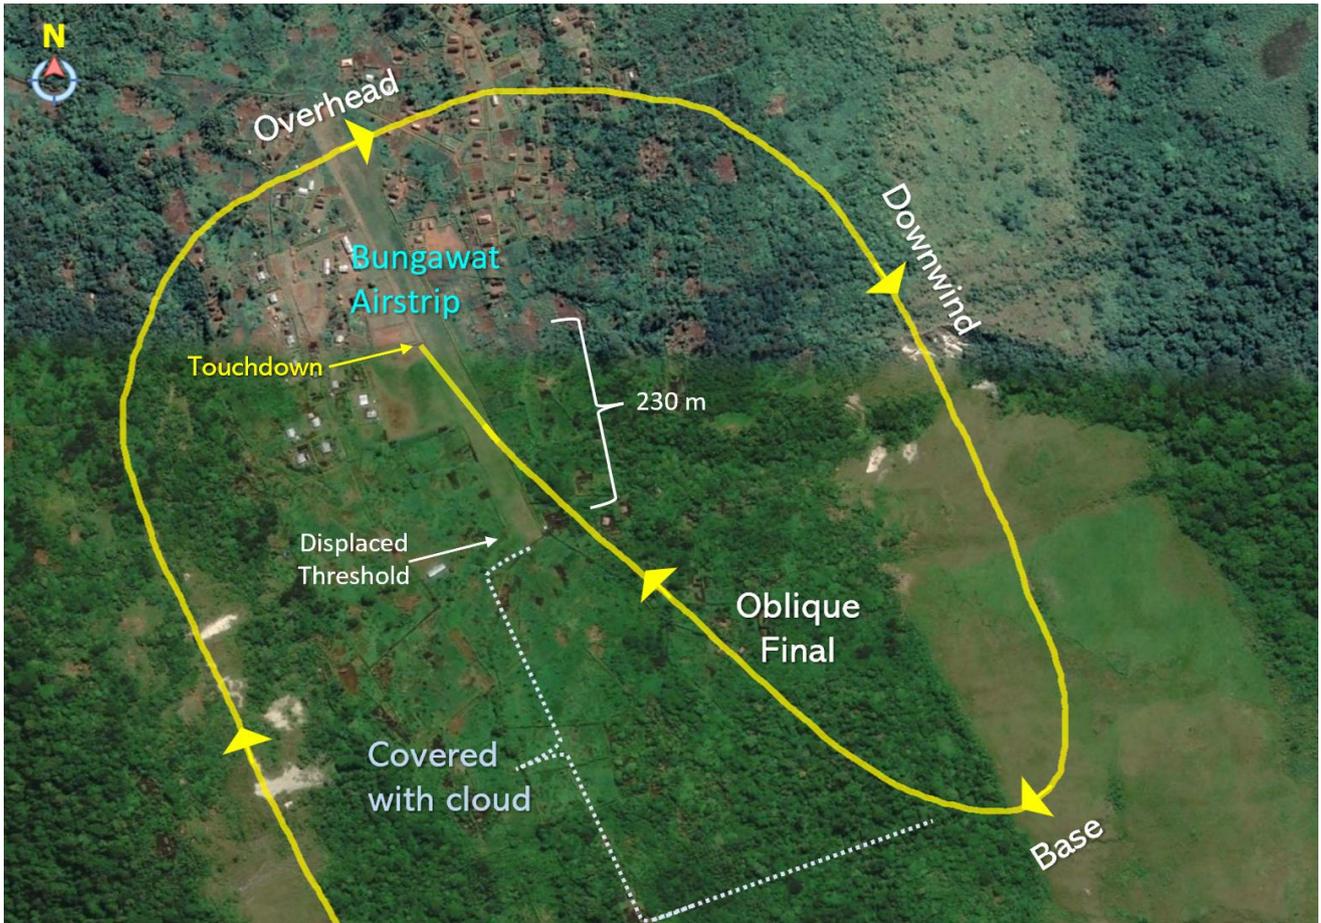
Figure 3: P2-NCA estimated overview of the circuit (Source: V2 Track recorded data and pilot interview)

The flight crew stated that they experienced a hard landing. The aircraft touched down at about 230 m beyond the displaced threshold of runway 36, towards the left of centerline. The pilot subsequently applied full right rudder to bring the aircraft back onto the centerline, however the pilot overcorrected, resulting in the aircraft veering to the right side of the strip.
