PRELIMINARY REPORT

AIC 25-1002

23 MAY 2025

OPERATOR	: Liddle's Aerial Spraying Pty Ltd
REGISTRATION	: VH-SOY
MANUFACTURER	: Cessna Aircraft Company
MODEL	: T188C
OCCURRENCE DESCRIPTION /CLASS/CATEGORY	: Impacted Terrain During Low Altitude Operations (LALT)
LOCATION	: Sangkiang Village, Ramu, Madang Province
OCCURRENCE DATE	: 23 April 2025

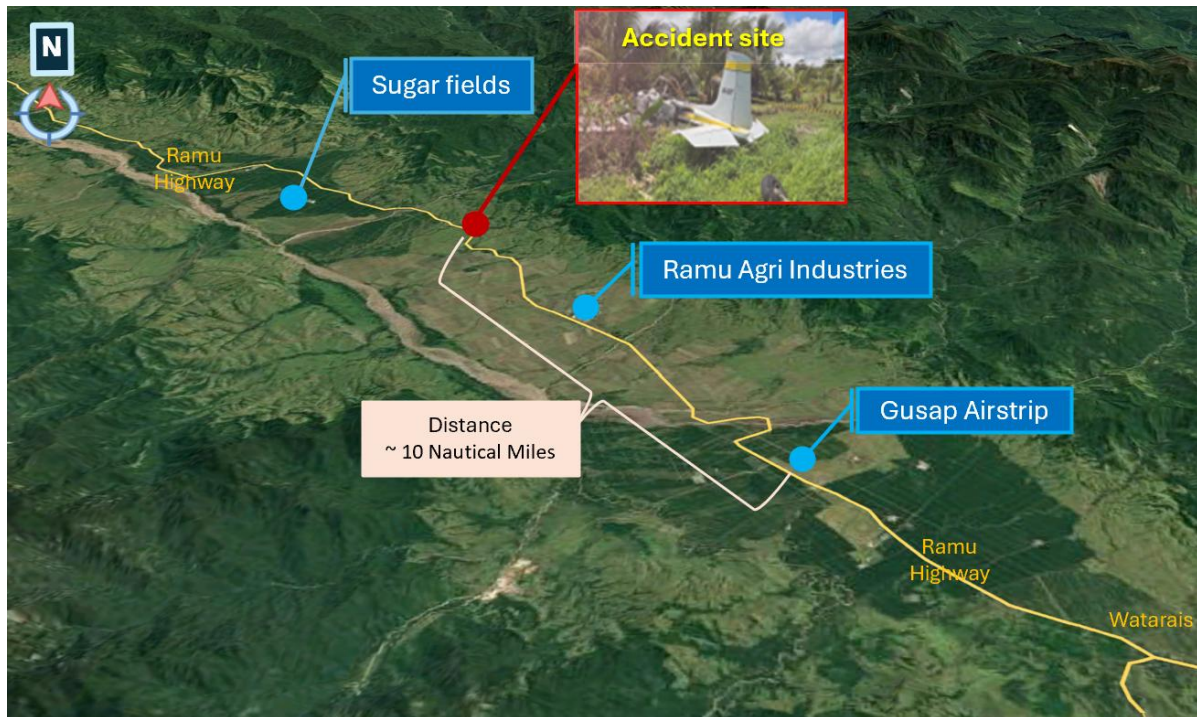
At about 08:30, while conducting the fourth round of crop spraying to the northwest, the aircraft impacted terrain at Sangkiang Village, about 10 nautical miles northwest of Gusap Airstrip.

Figure 2: Accident site in relation to Gusap Airstrip and the sugar fields.
