## FINAL REPORT

AIC 24-1003

OPERATOR	: North Coast Aviation Limited
REGISTRATION	: P2-SAM
MANUFACTURER	: Pilatus Britten-Norman
MODEL	: BN2B-26 Islander
CLASS/CATEGORY	: Controlled flight into terrain
LOCATION	: 32 nm Northeast of Nadzab Airport, Morobe Province
OCCURRENCE DATE	: 22 December 2024

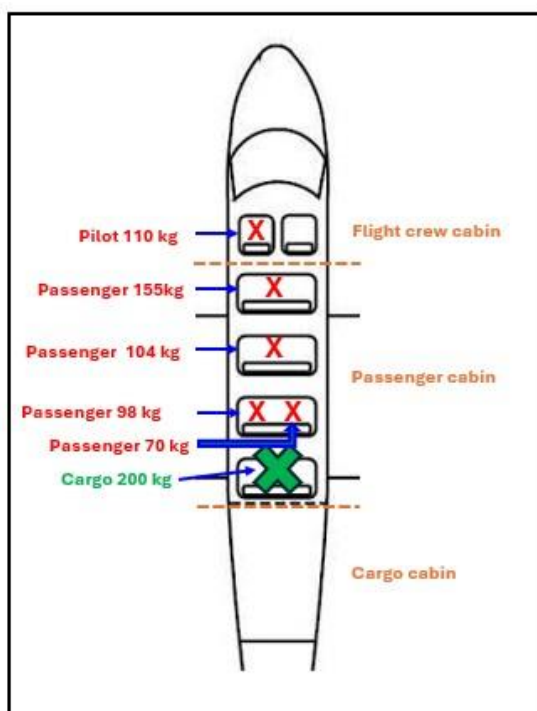
Figure 6: Weight Distribution Diagram

The pilots copy of the flight manifest for the accident flight was not recovered from the burnt aircraft wreckage. However, a copy was obtained from the Operator's agent in Wasu. The agent also provided details of where each passenger and the baggage/freight were located in the aircraft.<sup>13</sup>

<sup>13</sup> Figure 6 was prepared by the AIC from information supplied by the NCA agent at Wasu.

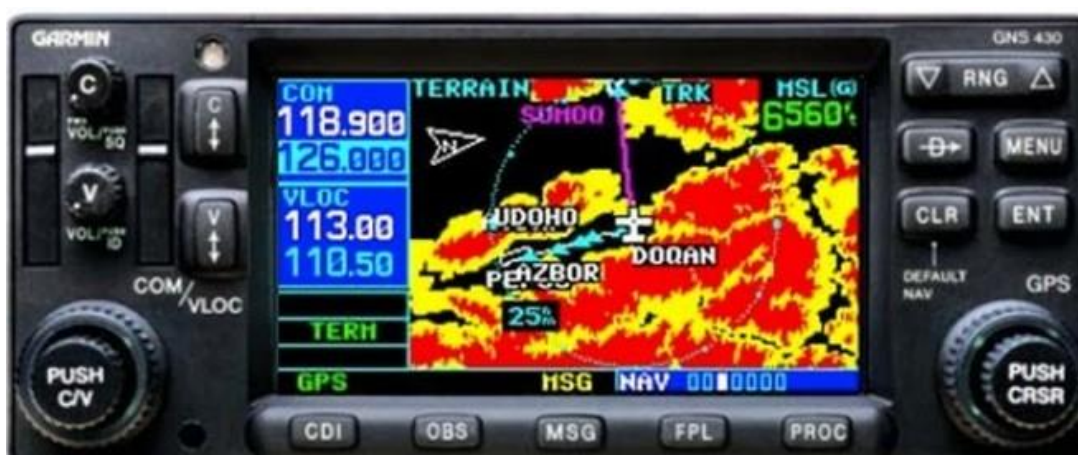
Figure 10: Garmin 430W receiver screen showing indicative terrain display

The operator informed the AIC that the installed *Garmin 430W* receiver was serviceable. The AIC found no evidence that it was not serviceable prior to departure from Nadzab.

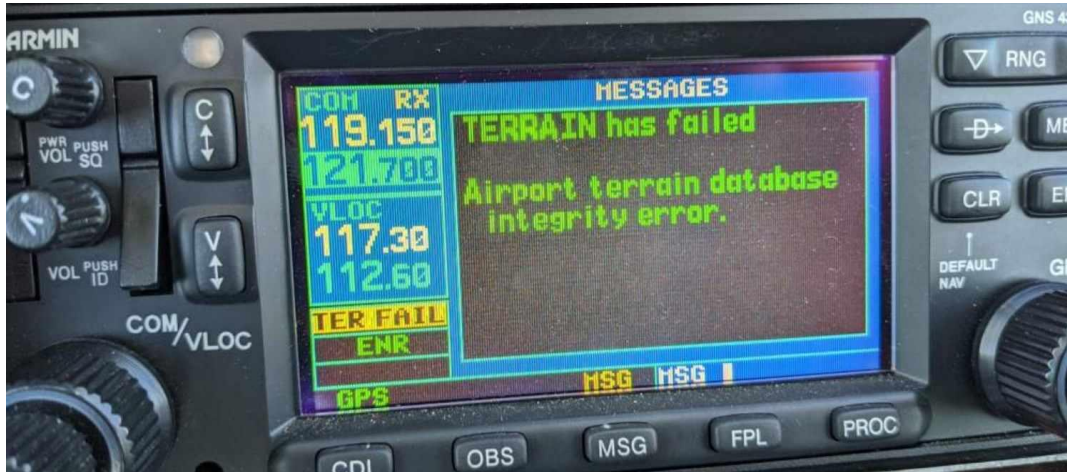
Figure 11: Garmin 430W receiver screen showing indicative terrain fail display

If the Garmin 430W TAWS system becomes unserviceable during flight it is designed to display a green coloured “TERRAIN has failed” message on the receiver’s screen.

Accordingly, if the Garmin 430W TAWS feature of the receiver had become unserviceable during accident flight, the pilot would have received a green coloured “TERRAIN has failed” message on the receiver’s screen.

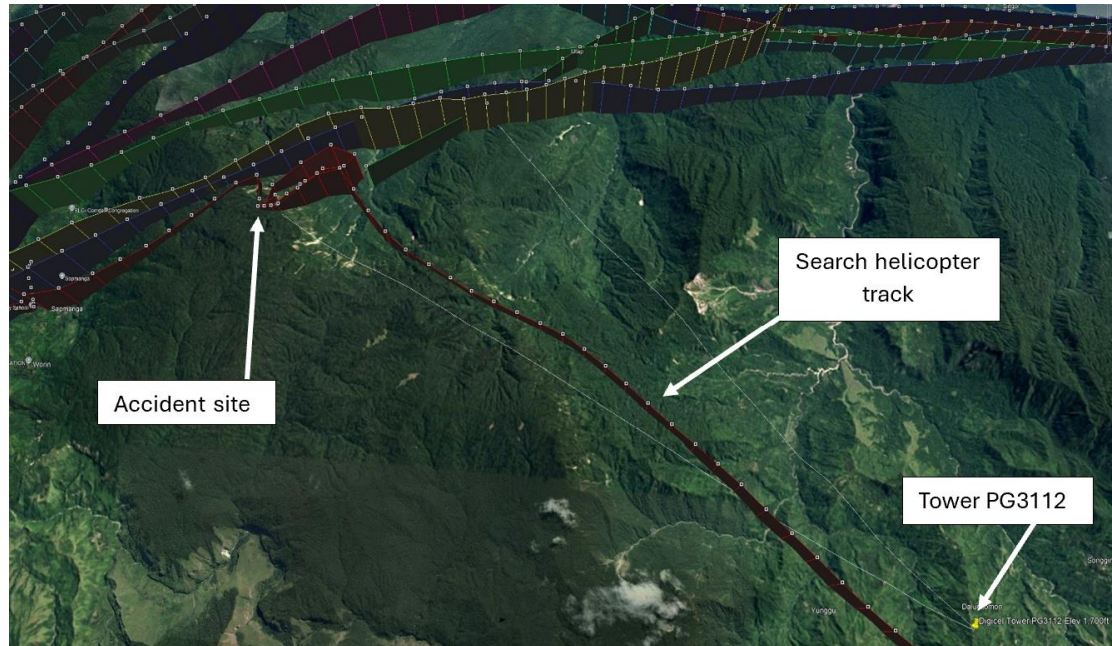
Figure 24: Search helicopter track and Digicel Cellular Tower

The Manalos Aviation search helicopter was tracked using the V2 Track system. Enroute to the accident site the Digicel Cellular Tower PG3112 automatically interrogated the search helicopter. The cell tower is located 12.08 NM bearing 115 deg from the accident site. PG3112 is 3.35 NM on a bearing of 105.24 deg to Derim airstrip.
