FINAL REPORT

AIC 25-1001

OPERATOR	: Tropicair Limited
REGISTRATION	: P2-AXL
MANUFACTURER	: De Havilland Aircraft of Canada
MODEL	: DHC-6-400
CLASS/CATEGORY	: Runway Excursion
LOCATION	: Kerema Airport, Gulf Province, Papua New Guinea
OCCURRENCE DATE	: 6 February 2025

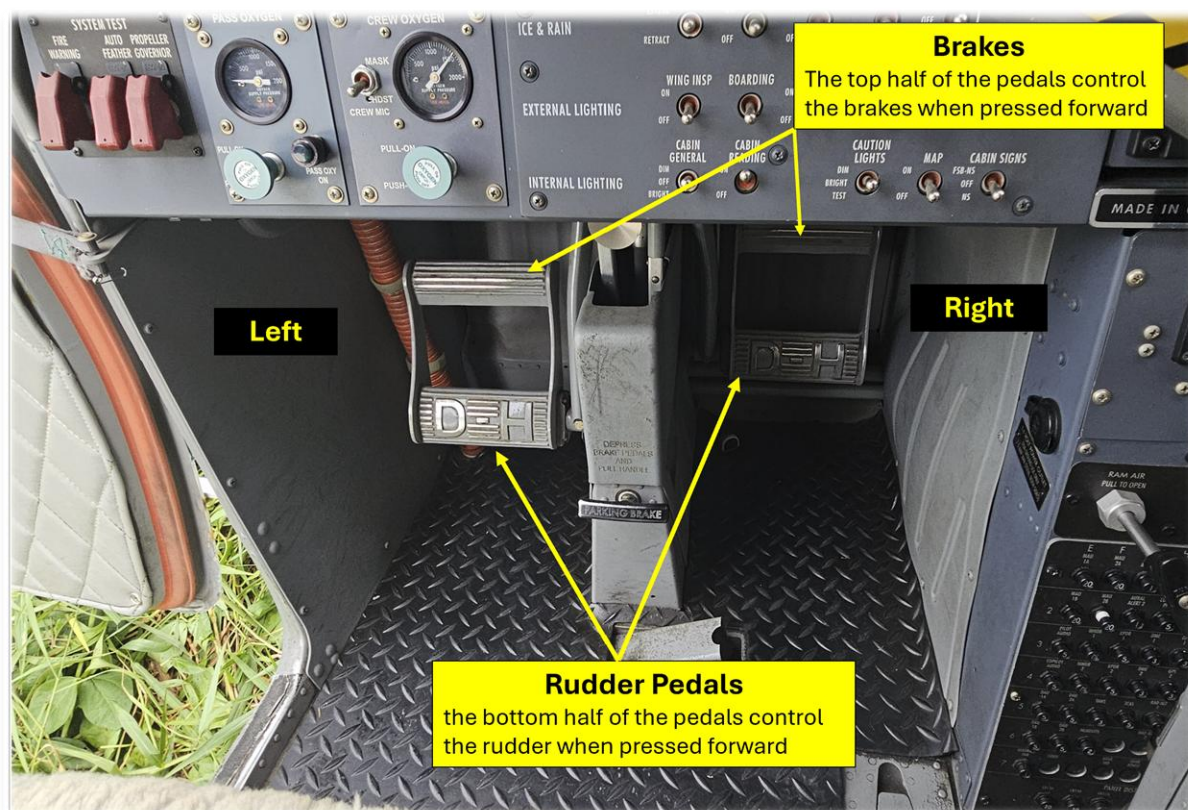
Figure 6 P2-AXL Rudder and Brake Pedals.

The rudder pedals control the aircraft's rudder, which adjusts yaw – the side-to-side movement of the aircraft's nose. They also function as independent left and right brake pedals when the top of each pedal is pressed forward.

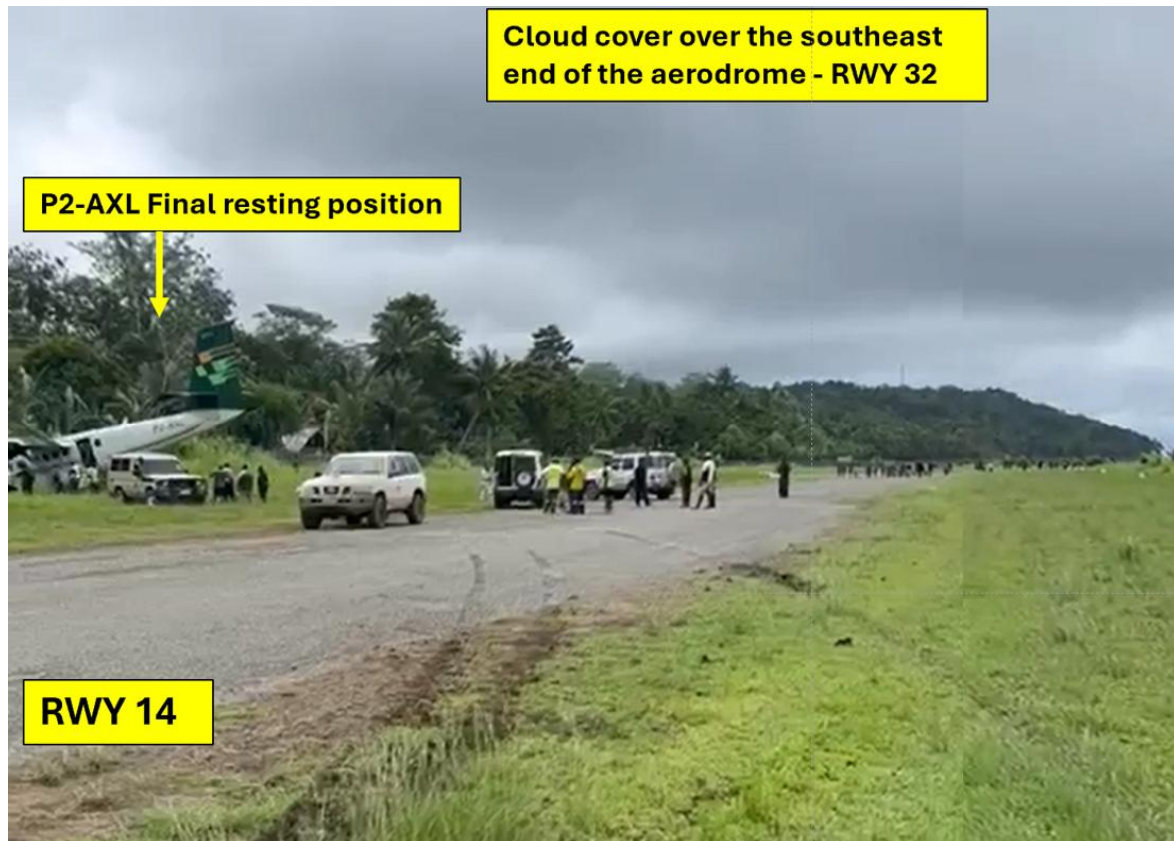
Figure 9: The cloud cover southeast of the aerodrome towards RWY 32, shortly after the accident: (Picture capture provided by a passenger after the evacuation from P2-AXL).

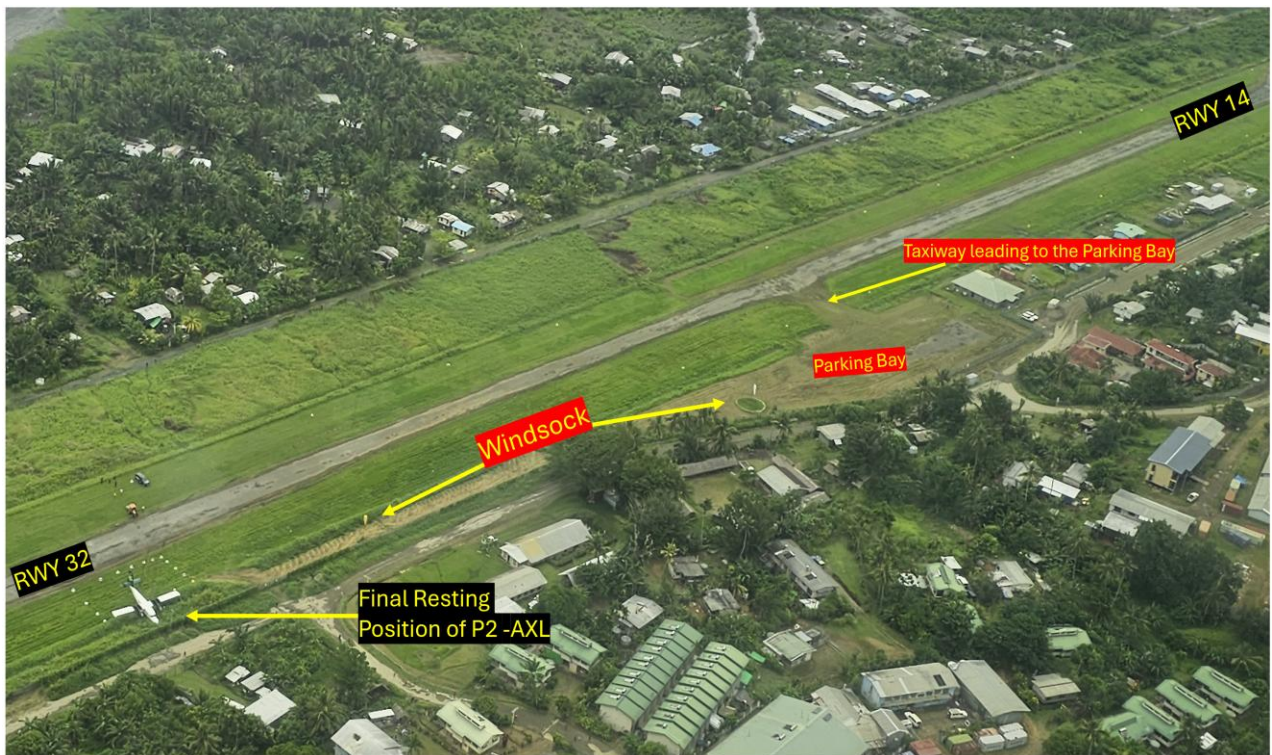
The main runway at Kerema Airport which composed of a bitumen surface, exhibited overall signs of deterioration. The surface appeared uneven in certain areas, with visible erosion and potholes along the runway. Vegetation encroachment was observed along the edges of the runway, where overgrown grass was seen extending inward toward the bitumen surface making the narrow runway width.

Adjacent to the bitumen surface, the grass edge is relatively short in height compared to the taller and denser grass located beyond the runway cones and extending up to the perimeter fencing. These grass areas that slope into drainage ditches along the edges of the runway, were observed to contain thick, overgrown vegetation as well as standing water and mud.

Figure 11: Aerial view of Kerema (AYKM) aerodrome.

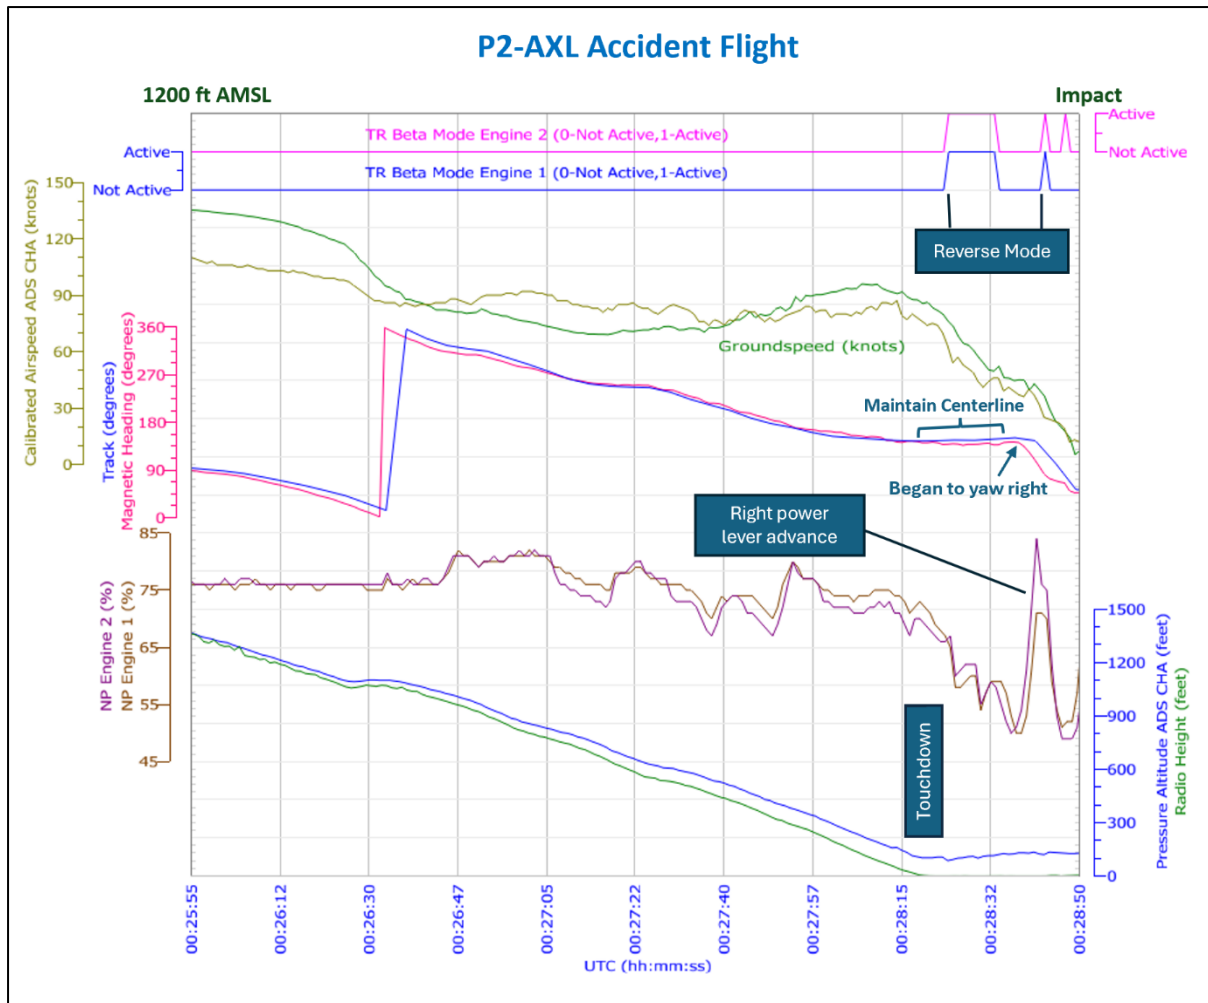
The FDR captured key parameters from the accident flight, which were plotted and analysed by the AIC to understand the sequence of events. The data spans from approximately 1,200 ft AMSL to the point of impact. Refer to Figure 13 below.

Figure 13: P2-AXL from 1,000 ft AMSL to impact.

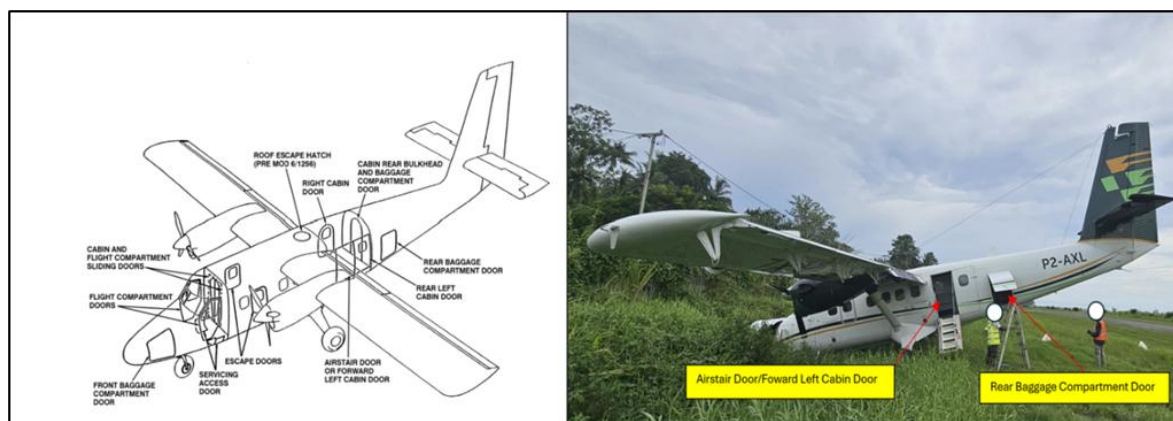
According to the crew, once the aircraft came to a complete stop and the engines were shut down by the PIC, the co-pilot made his way to the back of the aircraft and evacuated the passengers through the airstair door/forward left cabin door. Onsite investigation identified that the passengers were evacuated through the airstair door/forward left cabin door.

The co-pilot then offloaded all baggage from the rear baggage compartment door of the aircraft and relocated the passengers to a safe area away from the aircraft.

Figure 18: Aircraft schematic and P2-AXL post occurrence indicating door used for evacuating passengers and baggage compartment used to retrieve passenger baggage.
