**ACCIDENT INVESTIGATION COMMISSION**  
**OFFICE OF THE CHIEF COMMISSIONER**

**Safety recommendation: AIC 19-R22/18-1002**

**Addressed to: Air Vanuatu (Operations) Limited**

**Investigation link: AIC 18-1002**

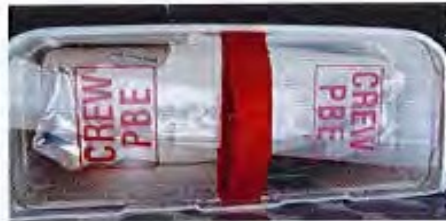
F7.02\_P8A: PBE stowage box

The PBE is a device that completely encloses the head of the wearer and seals around the neck with an elastic membrane. The unit is vacuum sealed in a bag and installed in a protective stowage box within the aeroplane cabin.

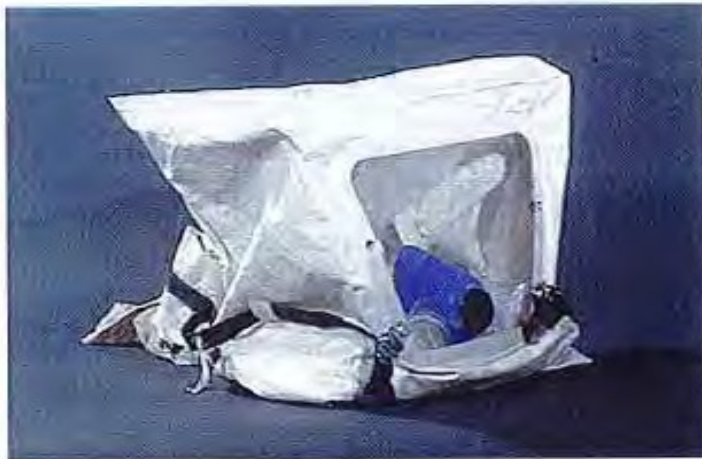
F7.02\_P8B: PBE deployed

The PBE can be worn with spectacles (eyeglasses).
