OFFICE OF THE CHIEF COMMISSIONER

Safety recommendation: AIC 19-R19/18-1002

Addressed to: Avions de Transport Regional (ATR) Limited

Recommendation number *AIC 19-R19/18-1002* to Avions de Transport Regional (ATR) Limited

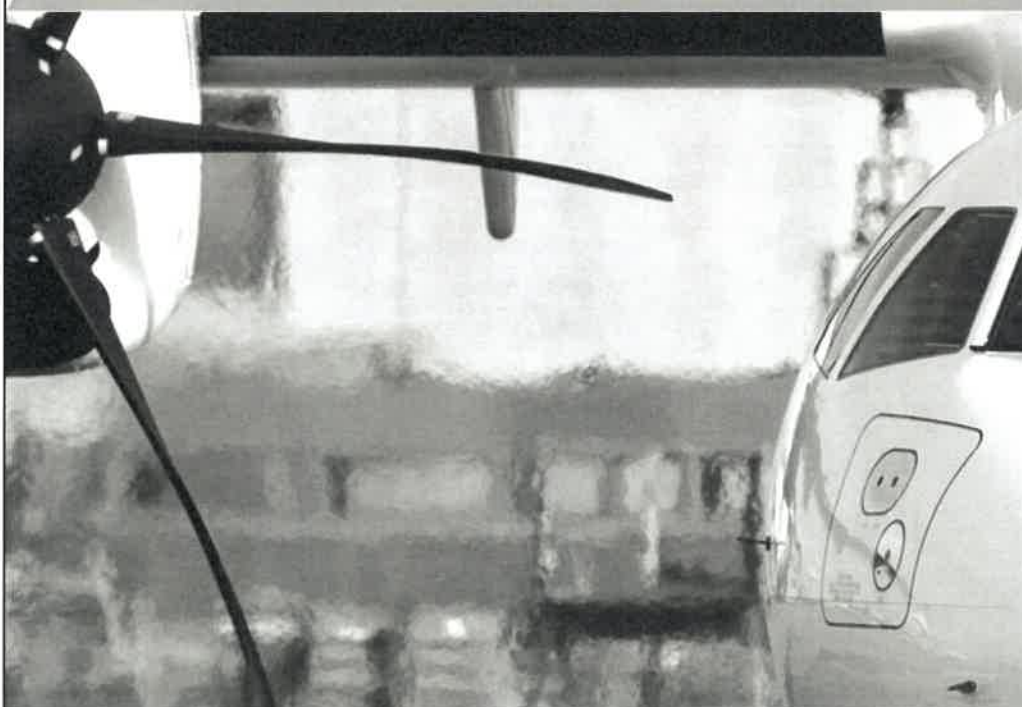
QRH Quick Reference Handbook

On 14 October 2022, Avions de Transport Regional (ATR) Limited issued a QRH revision package to address the safety deficiencies identified in AIC *Safety Recommendation AIC 19-R19/18-1002*.
